the **play inspection** company

Annual Inspection

Rendlesham Parish Council

Jubilee Park Play Area

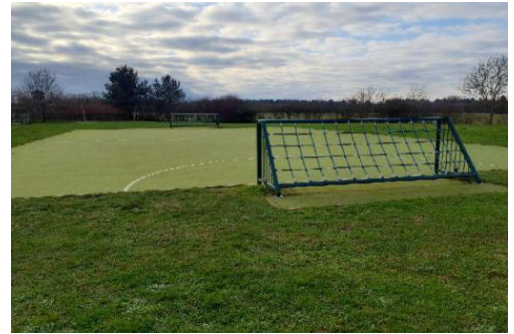
Finding 1
 There are trip hazards at the edges of the surface - Reinstate surrounding surface levels to remove the trip points

Finding 2
 The design of the equipment may encourage climbs onto the goal, and the concrete edgings form an hard object in the impact area in contravention of BS EN 15312 - Refer to the manufacturer / contractor and modify the design to comply with the requirements of BS EN 15312

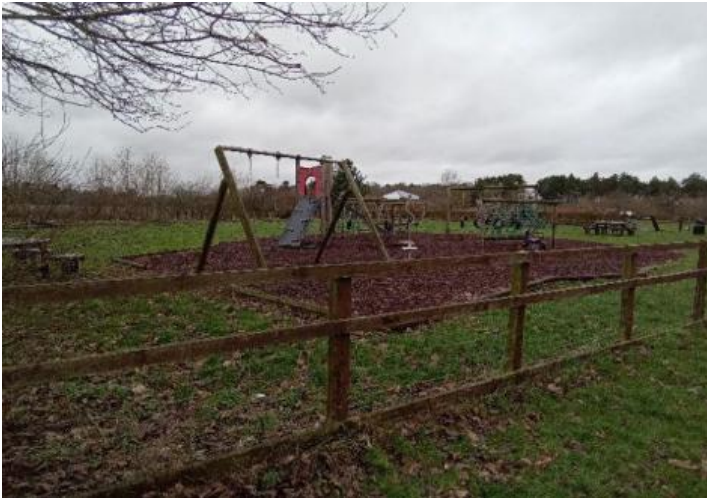
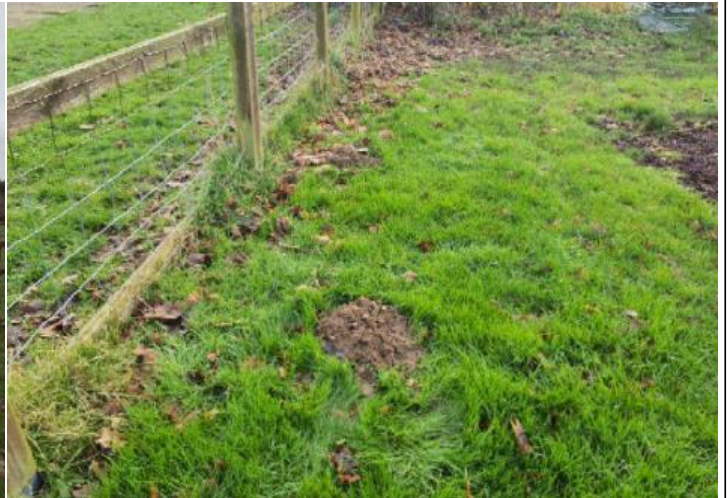
Finding: There are a number of molehills within the area and these may present unforeseen hazards for users

Action: Remove moles by appropriate means, reinstate surfaces to level and maintain the area

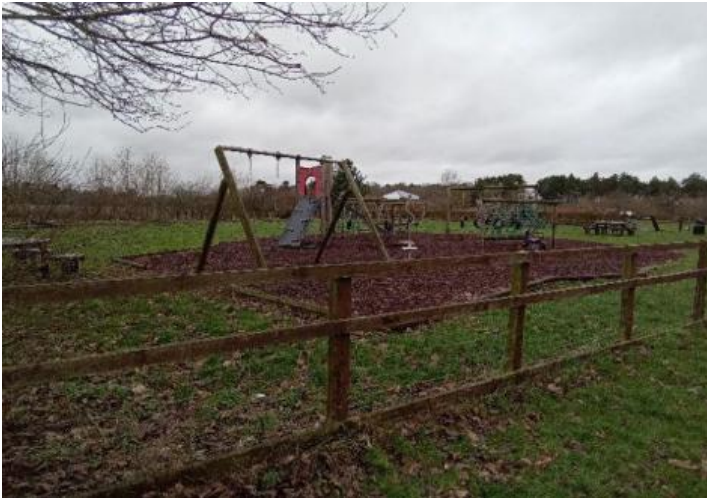
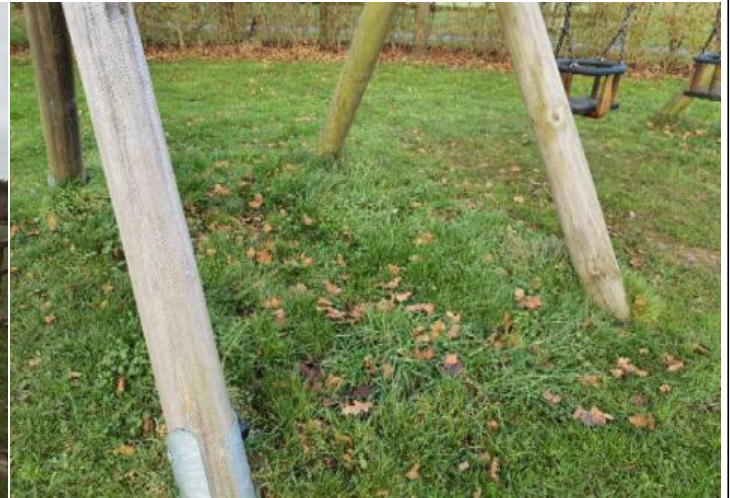
Finding: The grass is overgrown within the play area and may hide hazards

Action: Reduce the length of grass to an acceptable height and maintain

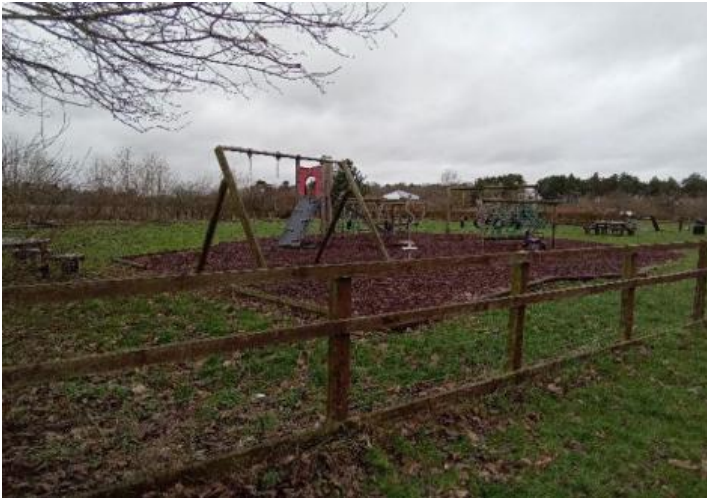
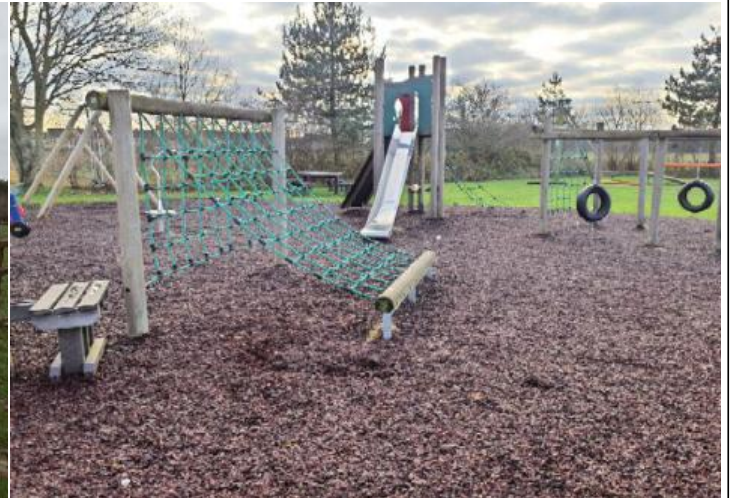
Finding: The depth of the loose fill surfacing is lower than the recommended depth specified in BS EN 1176; the free height of fall of the equipment is less than 2.0m and a minimum of 300mm depth should be provided (including an extra 100mm to allow for compaction and displacement as per BS EN 1176 Part 1 - Table 4)

Action: Top up loose fill surfacing to recommended levels

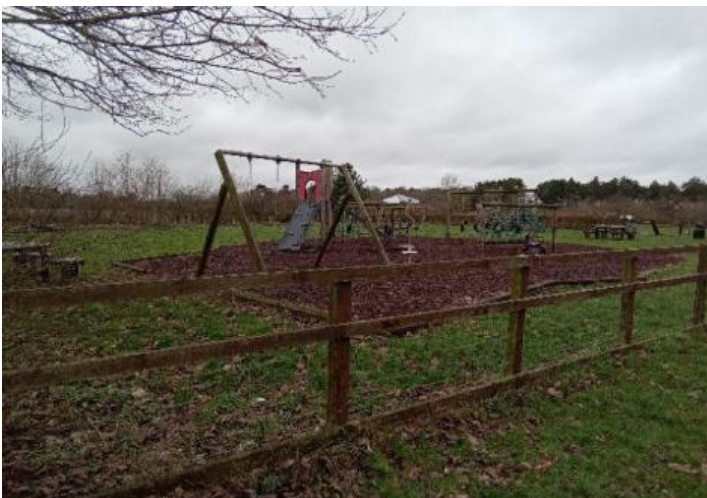
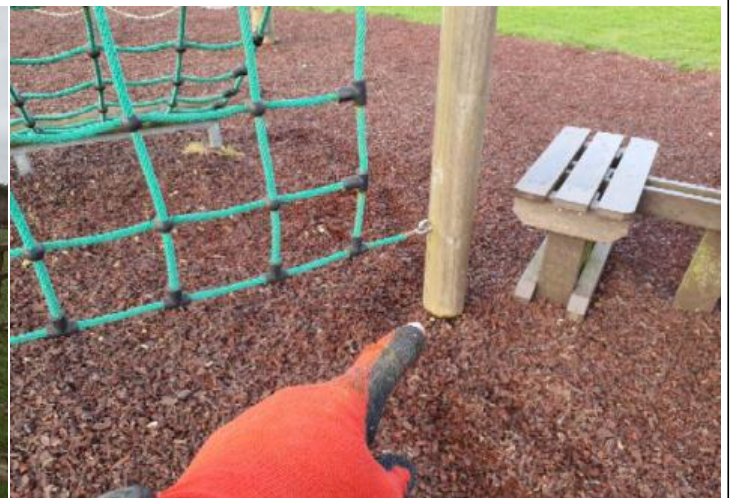
Finding: There is some evidence of rot in the timber

Action: Monitor for any further deterioration and replace as required

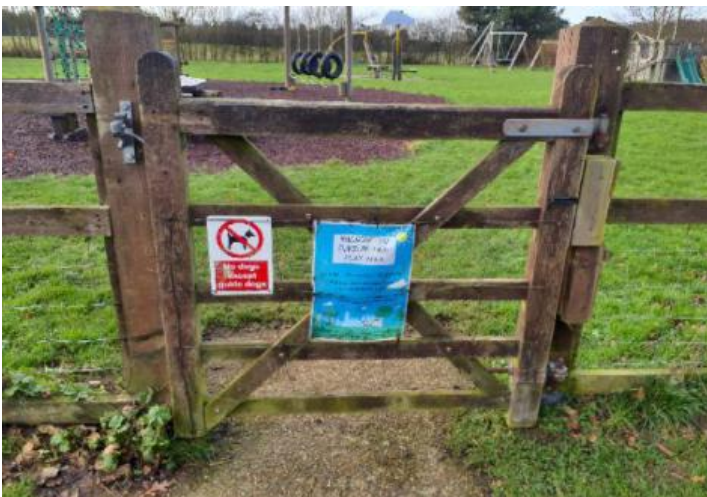
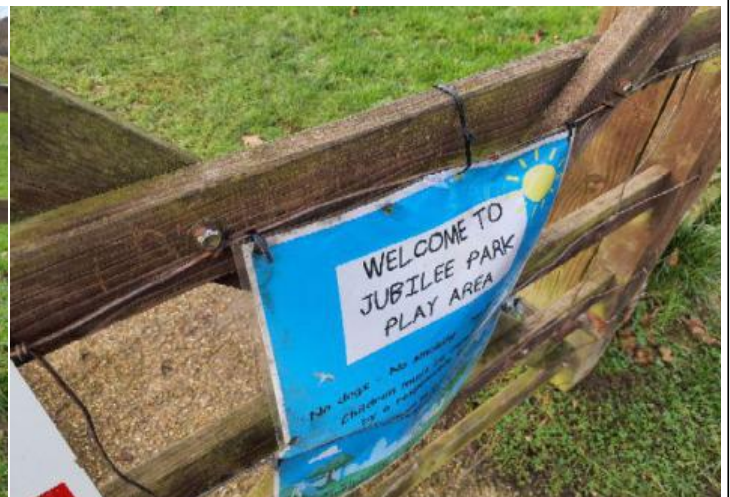
Finding: Cable ties are present and there are sharp projecting ends

Action: Replace with a more appropriate fixing method

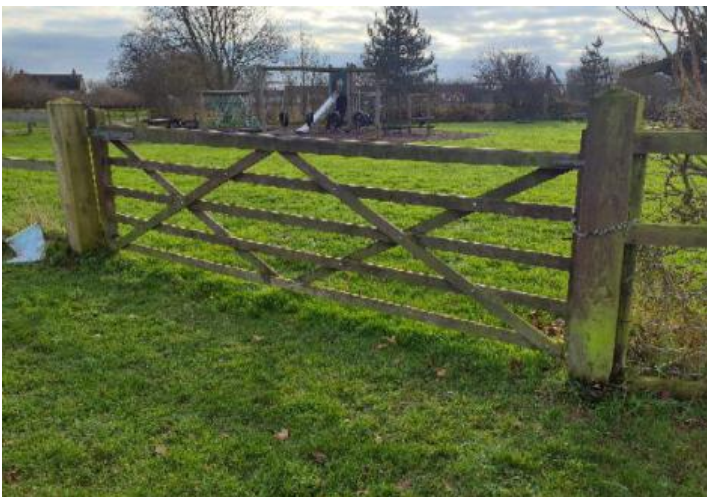
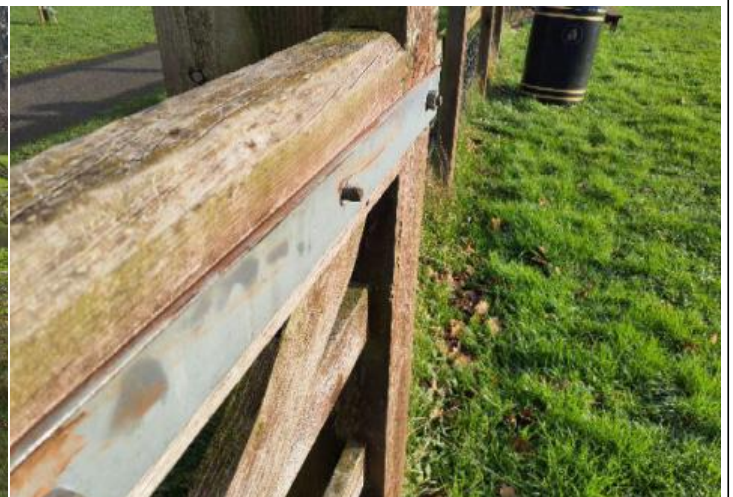
Finding: There is or are fixings missing on the item

Action: Replace all missing fixings

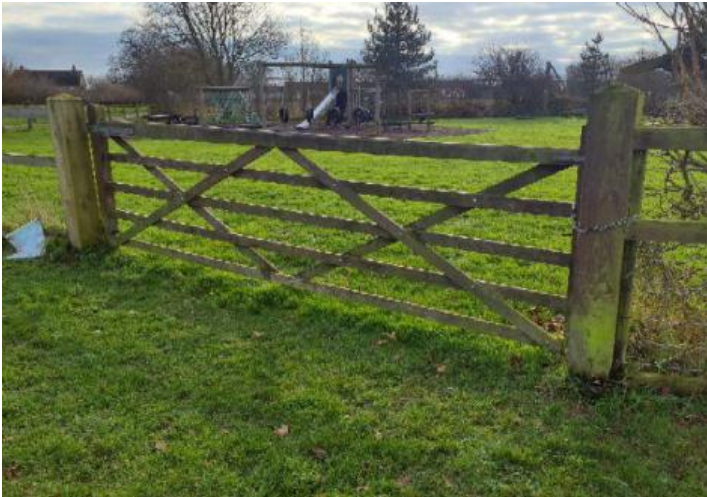
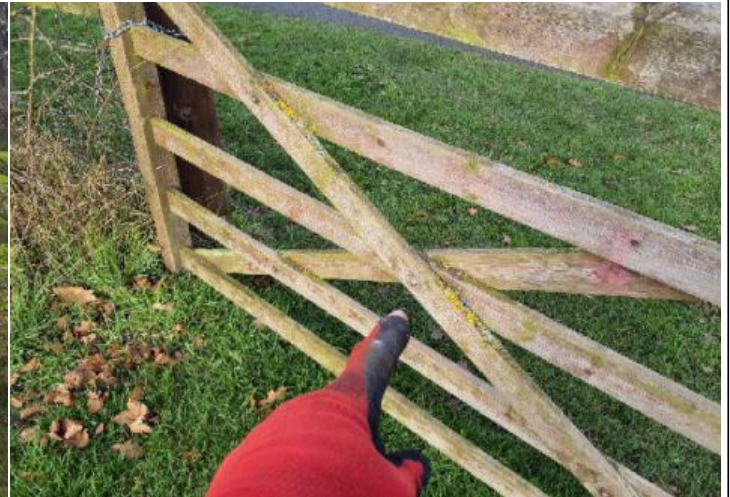
Finding: There is or are fixings missing on the item

Action: Replace all missing fixings

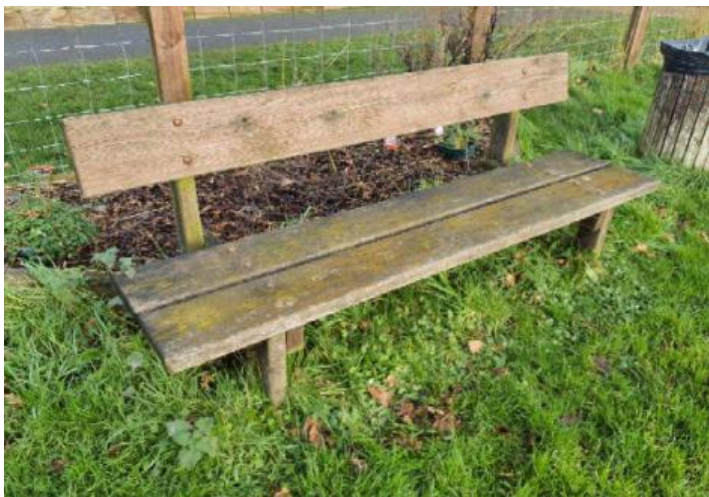
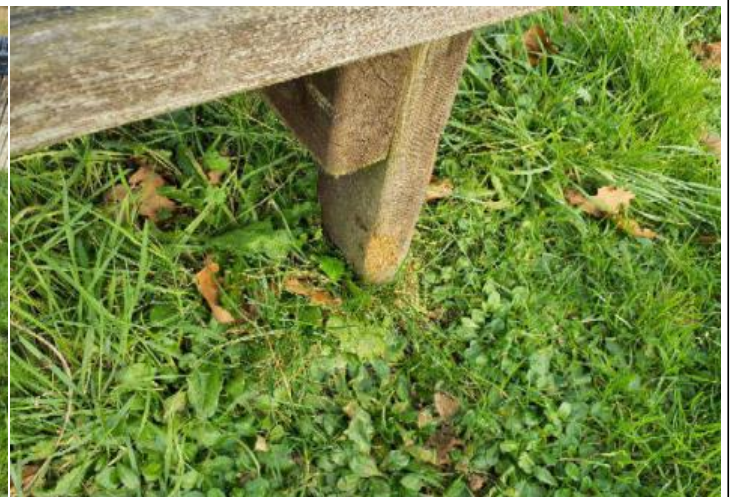
Finding: There is some strimmer / machinery damage apparent on the posts, this can penetrate the preservative applied to the timber and accelerate the rotting process

Action: Monitor for any deterioration (rot) and replace as required

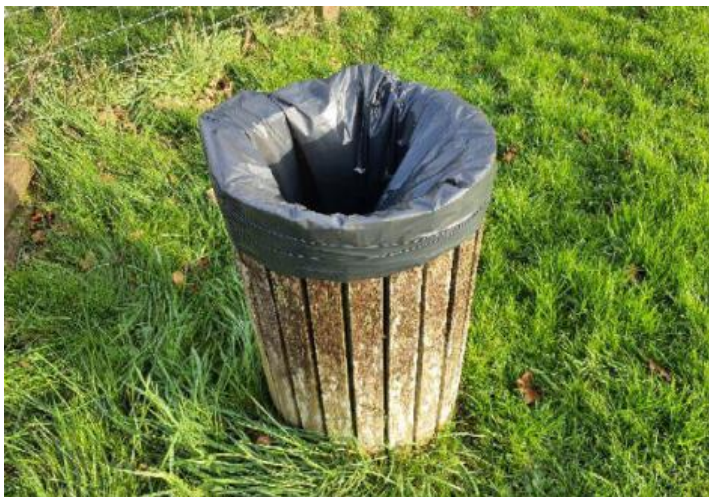
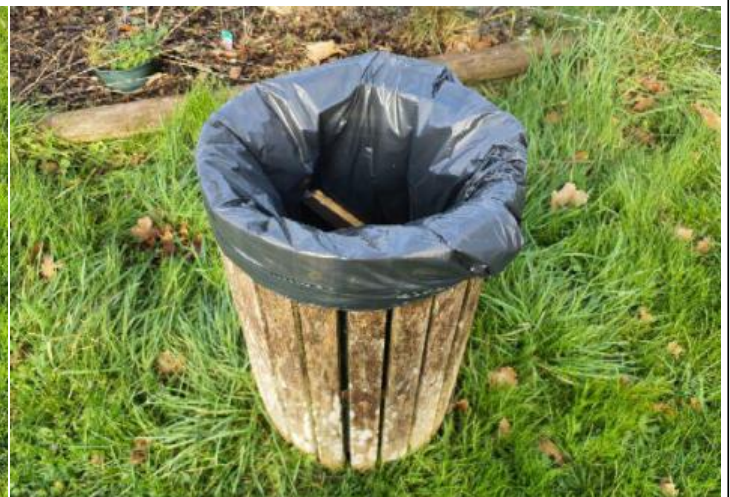
Finding: The lid of the bin is missing

Action: Replace

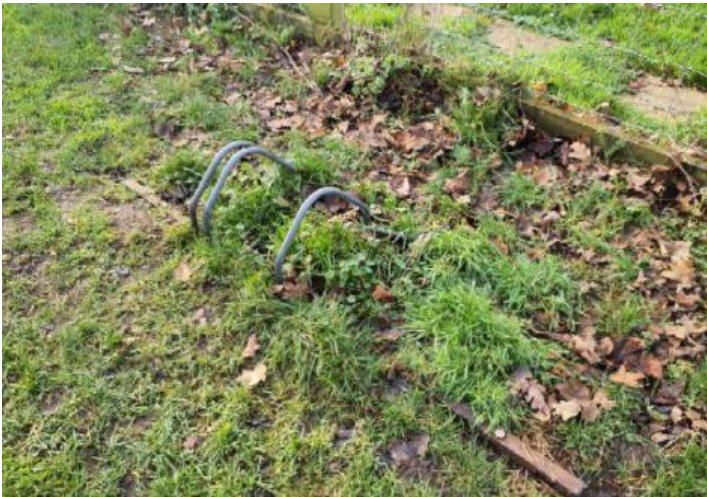
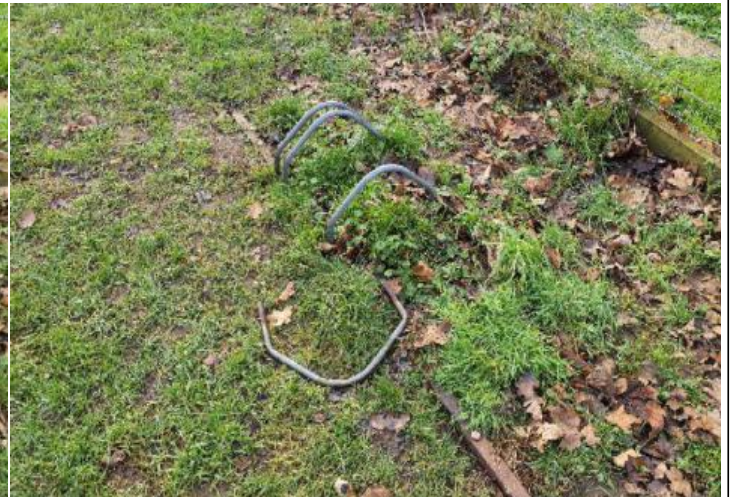
Finding: The item has been severely damaged
Action: Repair or replace the item / affected part

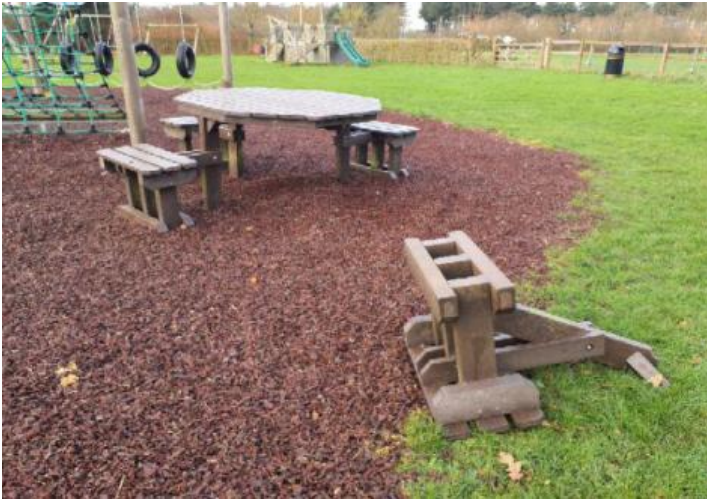
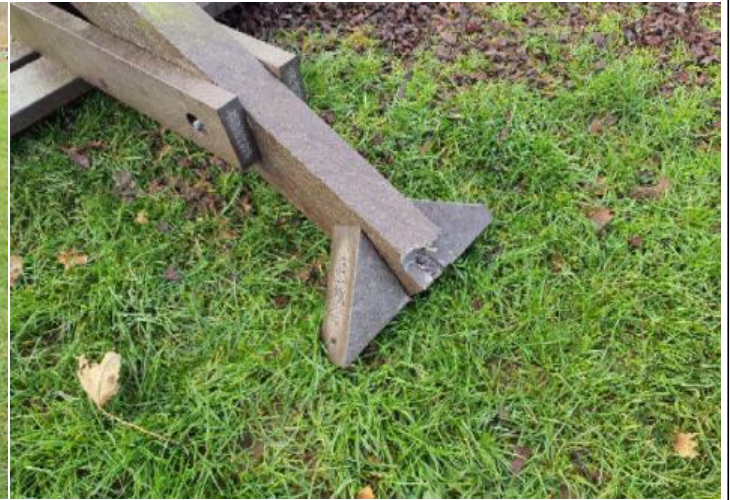
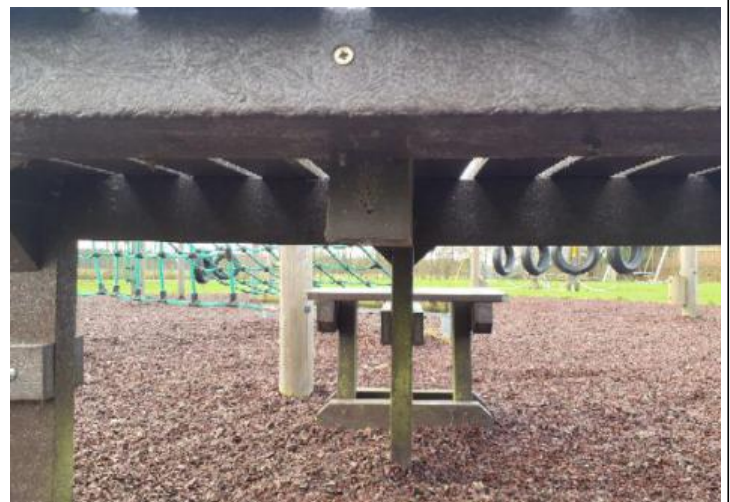
Finding: The item has been severely damaged

Action: Repair or replace the item / affected part

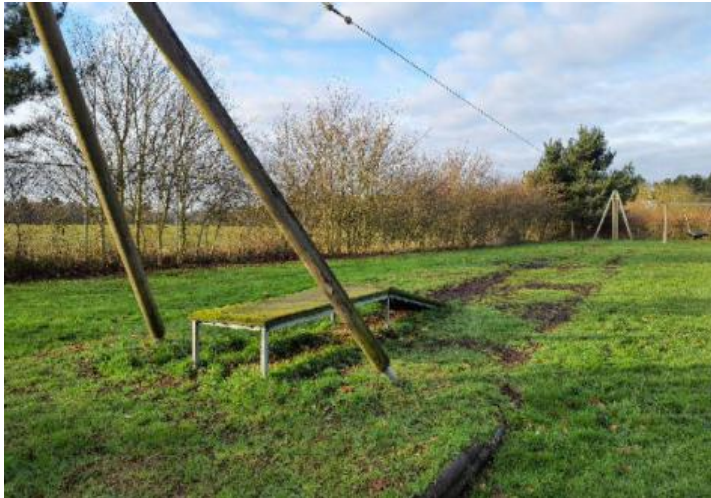
Finding: We have completed a visual inspection of the suspension links, cable and fixing points from ground level, however it is not possible to fully inspect these areas without either hiring equipment to gain access or removing the cable and suspension and inspecting at ground level. We recommend that the main cable and fixing security is thoroughly inspected at least in accordance with the manufacturers recommendations to check for wear, damage, security or internal rusting; this will help to ensure the continued safe use of the equipment

Action: Inspect in accordance with the manufacturers recommendations

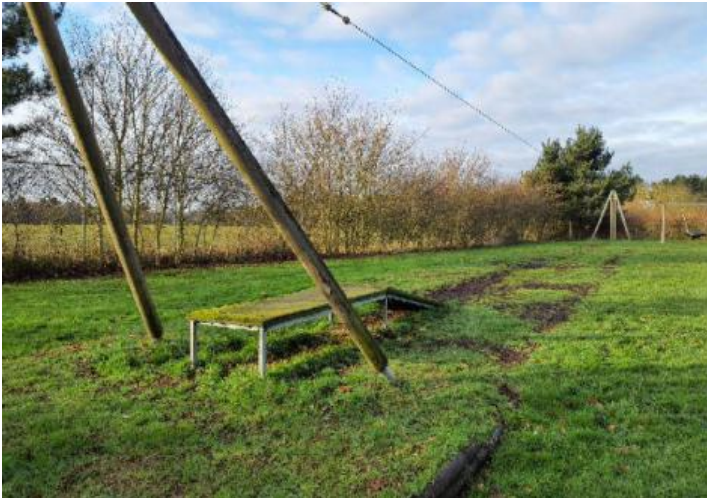
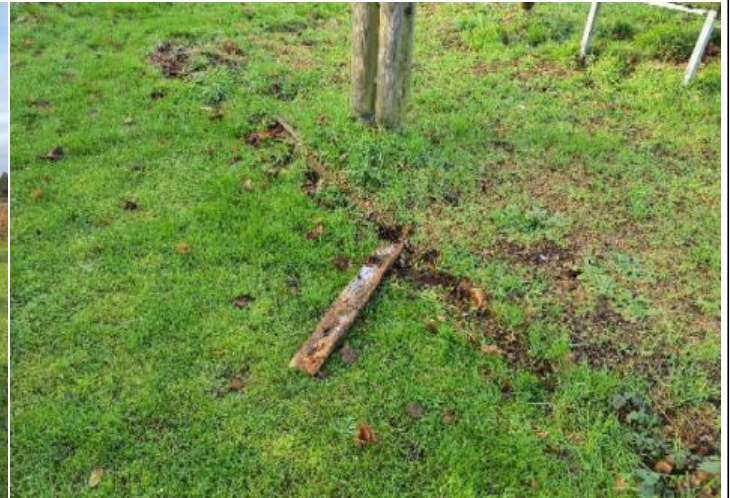
Finding: There are damaged/ unsecured edgings in the area

Action: Remove or replace

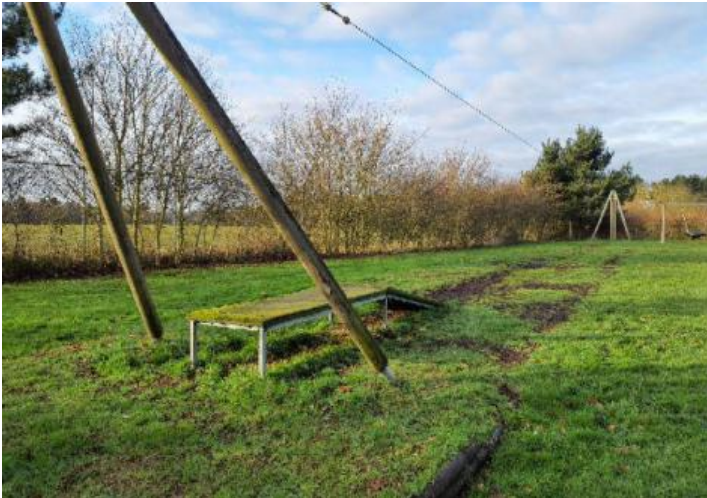
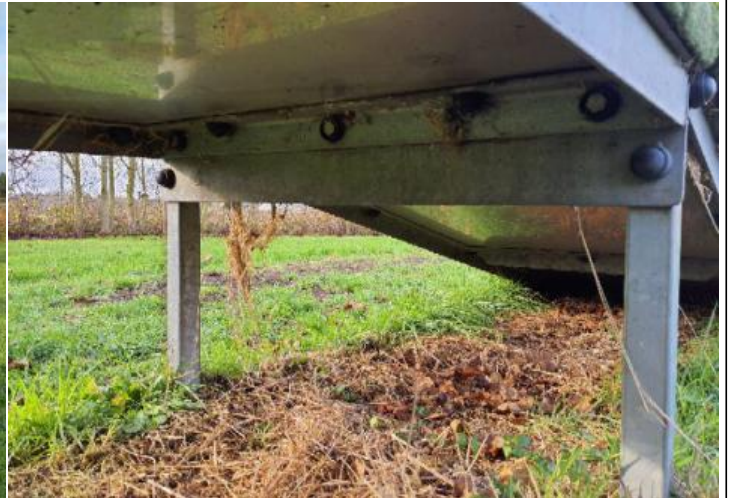
Finding: There is/are bolt cap covers missing or damaged on the item

Action: Replace missing or damaged bolt cap covers

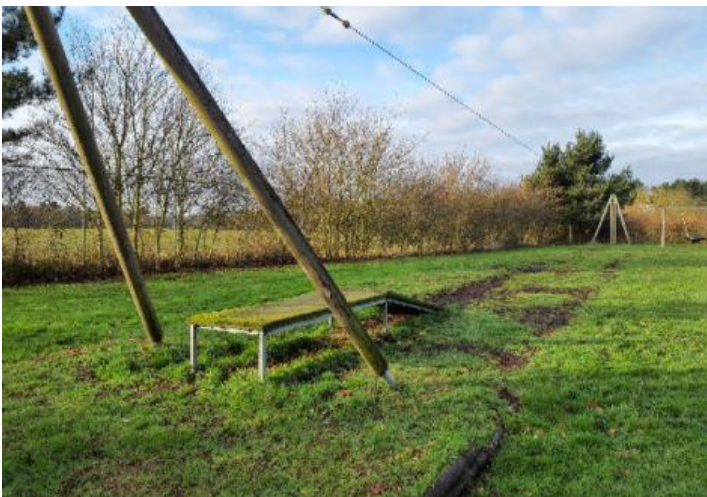
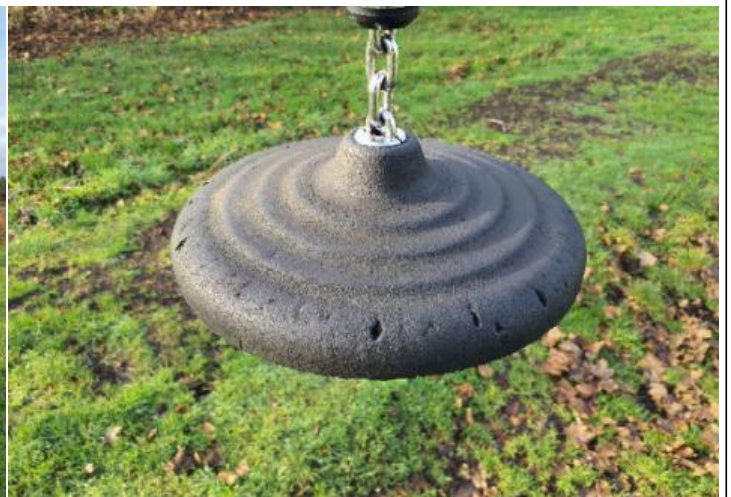
Finding: The cableway seat has been damaged

Action: Monitor for any further deterioration and replace as required

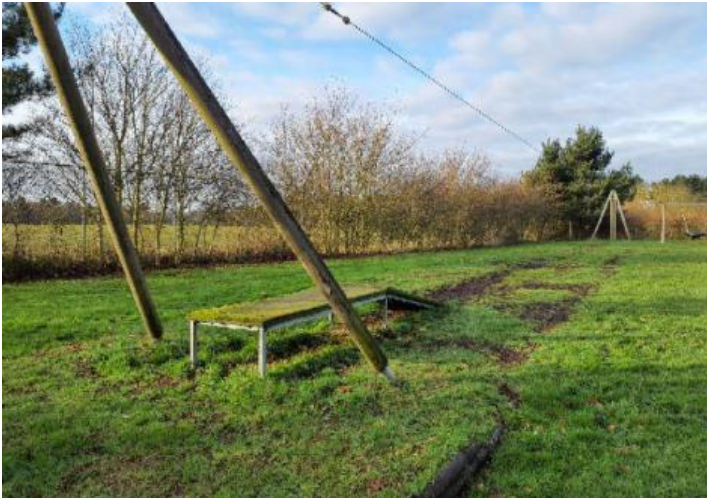
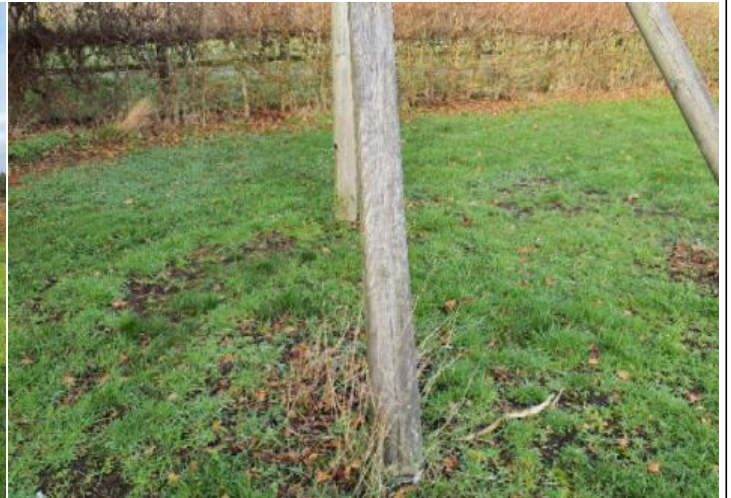
Finding: The timber has a number of splits/shakes or air cracks and this may affect the stability or allow water ingress which will accelerate the rotting process
Action: Monitor to ensure the splits do not cross through fixing points of the structure and/or cause any instability

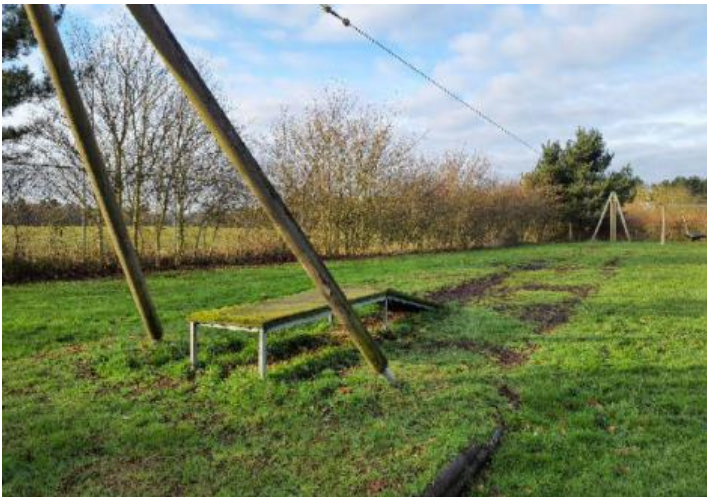
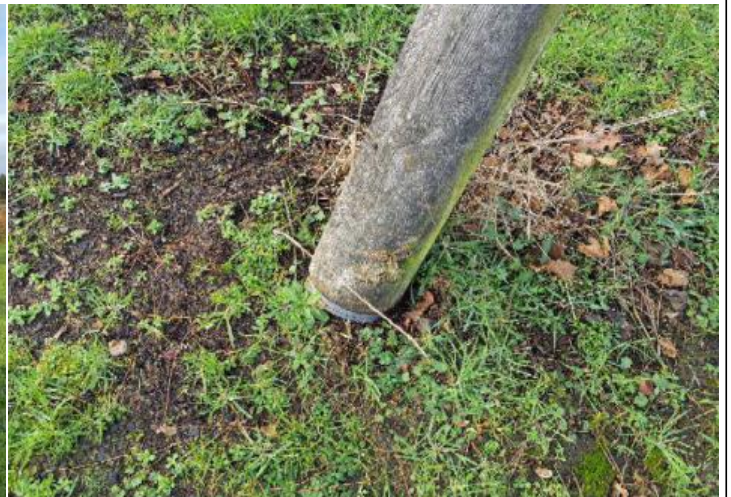
Finding: There is some strimmer / machinery damage apparent on the posts, this can penetrate the preservative applied to the timber and accelerate the rotting process
Action: Monitor for any deterioration (rot) and replace as required

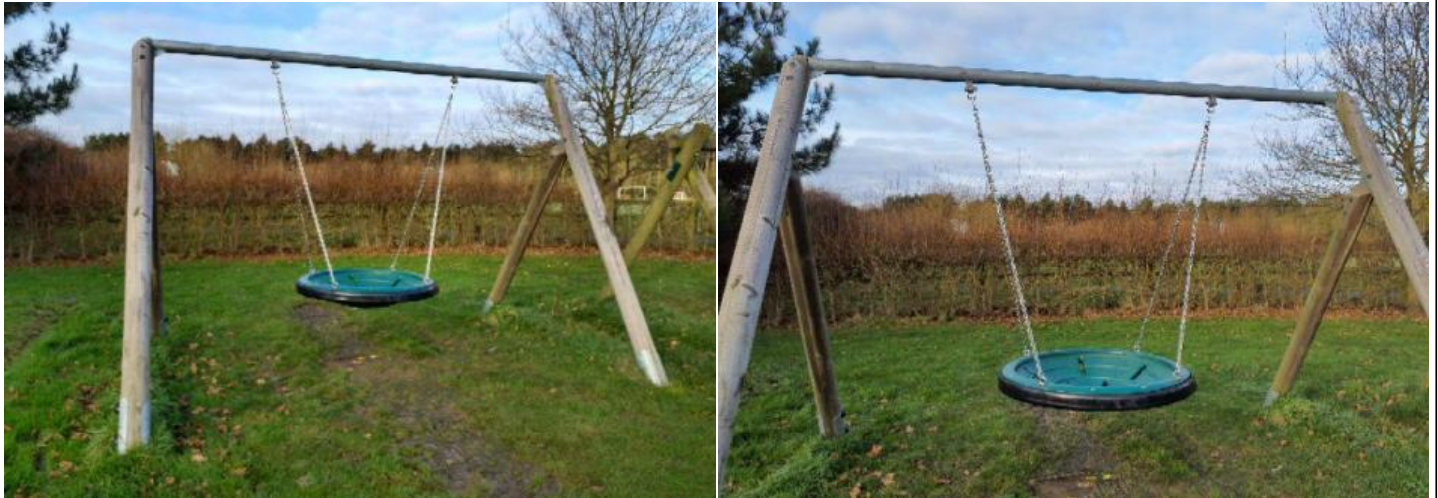
Finding: Swings of this design should have a secondary safety mechanism fitted to prevent collapse of the seat in the regularly event of a joint failure to comply with BS EN 1176 Part 2, however this swing was installed prior to the standards being updated in 2018 and the manufacturer has confirmed that the joint was independently cycle tested by BSi

Action: Monitor use and check the joint and fixing security

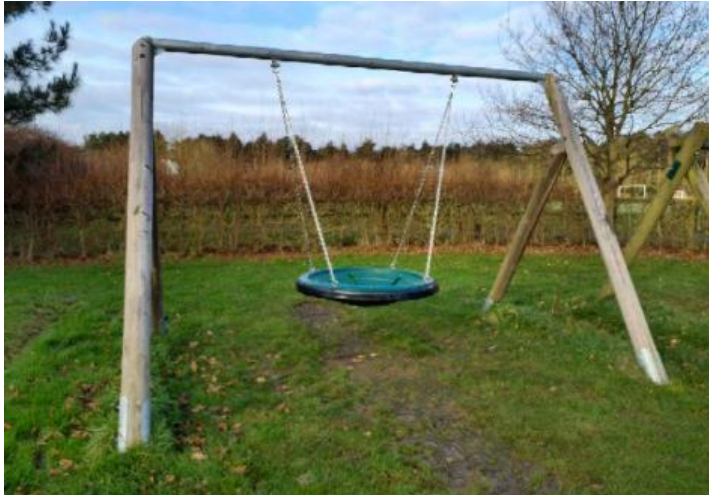
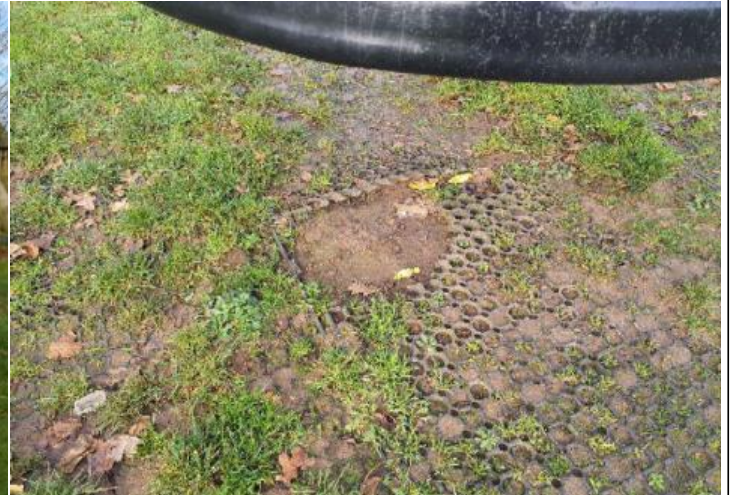
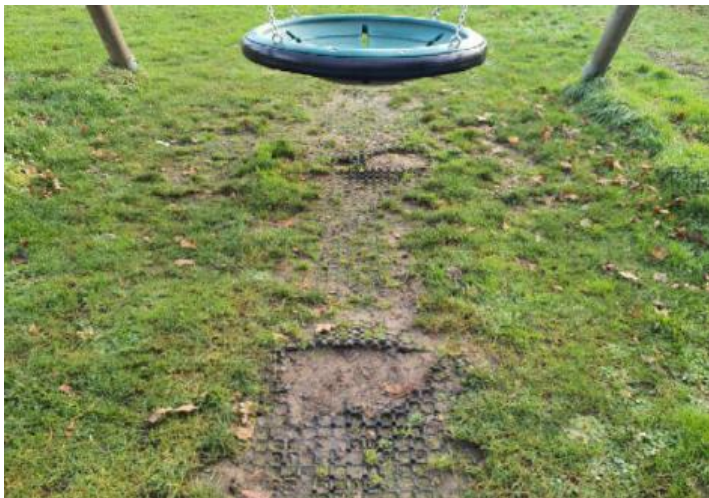
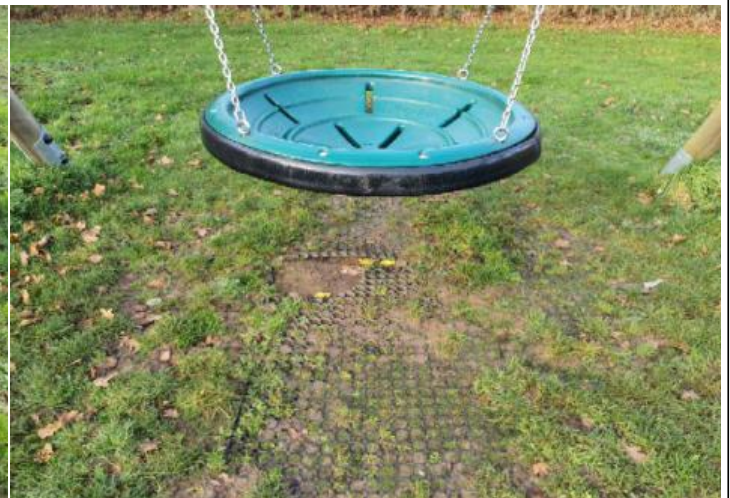
Finding: The surfacing is severely damaged

Action: Repair damaged areas of surfacing

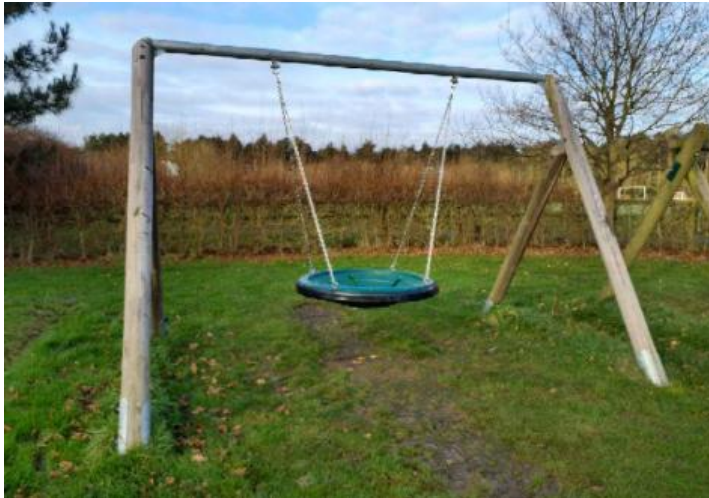
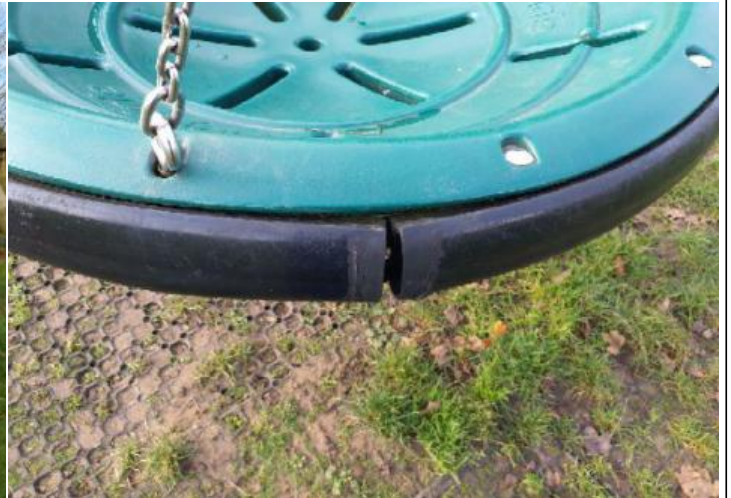
Finding: The joint collar is missing

Action: Replace

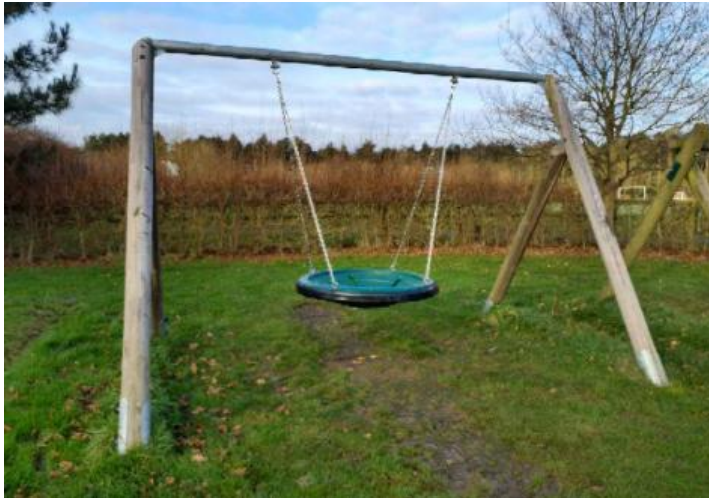
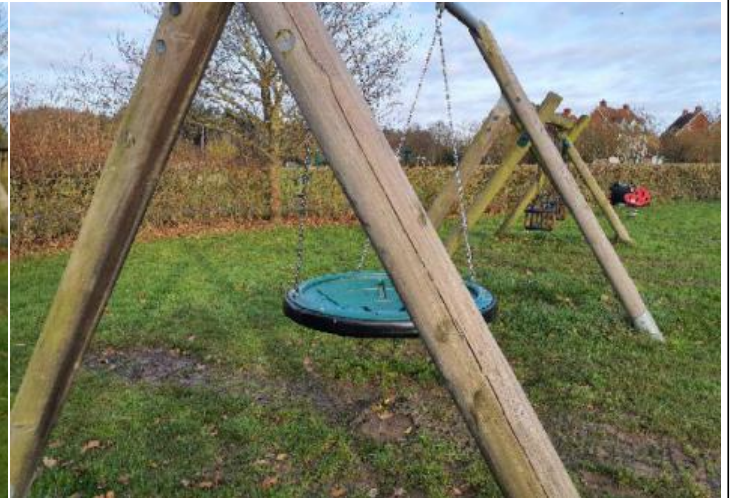
Finding: The timber has a number of splits/shakes or air cracks and this may affect the stability or allow water ingress which will accelerate the rotting process
Action: Monitor to ensure the splits do not cross through fixing points of the structure and/or cause any instability

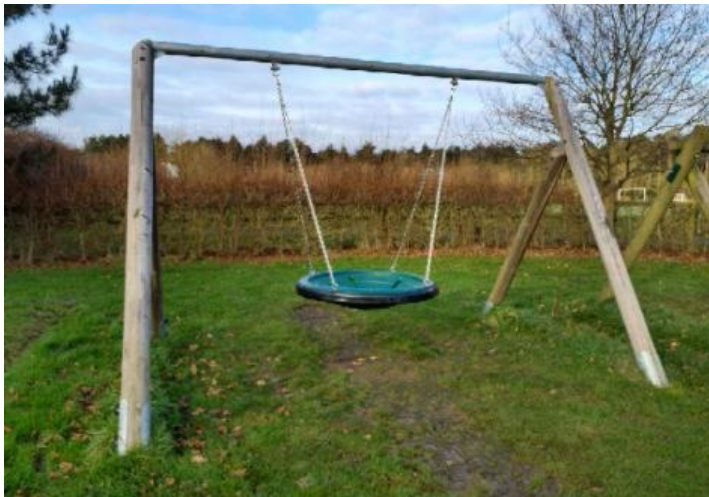
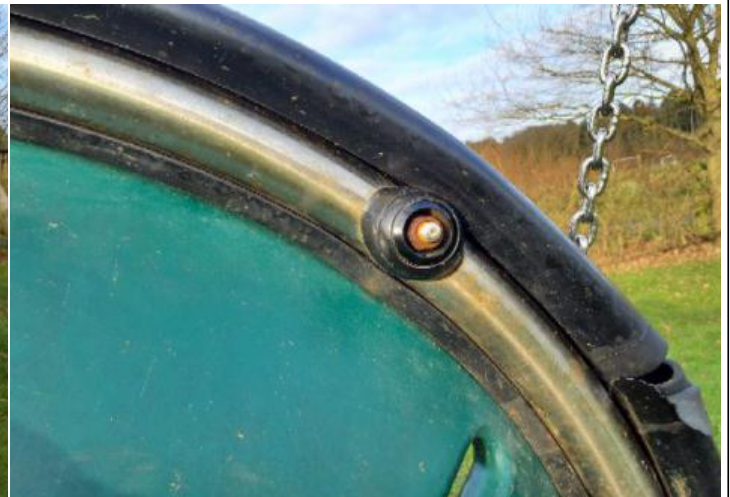
Finding: There is/are bolt cap covers missing or damaged on the item
Action: Replace missing or damaged bolt cap covers

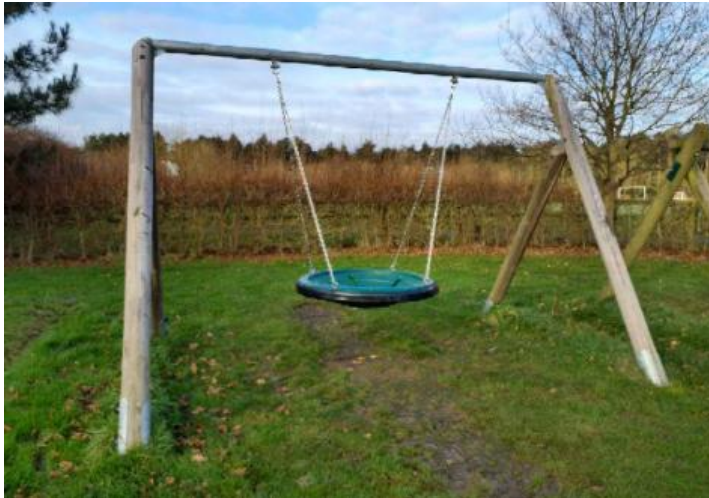
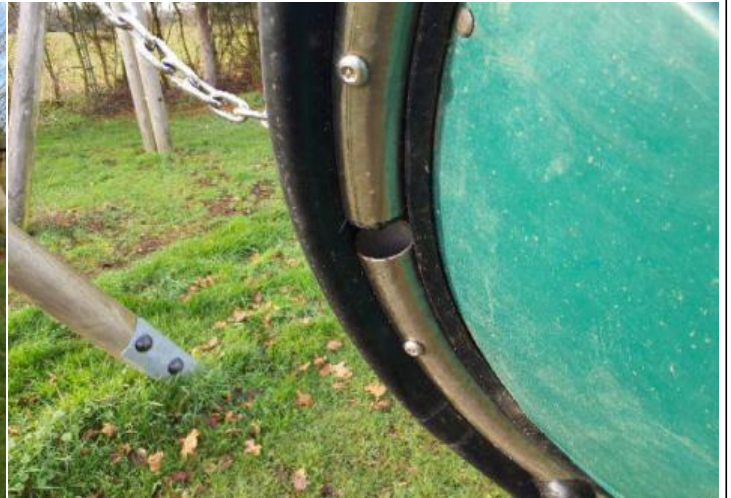
Finding: There is / are post or end caps missing / damaged on the item
Action: Replace missing / damaged post or end caps

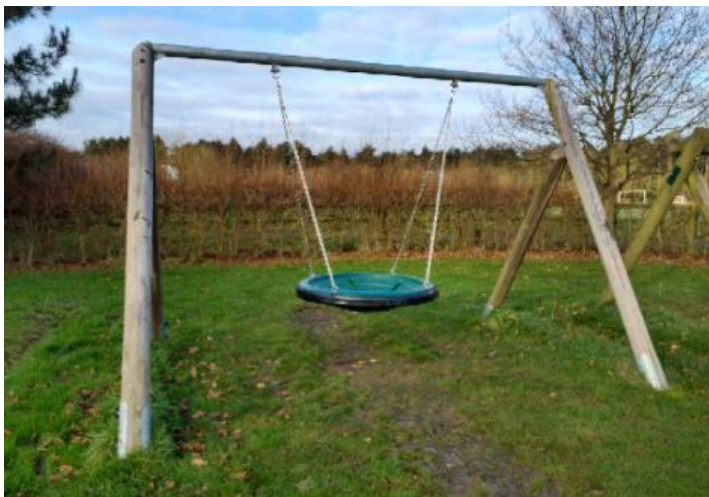
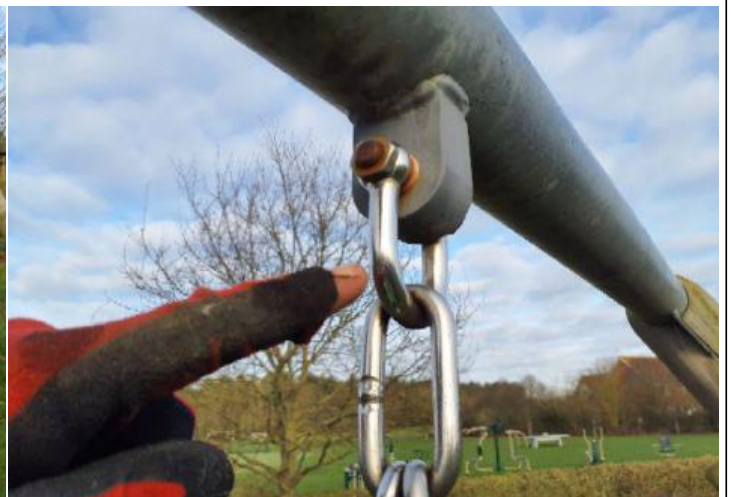
Finding: There is some notable evidence of chain wear
Action: Monitor for any further deterioration and replace when 40% worn

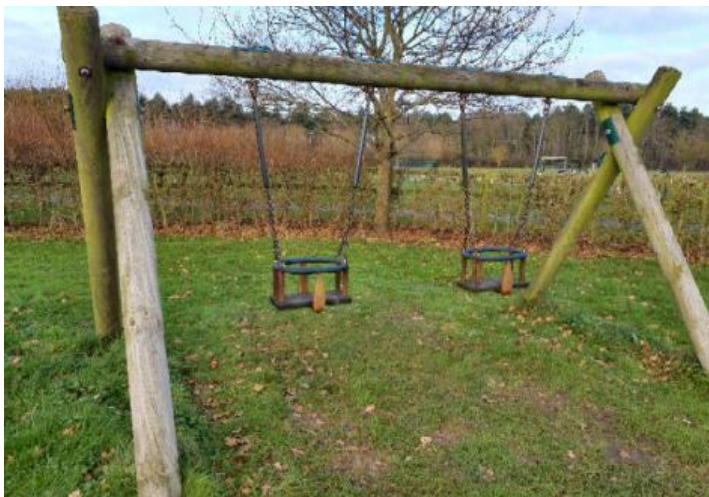
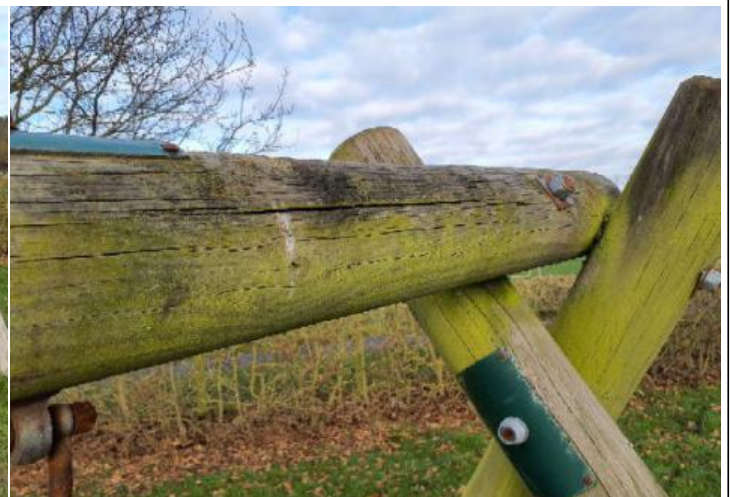
Finding: The timber has a number of splits/shakes or air cracks and this may affect the stability or allow water ingress which will accelerate the rotting process

Action: Monitor to ensure the splits do not cross through fixing points of the structure and/or cause any instability

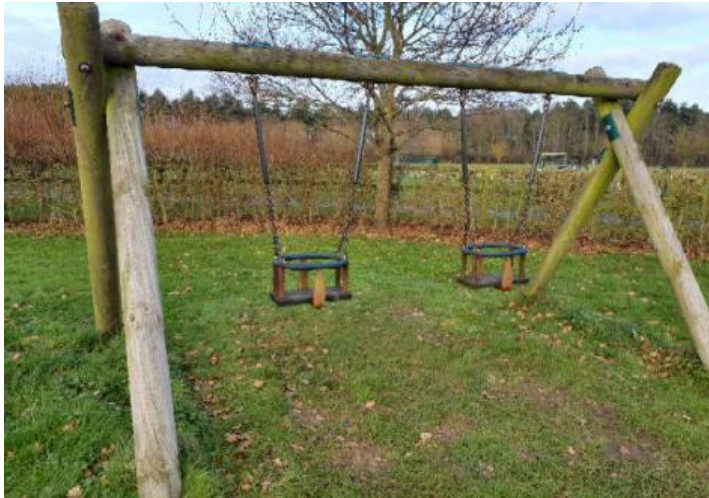
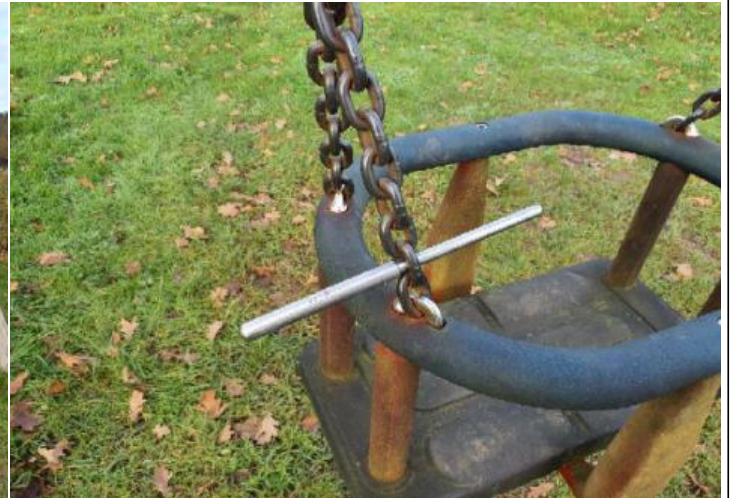
Finding: The chain openings are in excess of the 8.6mm as recommended by BS EN 1176
Action: Monitor - No action given the risk assessment

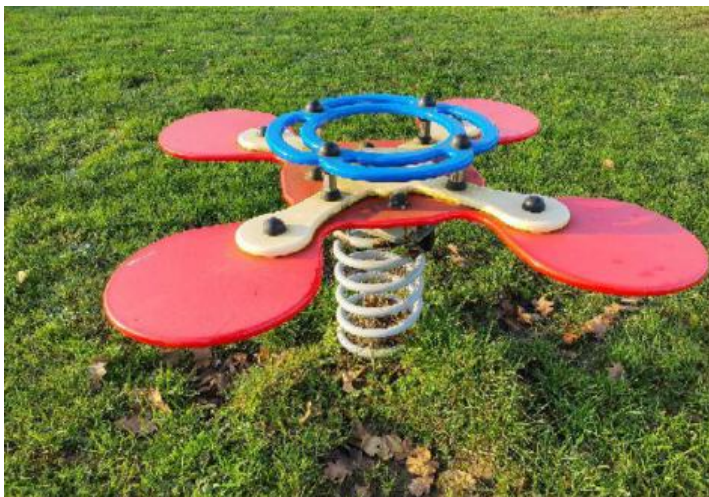
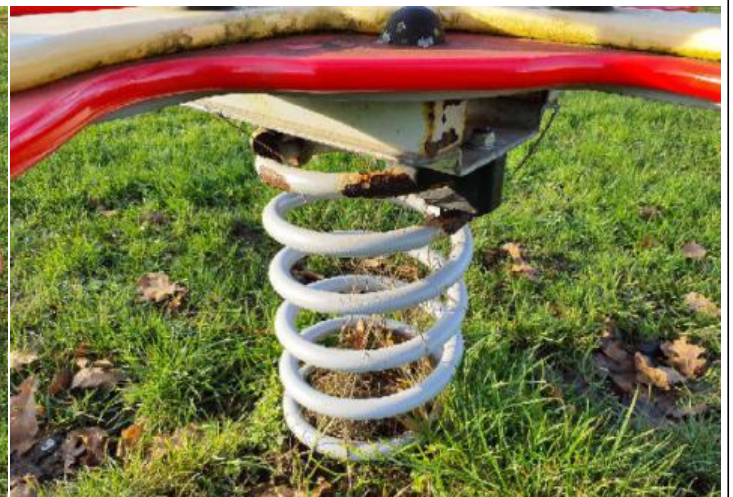
Finding: The paintwork on this item has been damaged or worn exposing the metal underneath which is rusting / corroding
Action: Treat affected areas and repaint

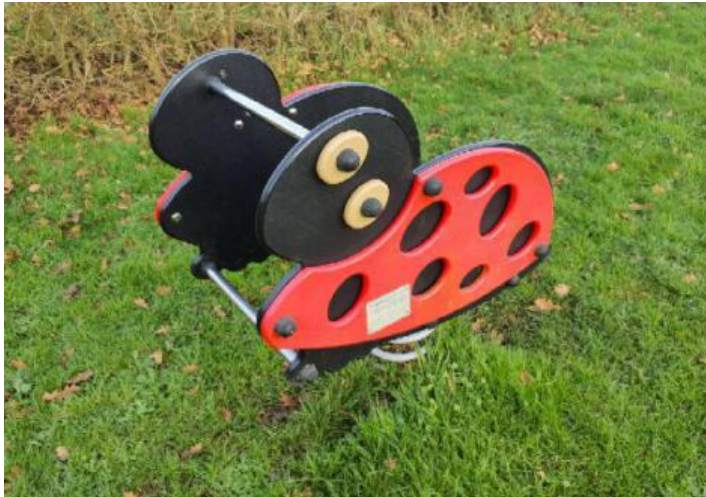
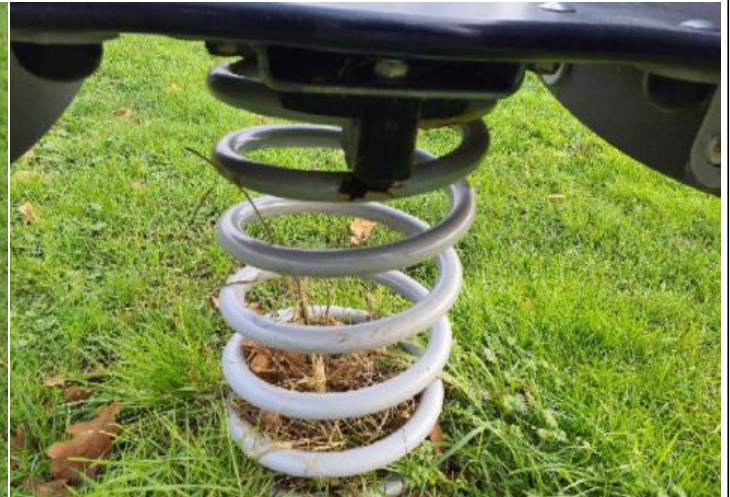
Finding: The paintwork on this item has been damaged or worn exposing the metal underneath which is rusting / corroding

Action: Treat affected areas and repaint

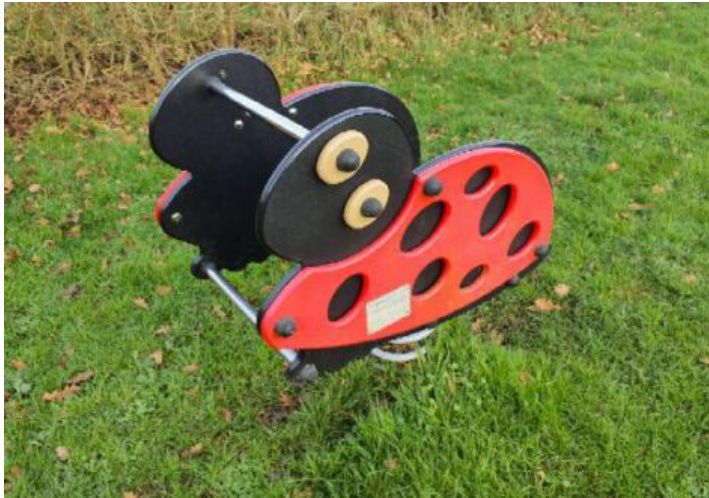
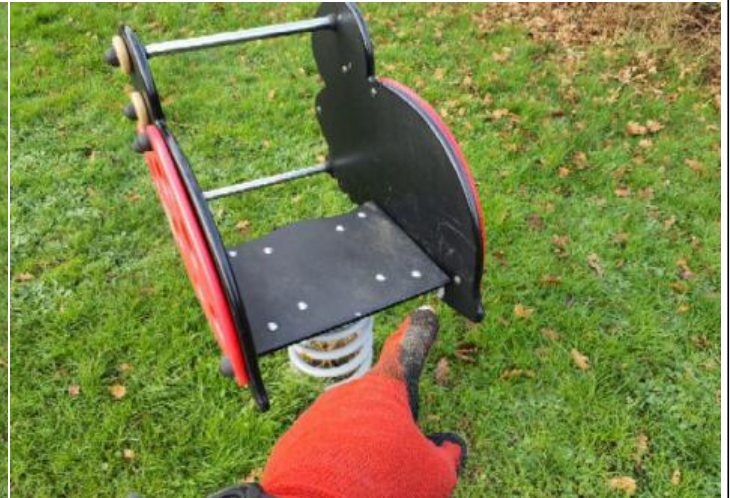
Finding: A number of fixing(s) have worked loose

Action: Secure all loose fixings
