the **play inspection** company

Annual Inspection

Rendlesham Parish Council

Jubilee Park Play Area

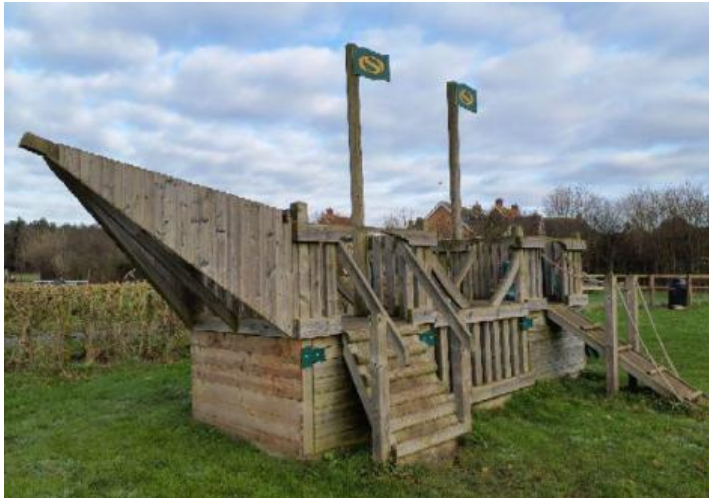
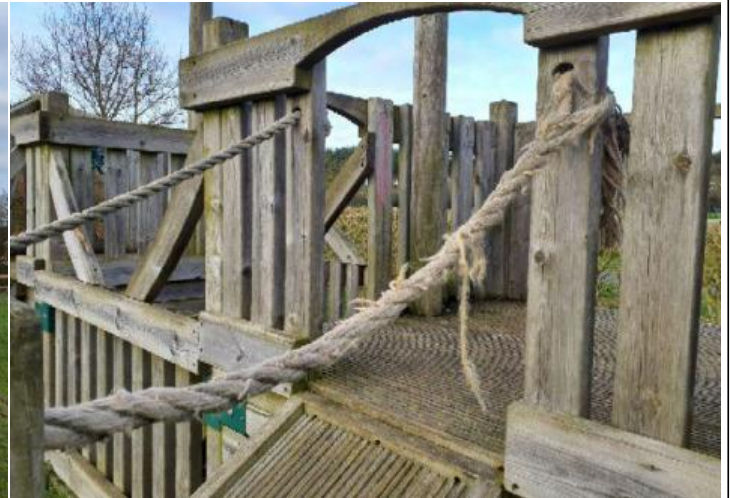
Finding: The rope has worn

Action: Replace rope or net
