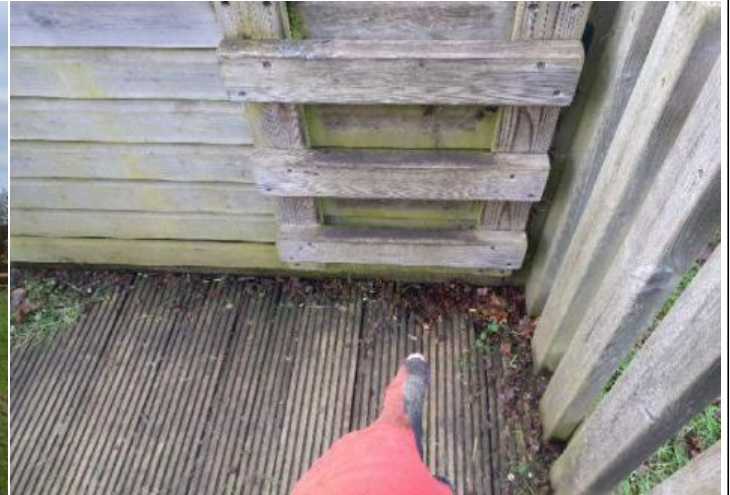
! 12 - Moderate Risk (Finding 4)

Risk Level: M - Moderate Risk
Surface: Grass Matrix Tiles

Finding: There are areas or parts of the timber on the structure that have rotted

Action: Replace all affected timbers

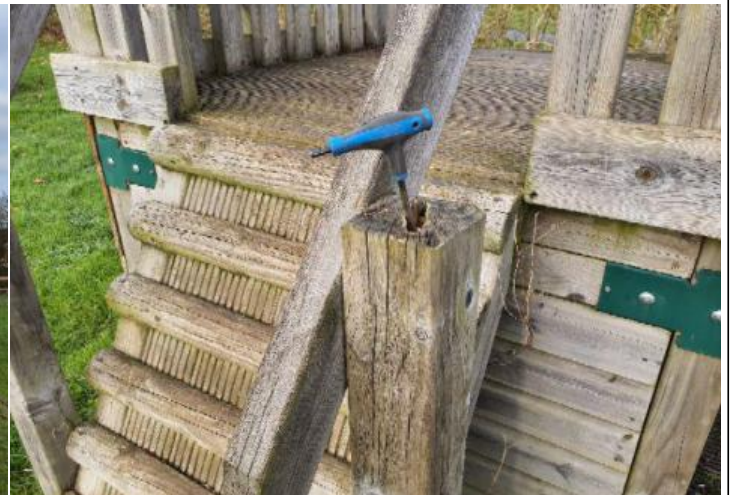
i 9 - Low Risk (Finding 5)

Risk Level: L - Low Risk
Surface: Grass Matrix Tiles

Finding: There are areas or parts of the timber on the structure that have rotted

Action: Replace all affected timbers

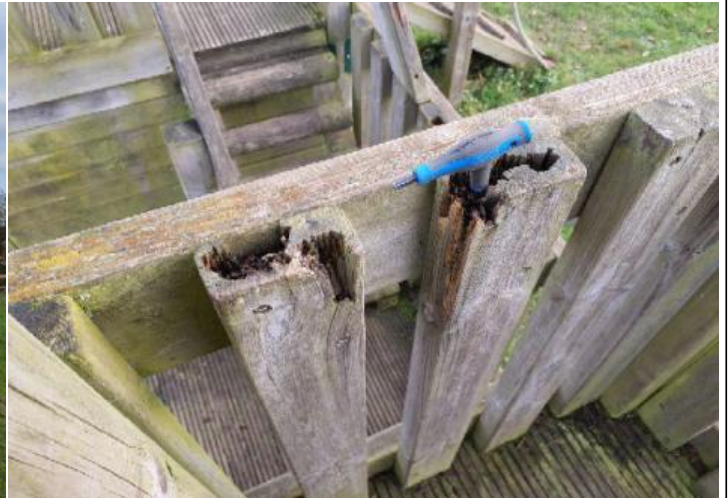
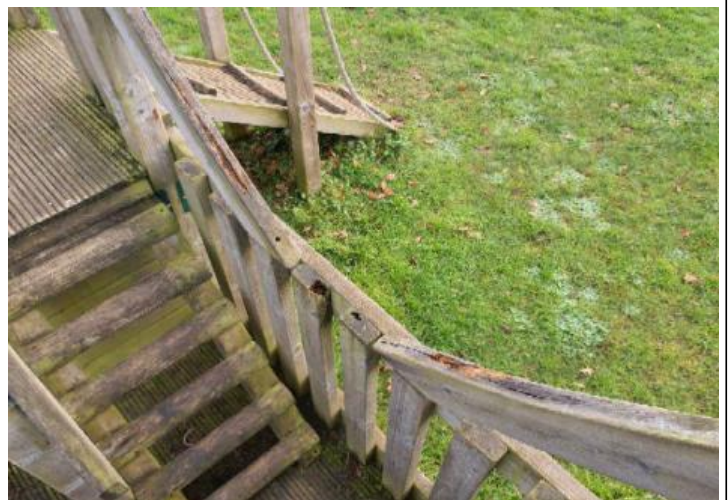
i 9 - Low Risk (Finding 6)

Risk Level: L - Low Risk
Surface: Grass Matrix Tiles

Finding: There are areas or parts of the timber on the structure that have rotted

Action: Replace all affected timbers

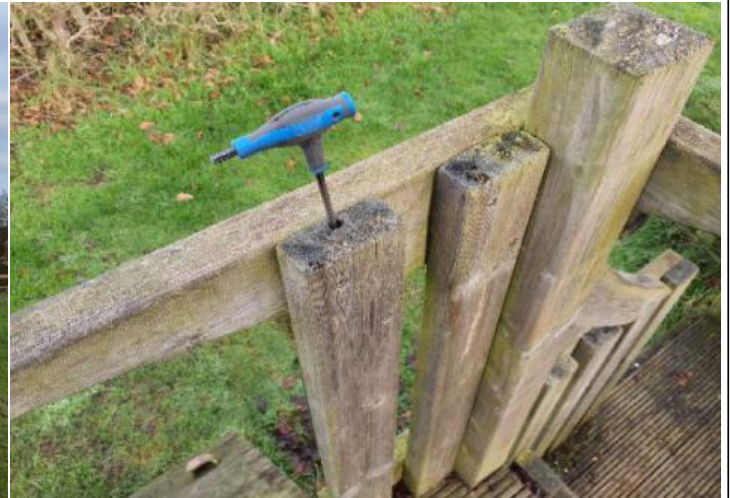
i 6 - Low Risk (Finding 7)

Risk Level: L - Low Risk
Surface: Grass Matrix Tiles

Finding: There is some evidence of rot in the timber

Action: Monitor for any further deterioration and replace as required

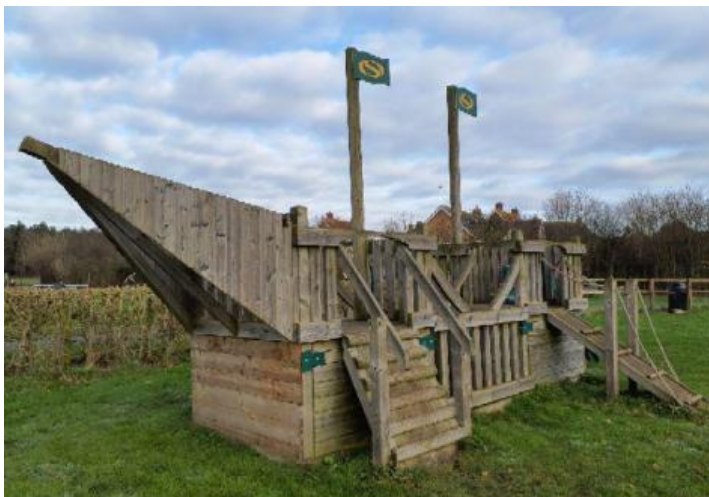
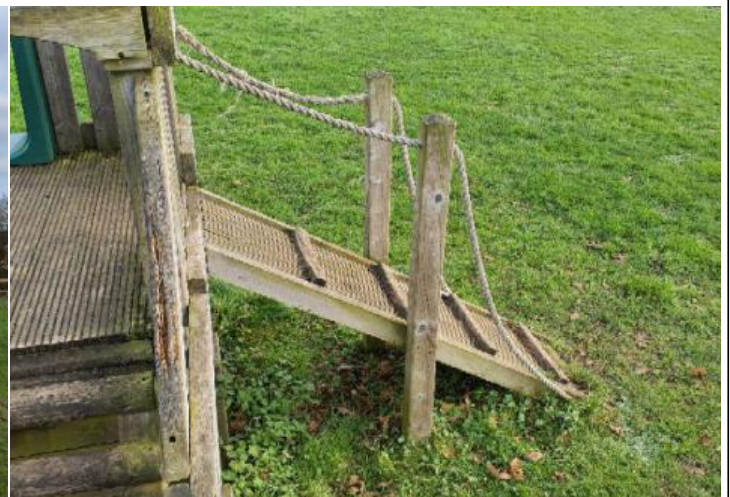
i 6 - Low Risk (Finding 8)

Risk Level: L - Low Risk
Surface: Grass Matrix Tiles

Finding: The access ramp height is greater than 600mm and the angle of ascent is less than 38 degrees. Barriers or guardrails are required to comply with the requirements BS EN 1176

Action: Monitor - No remedial work recommended

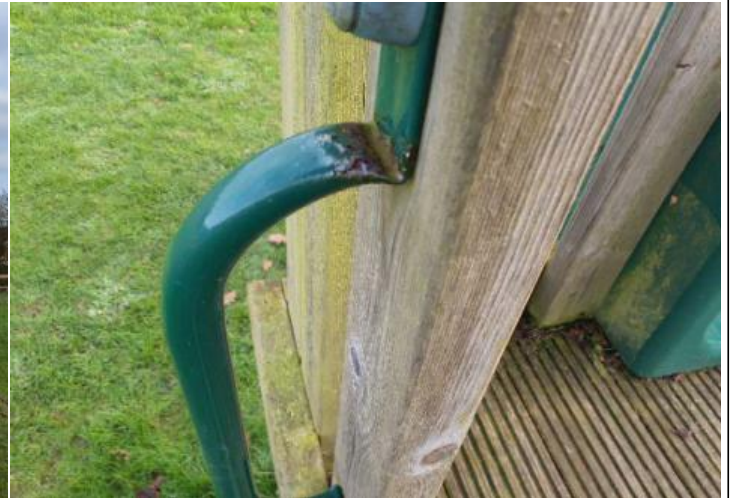
i 6 - Low Risk (Finding 9)

Risk Level: L - Low Risk
Surface: Grass Matrix Tiles

Finding: The paintwork on this item has been damaged or worn exposing the metal underneath which is rusting / corroding

Action: Treat affected areas and repaint

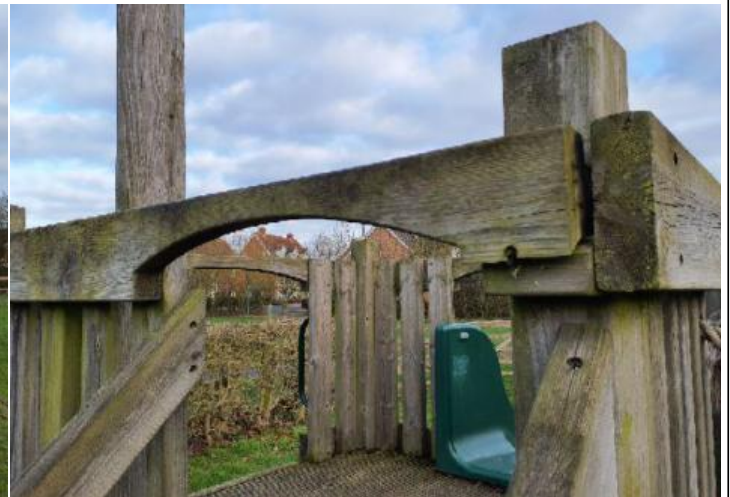
! 12 - Moderate Risk (Finding 10)

Risk Level: M - Moderate Risk
Surface: Grass Matrix Tiles

Finding: The crossbeam is damaged

Action: Repair or replace as required

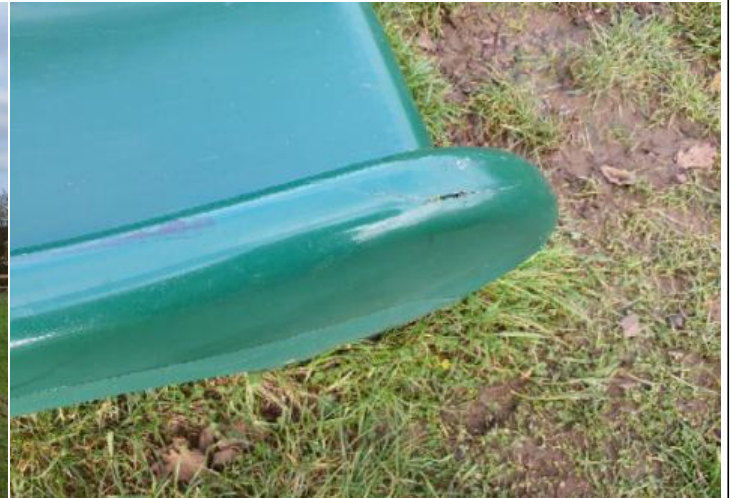
i 6 - Low Risk (Finding 11)

Risk Level: L - Low Risk
Surface: Grass Matrix Tiles

Finding: The item has been damaged

Action: Monitor for any further deterioration and replace as required

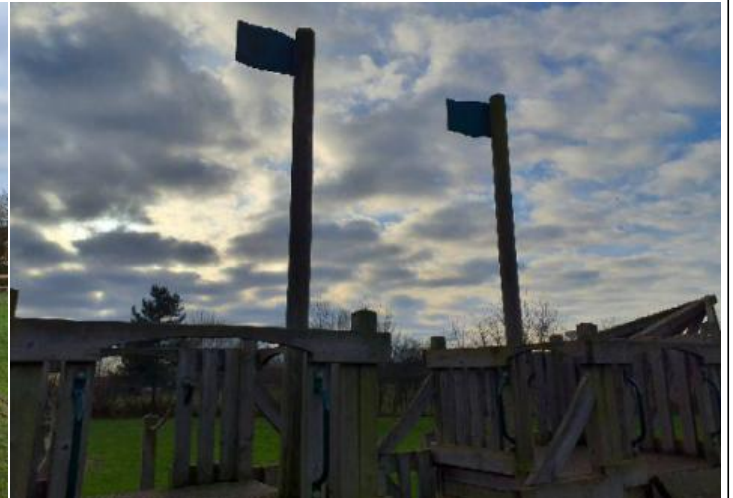
i 0 - Risk Assessment not Undertaken (Finding 12)

Finding: The fixings or components for this item were in excess of 2.5m above the standing surface and could not be fully accessed by the inspector. We have completed a visual inspection of the fixings from ground level but a maintenance inspection should be undertaken to assess the condition, security and wear of the components at intervals in accordance with the manufacturers recommendations.

Action: Inspect in accordance with the manufacturers recommendations

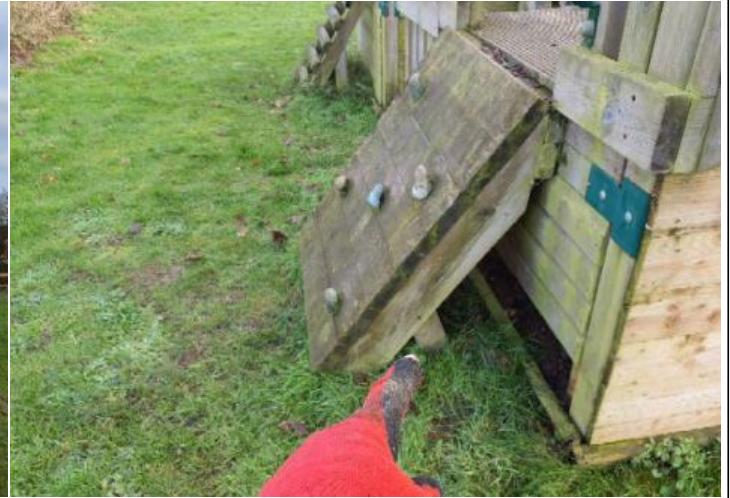
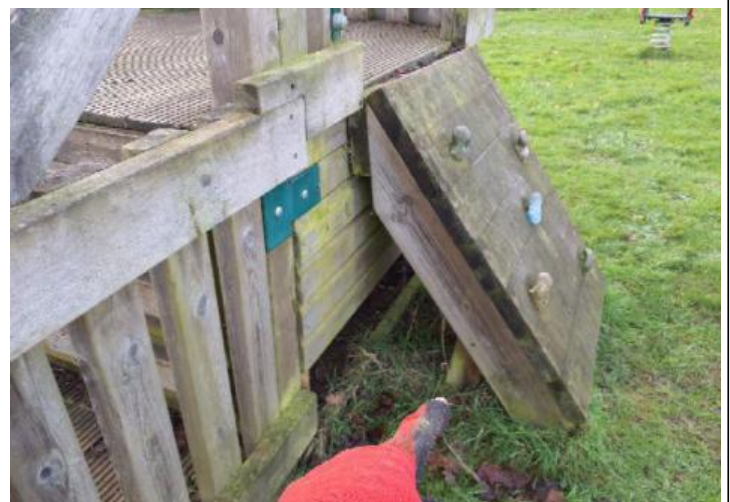
12 - Moderate Risk (Finding 13)

Risk Level: M - Moderate Risk
Surface: Grass Matrix Tiles

Finding: There are areas or parts of the timber on the structure that have rotted

Action: Replace all affected timbers

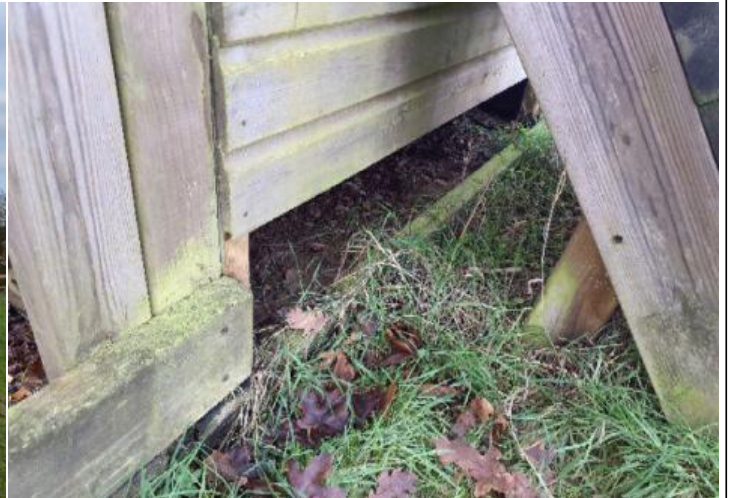
i 6 - Low Risk (Finding 14)

Risk Level: L - Low Risk
Surface: Grass Matrix Tiles

Finding: The item has missing component(s)

Action: Consider replacing missing components

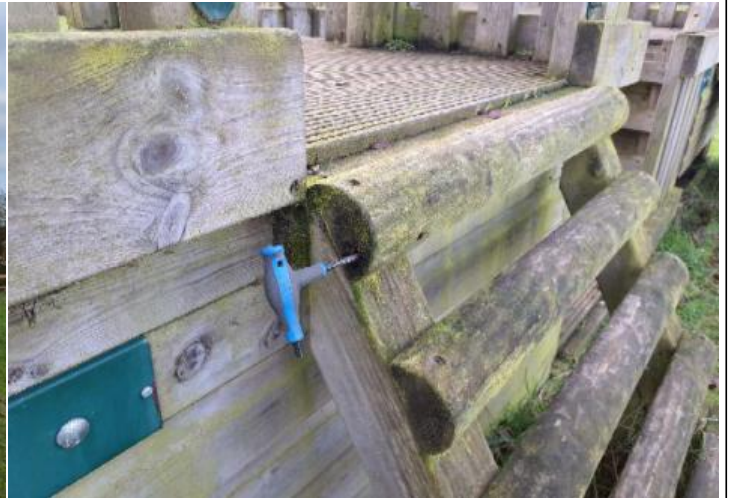
i 8 - Low Risk (Finding 16)

Risk Level: L - Low Risk
Surface: Grass Matrix Tiles

Finding: There is some evidence of rot in the timber

Action: Monitor for any further deterioration and replace as required

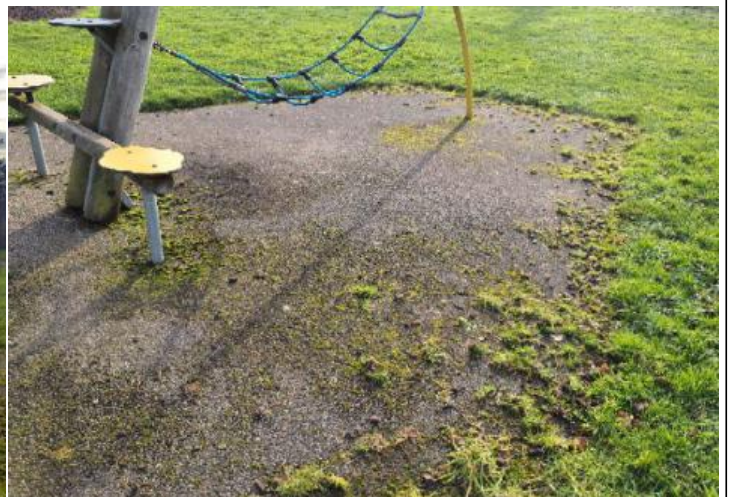
i 8 - Low Risk (Finding 1)

Risk Level: L - Low Risk
Surface: Bitmac

Finding: There is algae, silt or moss growth on the surface resulting in slippery conditions

Action: Clean and treat appropriately

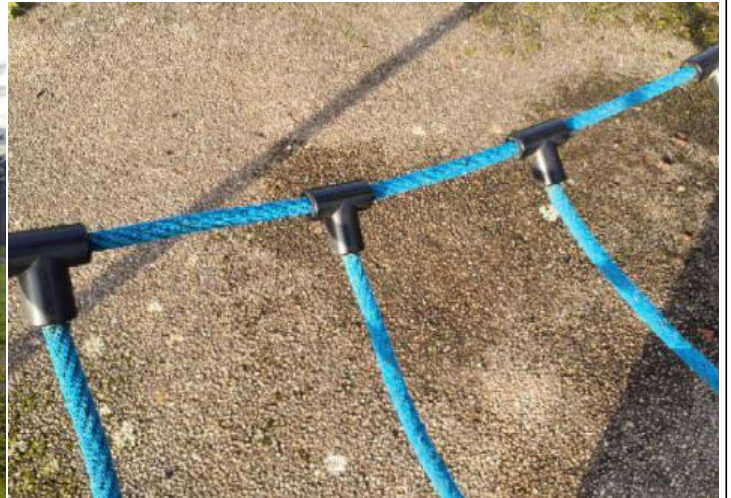
i 6 - Low Risk (Finding 4)

Risk Level: L - Low Risk
Surface: Bitmac

Finding: The ropes/nets are worn/damaged in places

Action: Monitor for any further deterioration and repair or replace as required

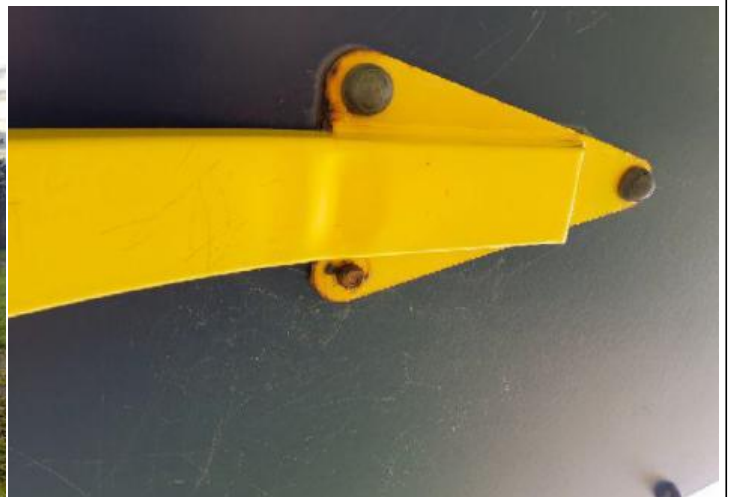
i 8 - Low Risk (Finding 5)

Risk Level: L - Low Risk
Surface: Bitmac

Finding: The fixings have corroded excessively

Action: Replace all corroded fixings

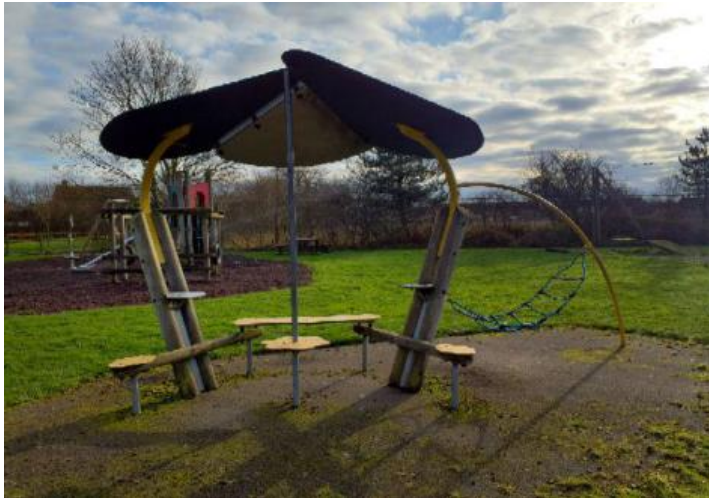
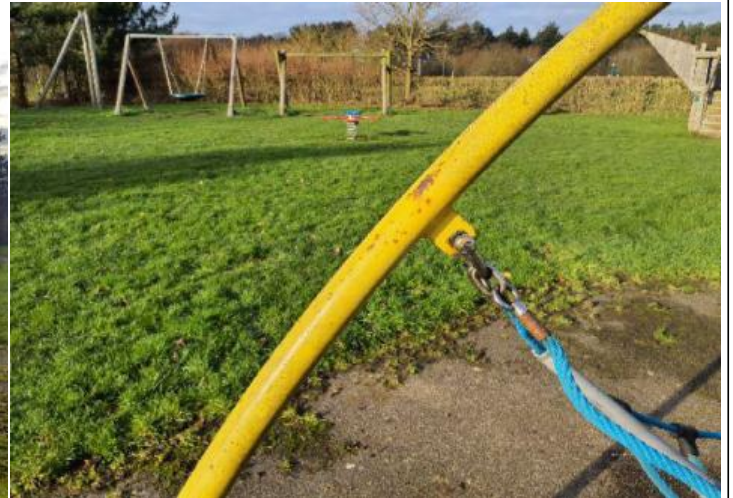
i 6 - Low Risk (Finding 6)

Risk Level: L - Low Risk
Surface: Bitmac

Finding: The paintwork on this item has been damaged or worn exposing the metal underneath which is rusting / corroding

Action: Treat affected areas and repaint

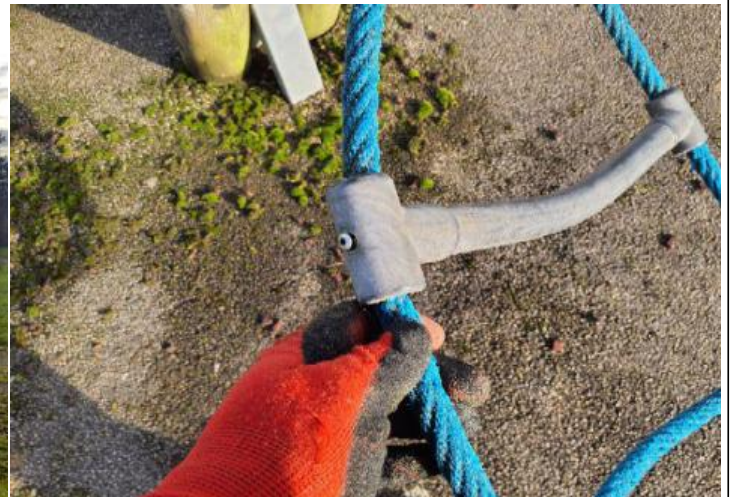
i 6 - Low Risk (Finding 7)

Risk Level: L - Low Risk
Surface: Bitmac

Finding: A number of fixing(s) have worked loose

Action: Secure all loose fixings

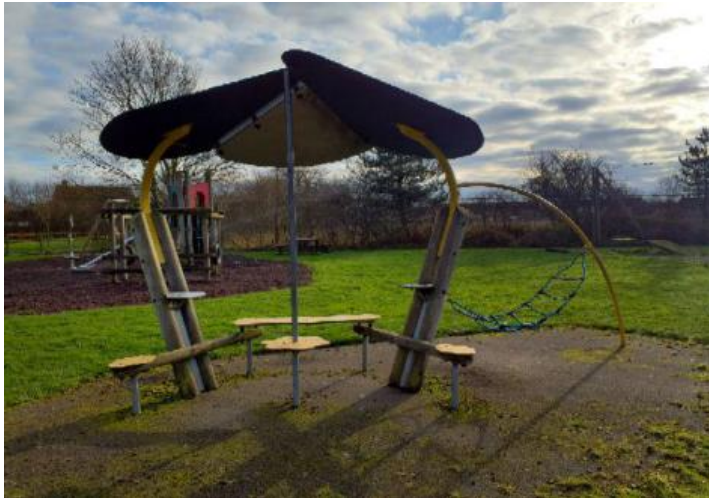
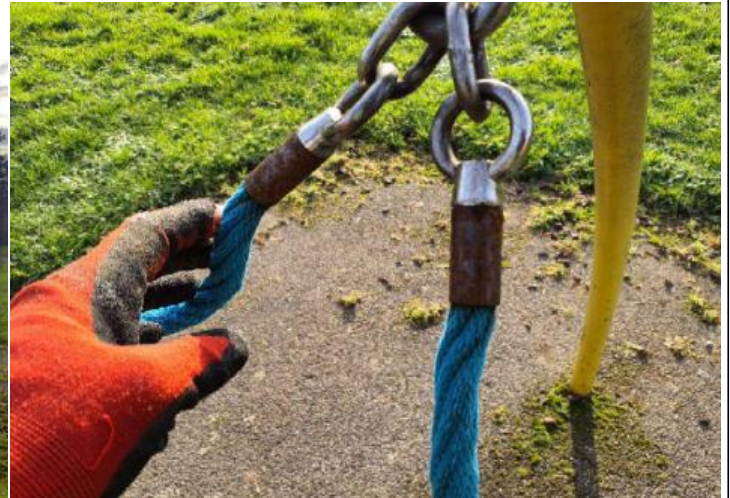
i 6 - Low Risk (Finding 8)

Risk Level: L - Low Risk
Surface: Bitmac

Finding: The fixings are corroding

Action: Monitor for any further deterioration and replace as required

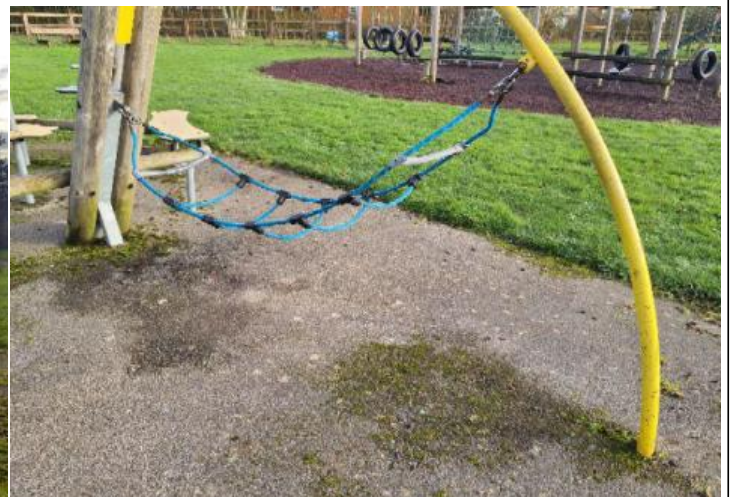
i 8 - Low Risk (Finding 9)

Risk Level: L - Low Risk
Surface: Bitmac

Finding: The location of this item may encourage use by younger users leading to fall heights exceeding 600mm to the hard surface below

Action: Monitor use and risk assess regularly and consider relocating the equipment if found to be necessary

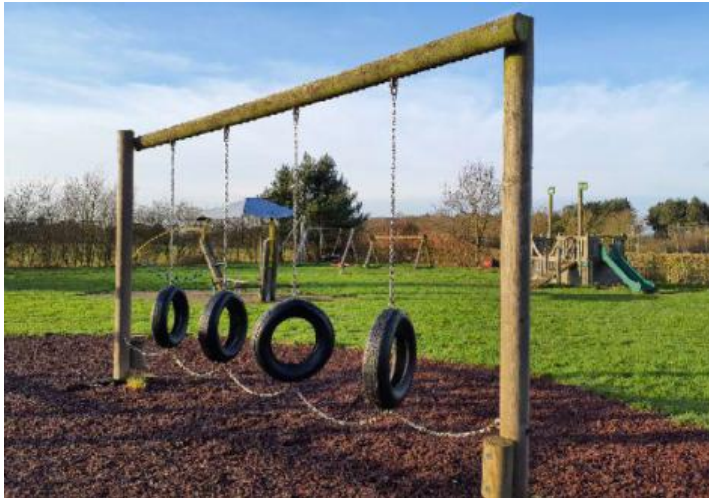
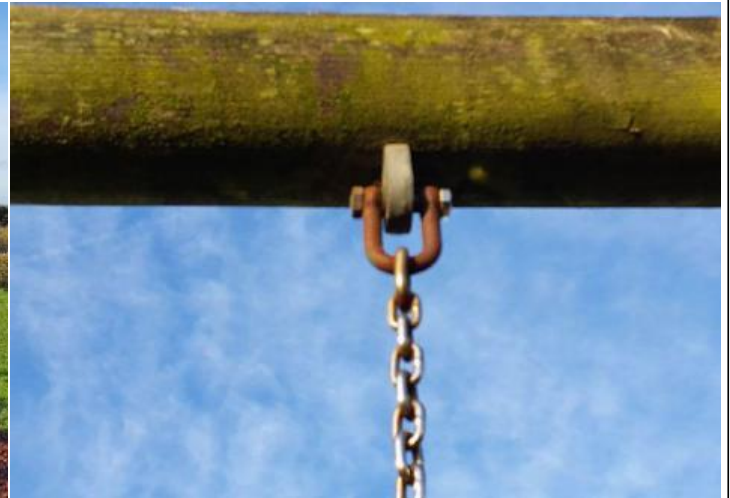
i 6 - Low Risk (Finding 1)

Risk Level: L - Low Risk
Surface: Loose Rubber Mulch

Finding: The fixings are corroding

Action: Monitor for any further deterioration and replace as required

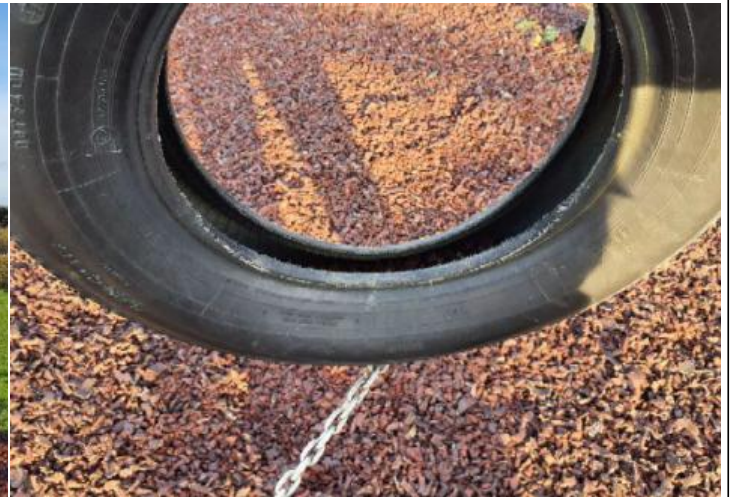
i 6 - Low Risk (Finding 2)

Risk Level: L - Low Risk
Surface: Loose Rubber Mulch

Finding: The item has been damaged

Action: Monitor for any further deterioration and replace as required

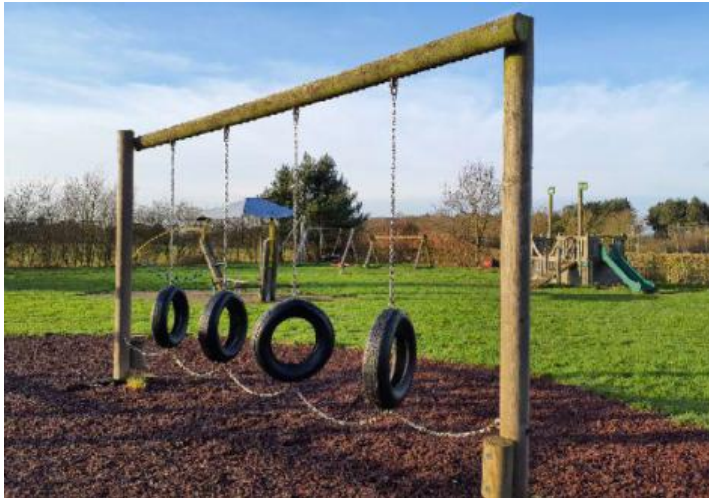
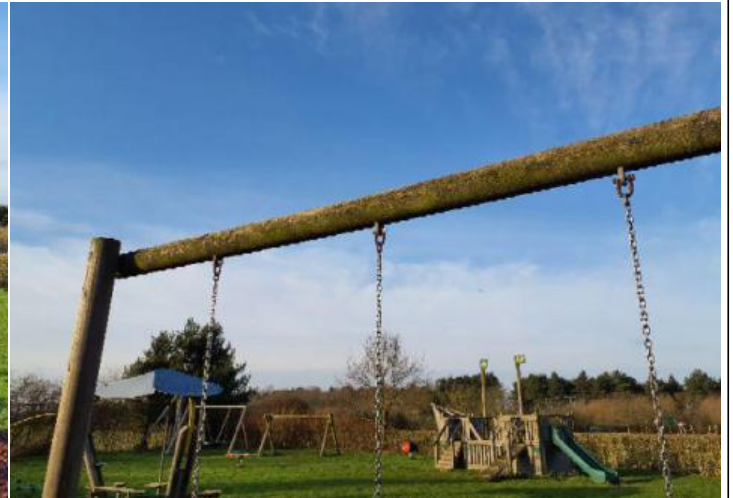
i 0 - Risk Assessment not Undertaken (Finding 3)

Finding: The inspector has some concerns about the internal condition of the timber and was unable to verify the structural integrity without further testing. We recommend a Resi-PD survey to establish the condition of the timber at it's core.

Action: Contact the Play Inspection Company office for further information

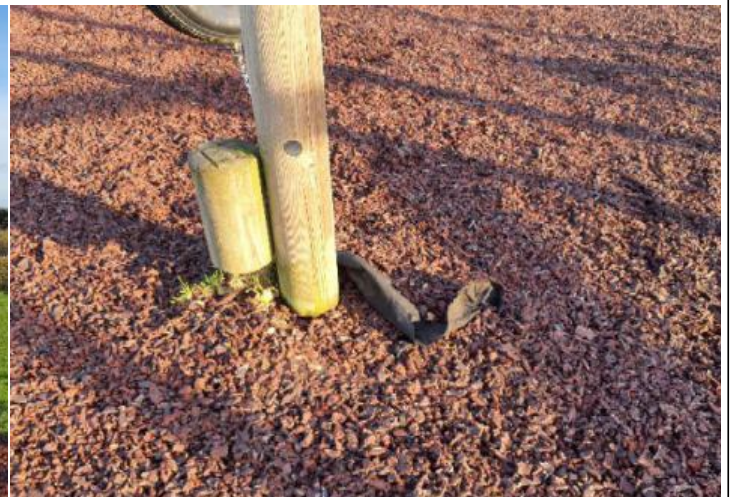
i 8 - Low Risk (Finding 4)

Risk Level: L - Low Risk
Surface: Loose Rubber Mulch

Finding: The safety surface is low and the membrane is exposed creating trip points

Action: Remove or resecure the exposed membrane and top up the surface to the correct level

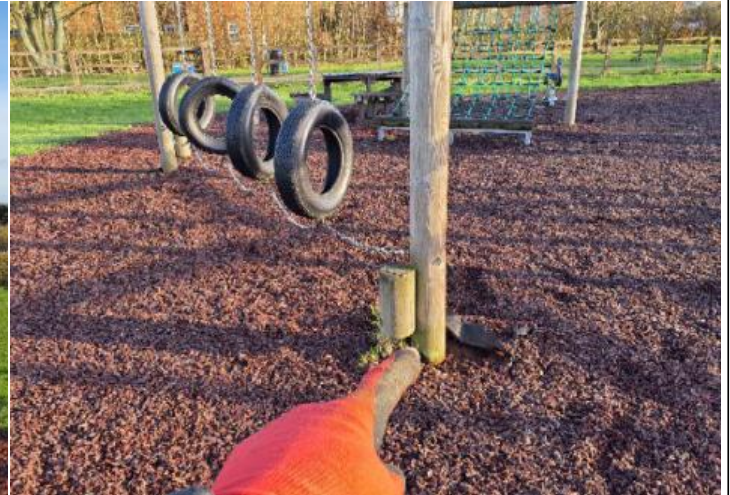
12 - Moderate Risk (Finding 5)

Risk Level: M - Moderate Risk
Surface: Loose Rubber Mulch

Finding: There are areas or parts of the timber on the structure that have rotted

Action: Replace all affected timbers

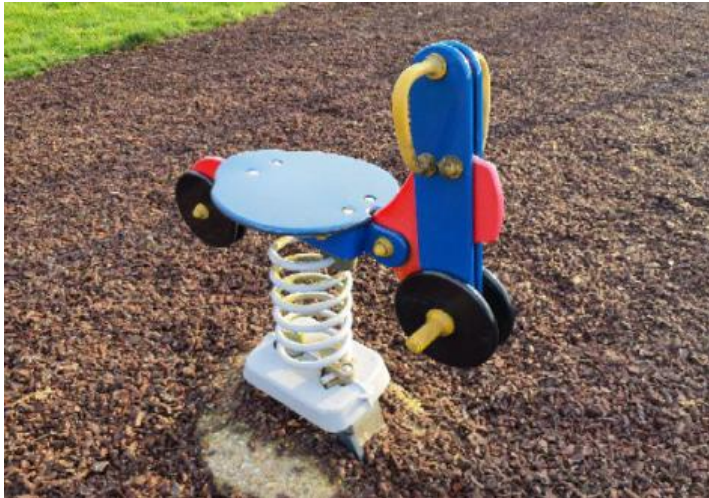
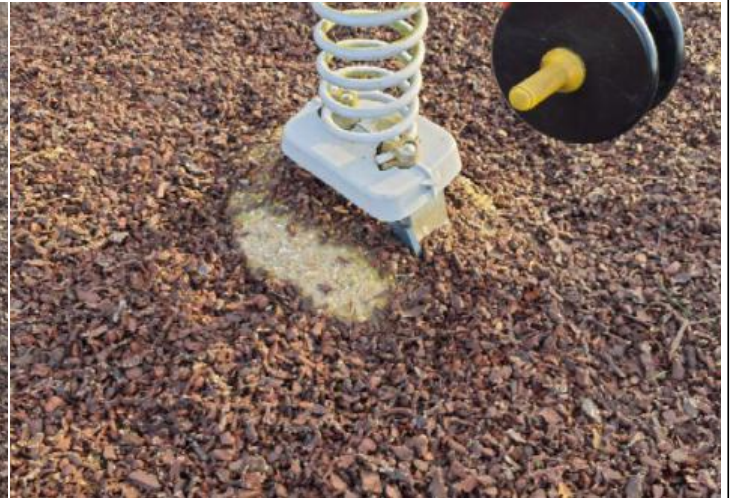
i 10 - Low Risk (Finding 1)

Risk Level: L - Low Risk
Surface: Loose Rubber Mulch

Finding: The depth of the loose fill surfacing is lower than the recommended depth specified in BS EN 1176 exposing the concrete foundations; the free height of fall of the equipment is less than 2.0m and a minimum of 300mm depth should be provided (including an extra 100mm to allow for compaction and displacement as per BS EN 1176 Part 1 - Table 4)

Action: Top up loose fill surfacing to recommended levels

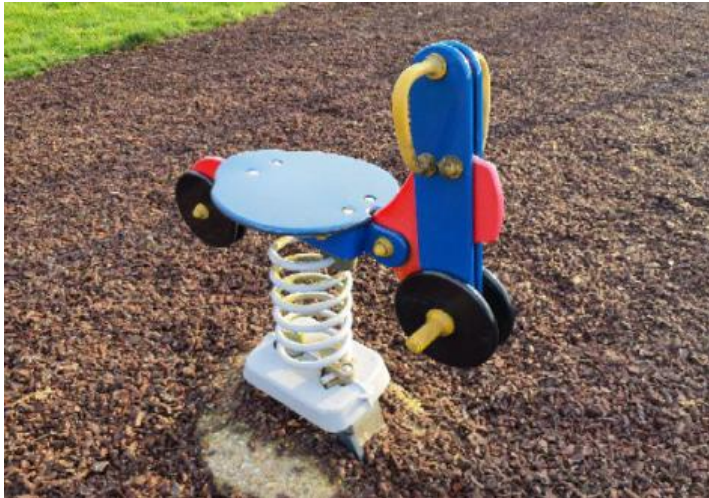
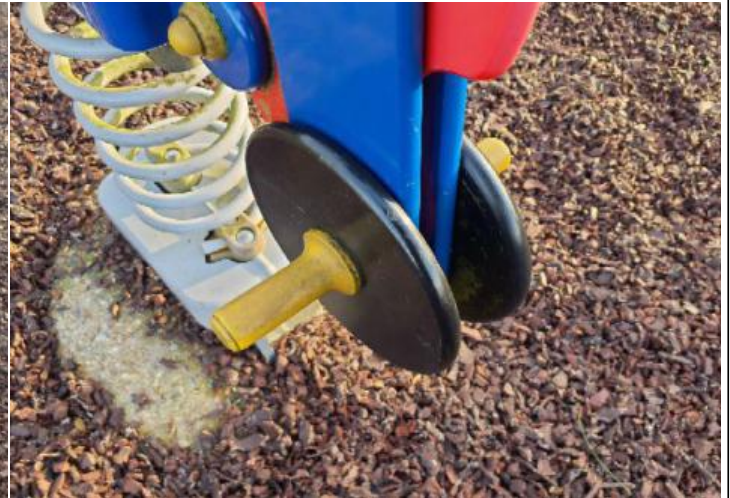
i 6 - Low Risk (Finding 2)

Risk Level: L - Low Risk
Surface: Loose Rubber Mulch

Finding: The end of handgrips and/or footrests have a cross section of less than 15cm² and fail to meet the requirements of BS EN 1176 Part 6
Action: Monitor - No action given the risk assessment

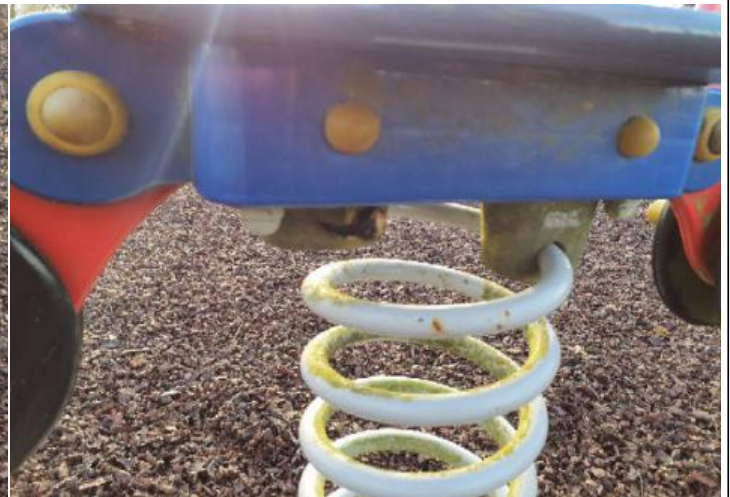
i 6 - Low Risk (Finding 3)

Risk Level: L - Low Risk
Surface: Loose Rubber Mulch

Finding: The paintwork on this item has been damaged or worn exposing the metal underneath which is rusting / corroding
Action: Treat affected areas and repaint

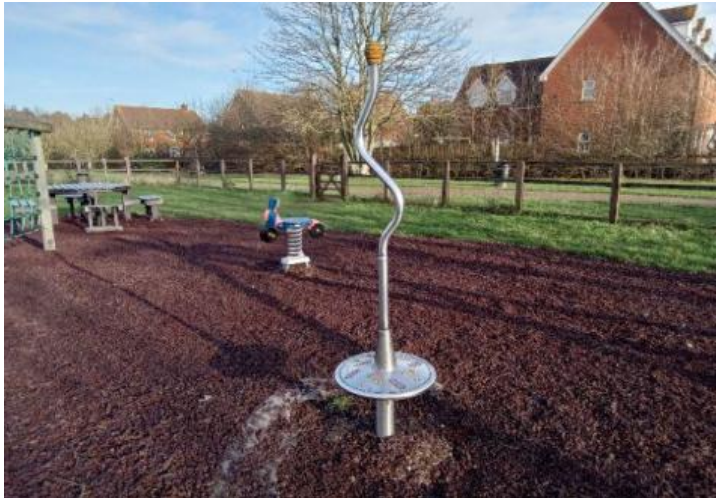
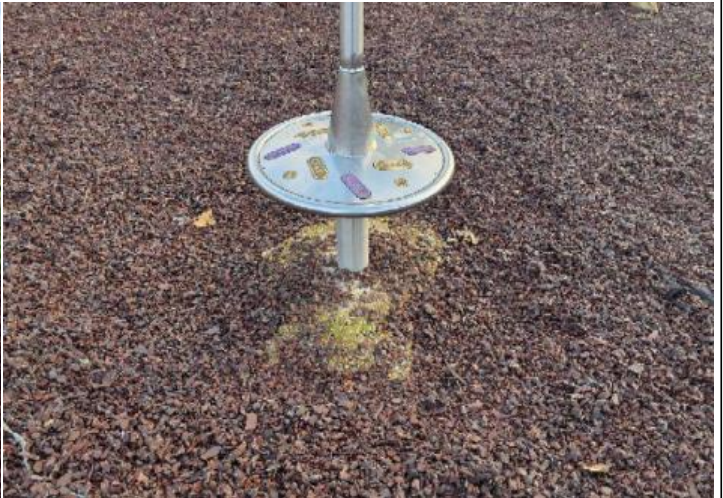
i 10 - Low Risk (Finding 1)

Risk Level: L - Low Risk
Surface: Loose Rubber Mulch

Finding: The depth of the loose fill surfacing is lower than the recommended depth specified in BS EN 1176 exposing the concrete foundations; the free height of fall of the equipment is less than 2.0m and a minimum of 300mm depth should be provided (including an extra 100mm to allow for compaction and displacement as per BS EN 1176 Part 1 - Table 4)

Action: Top up loose fill surfacing to recommended levels

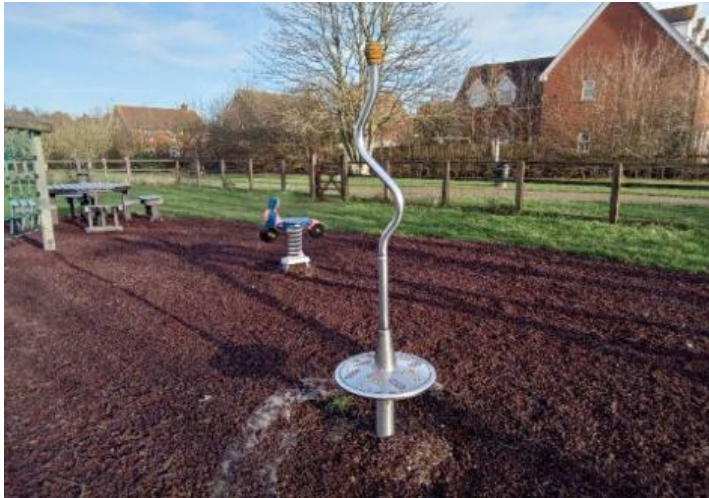
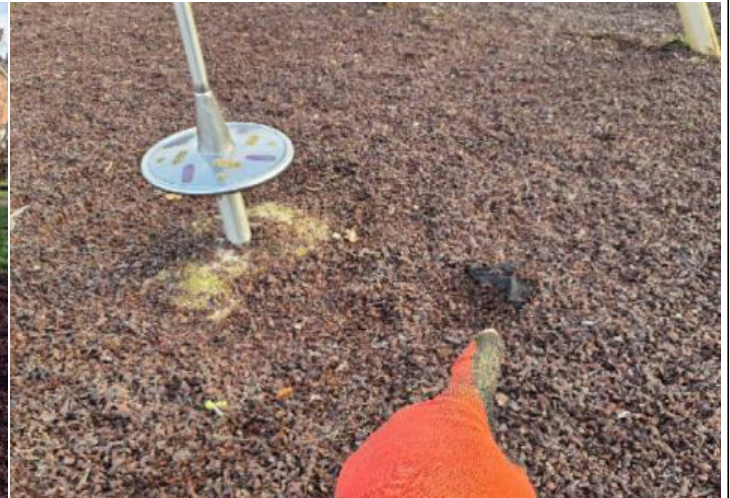
i 8 - Low Risk (Finding 2)

Risk Level: L - Low Risk
Surface: Loose Rubber Mulch

Finding: The safety surface is low and the membrane is exposed creating trip points

Action: Remove or resecure the exposed membrane and top up the surface to the correct level

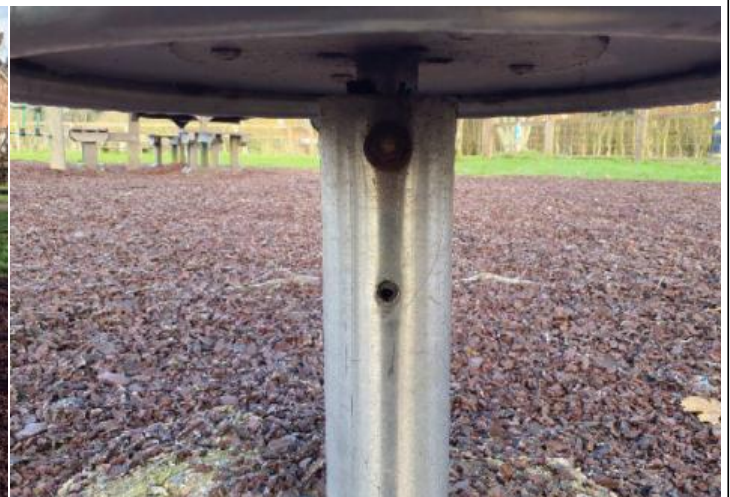
i 8 - Low Risk (Finding 3)

Risk Level: L - Low Risk
Surface: Loose Rubber Mulch

Finding: There is or are fixings missing on the item

Action: Replace all missing fixings

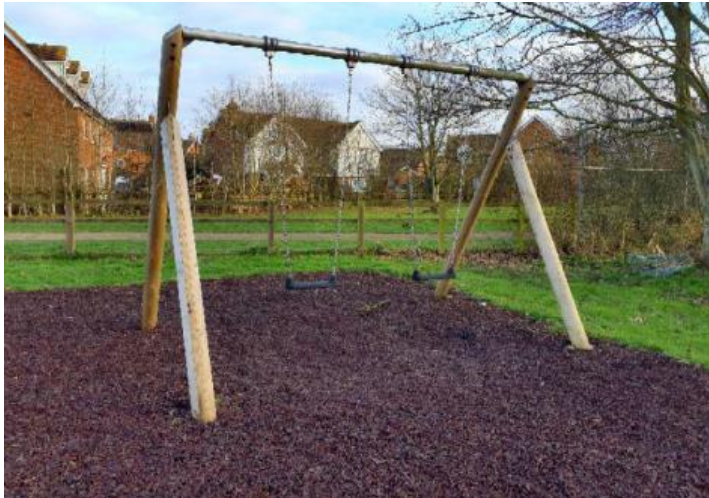
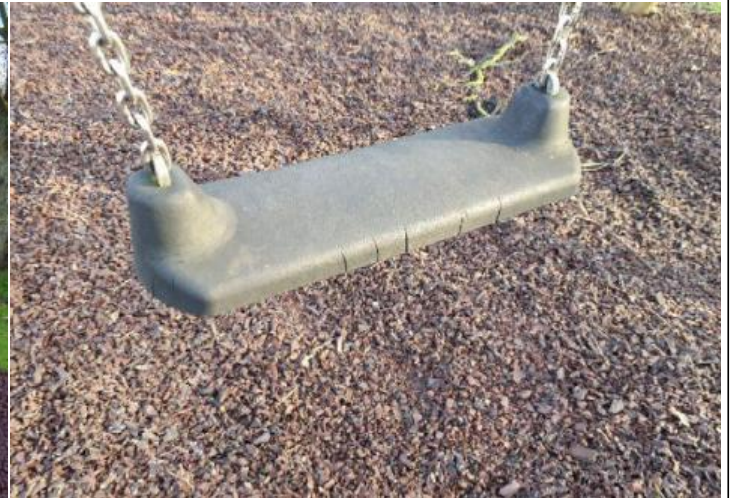
i 6 - Low Risk (Finding 1)

Risk Level: L - Low Risk
Surface: Loose Rubber Mulch

Finding: The seat has minor damage or wear

Action: Monitor for any further deterioration and replace as required

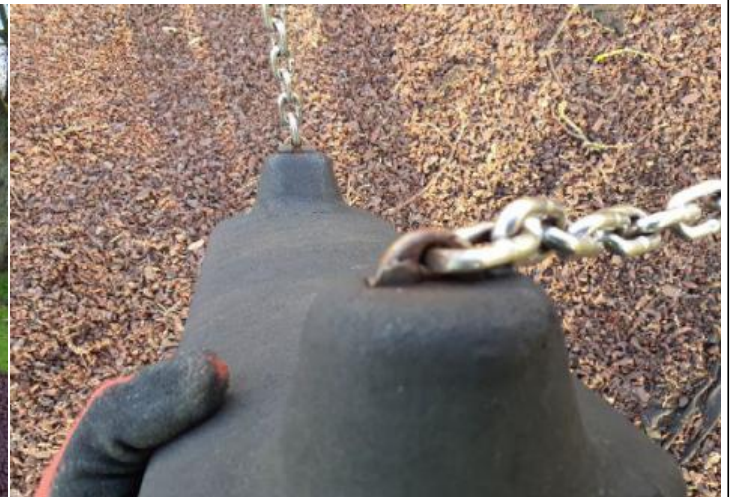
! 15 - Moderate Risk (Finding 2)

Risk Level: M - Moderate Risk
Surface: Loose Rubber Mulch

Finding: The swing seat connectors are worn more than 40% and require replacement

Action: Replace swing seat connectors if possible or replace seat

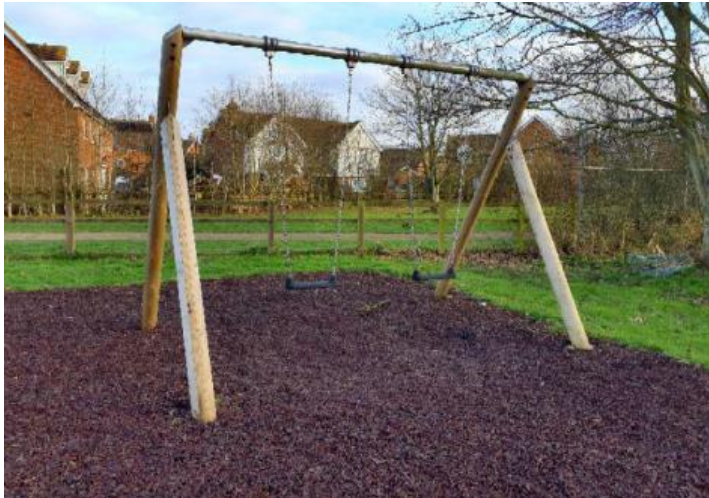
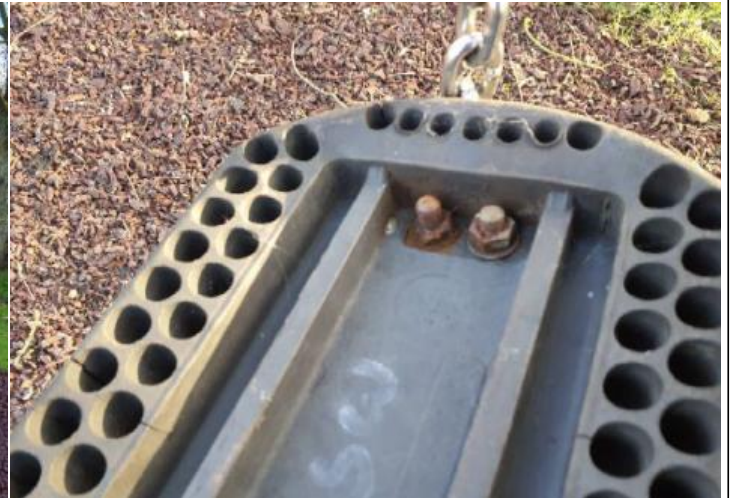
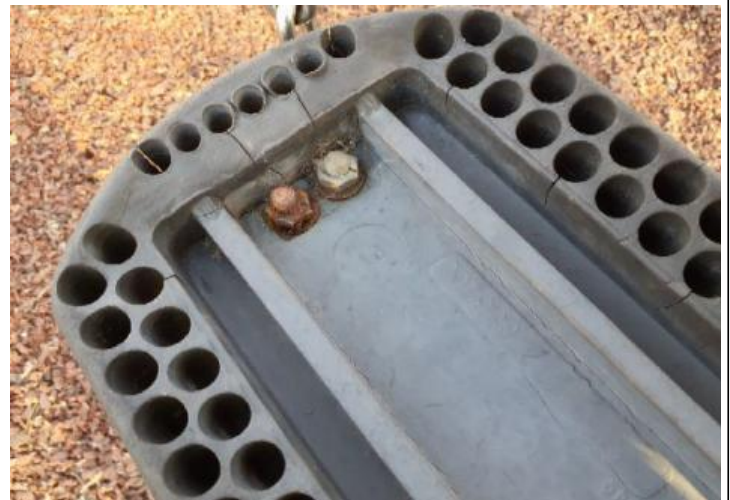
i 10 - Low Risk (Finding 3)

Risk Level: L - Low Risk
Surface: Loose Rubber Mulch

Finding: The fixings have corroded excessively

Action: Replace all corroded fixings

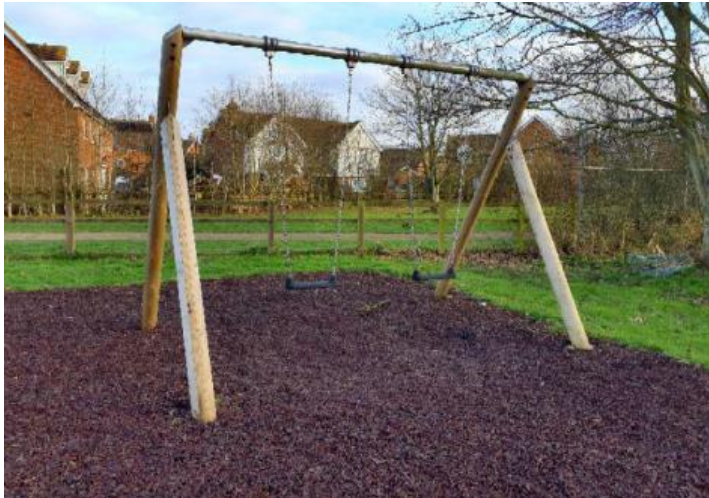
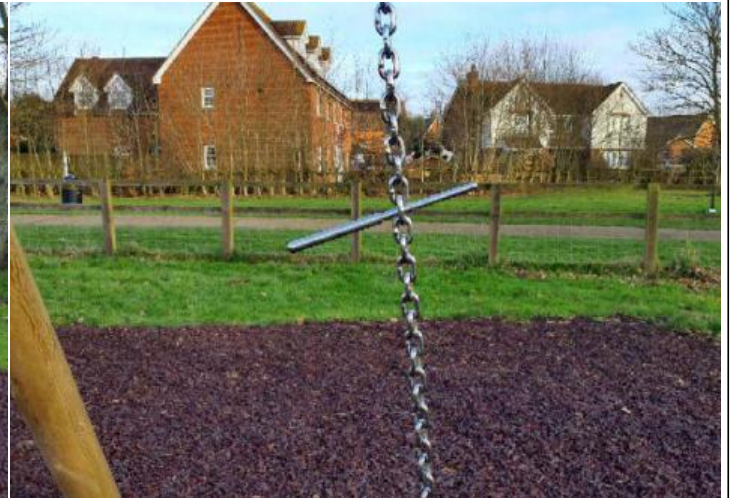
i 5 - Very Low Risk (Finding 4)

Risk Level: V - Very Low Risk
Surface: Loose Rubber Mulch

Finding: The chain openings are in excess of the 8.6mm as recommended by BS EN 1176
Action: Monitor - No action given the risk assessment

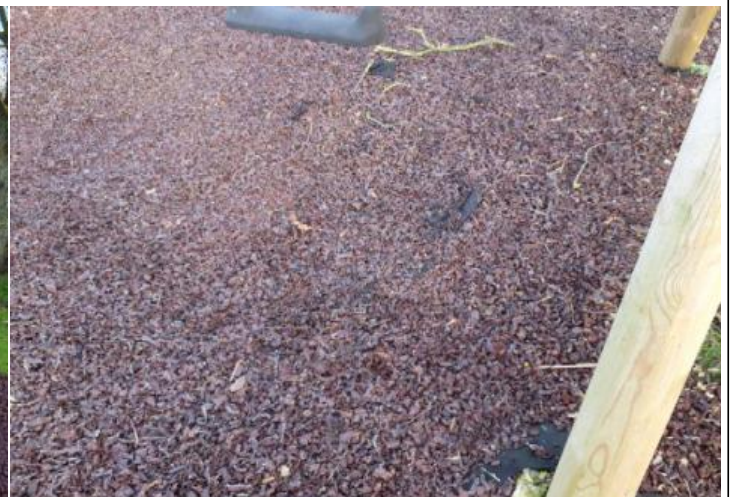
i 8 - Low Risk (Finding 5)

Risk Level: L - Low Risk
Surface: Loose Rubber Mulch

Finding: The safety surface is low and the membrane is exposed creating trip points
Action: Remove or resecure the exposed membrane and top up the surface to the correct level

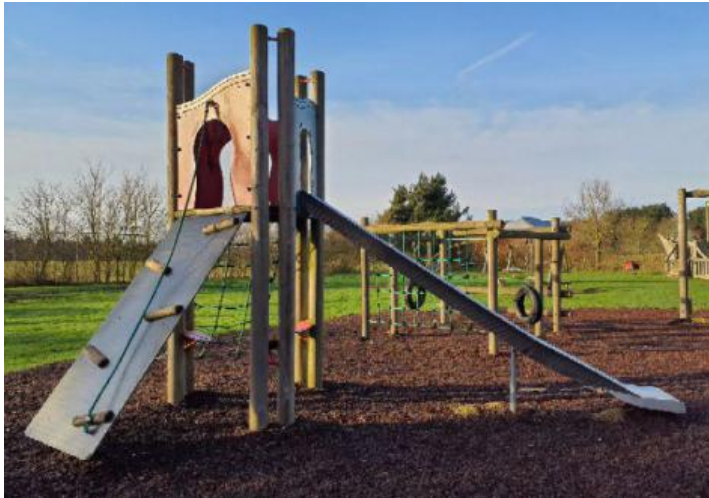
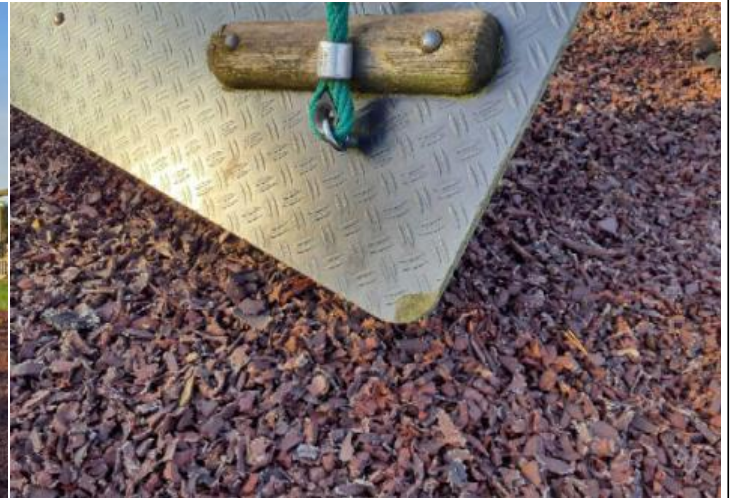
i 6 - Low Risk (Finding 1)

Risk Level: L - Low Risk
Surface: Loose Rubber Mulch

Finding: The item has been damaged

Action: Monitor for any further deterioration and replace as required

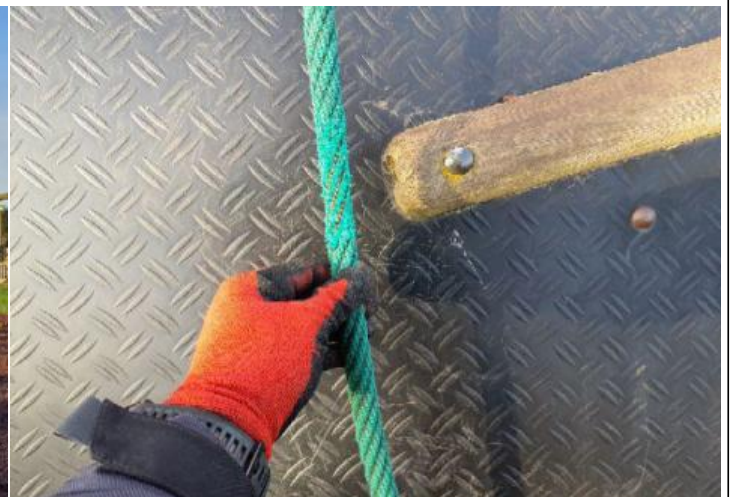
i 6 - Low Risk (Finding 2)

Risk Level: L - Low Risk
Surface: Loose Rubber Mulch

Finding: The ropes/nets are worn/damaged in places

Action: Monitor for any further deterioration and repair or replace as required

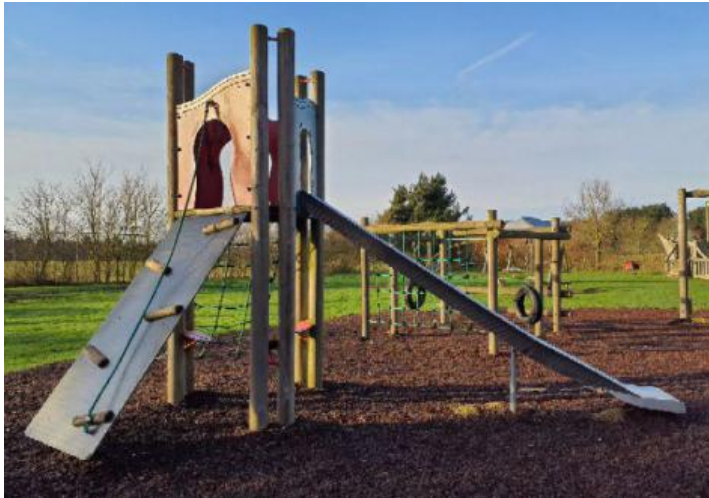
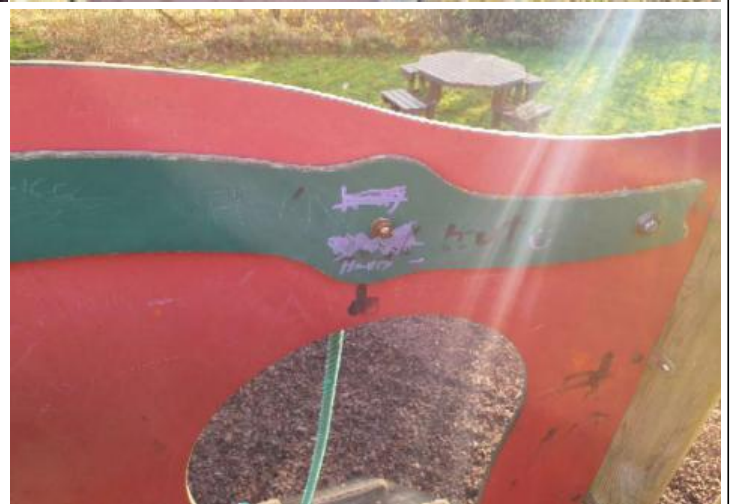
i 0 - Risk Assessment not Undertaken (Finding 3)

Finding: There is some graffiti present

Action: Remove the graffiti

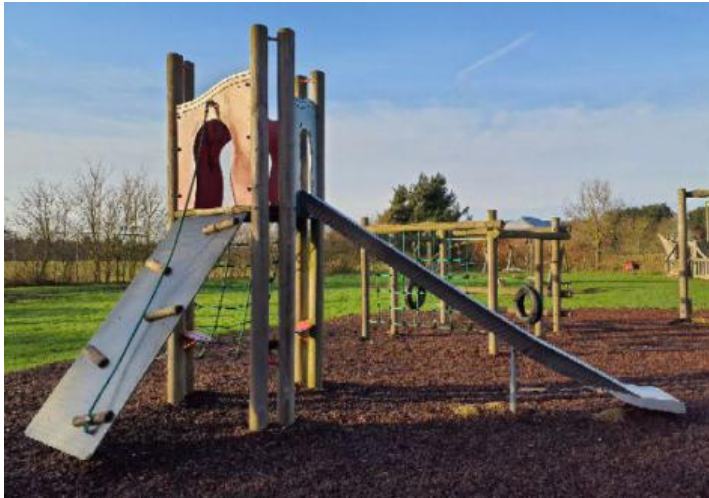
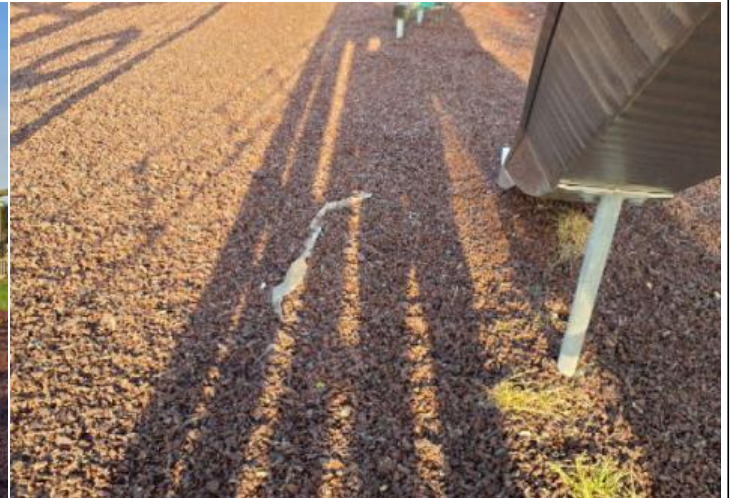
i 8 - Low Risk (Finding 4)

Risk Level: L - Low Risk
Surface: Loose Rubber Mulch

Finding: The safety surface is low and the membrane is exposed creating trip points

Action: Remove or resecure the exposed membrane and top up the surface to the correct level
