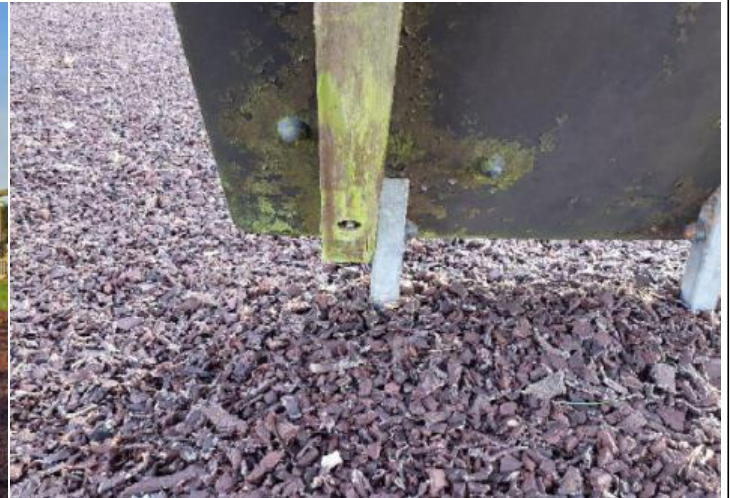
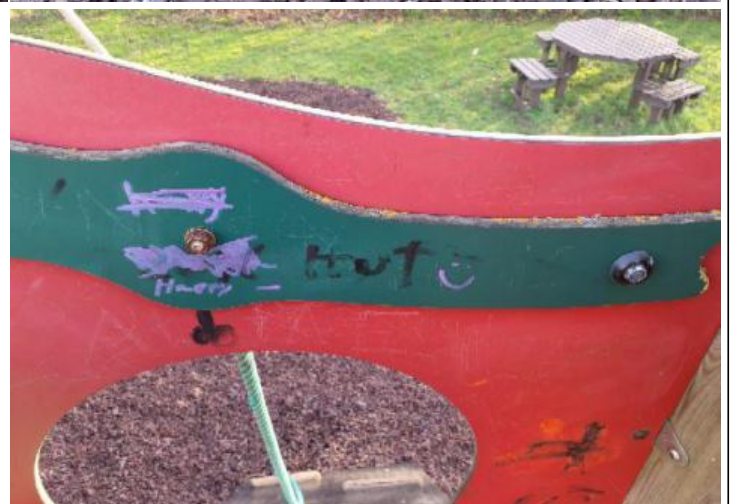
i 4 - Very Low Risk (Finding 5)

Risk Level: V - Very Low Risk
Surface: Loose Rubber Mulch

Finding: There is/are bolt cap covers missing or damaged on the item

Action: Replace missing or damaged bolt cap covers

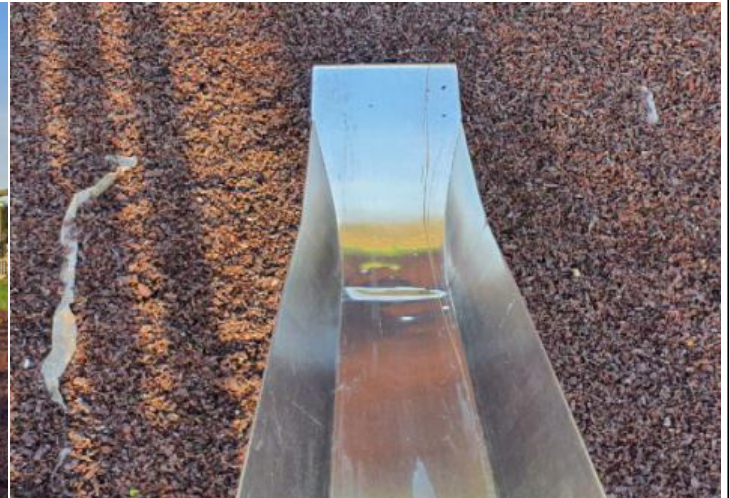
i 4 - Very Low Risk (Finding 6)

Risk Level: V - Very Low Risk
Surface: Loose Rubber Mulch

Finding: There are a number of dents in the slide surface

Action: Monitor for any further deterioration and repair as required

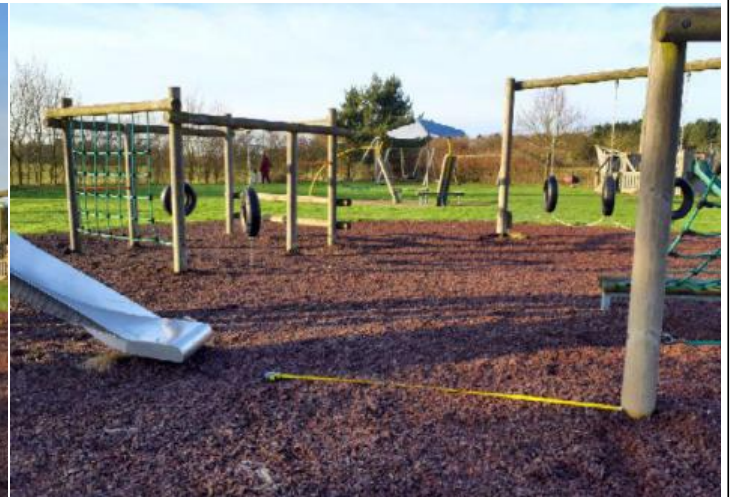
i 6 - Low Risk (Finding 7)

Risk Level: L - Low Risk
Surface: Loose Rubber Mulch

Finding: The impact area of the climbing frame overlaps the freespace of the slide in contravention of BS EN 1176

Action: Monitor - No remedial work recommended

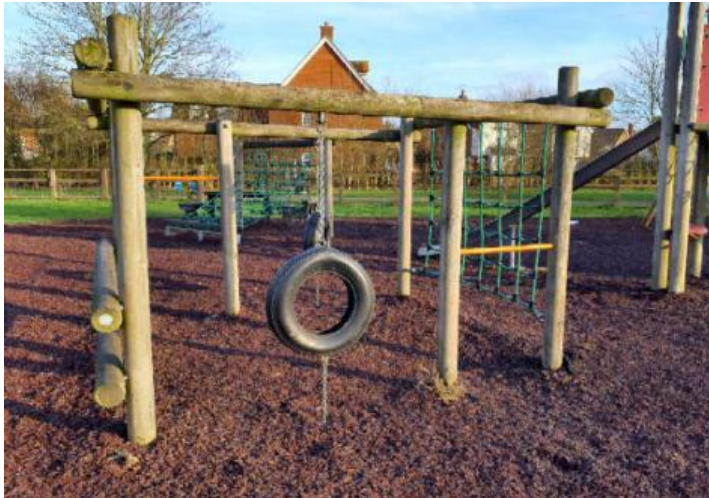
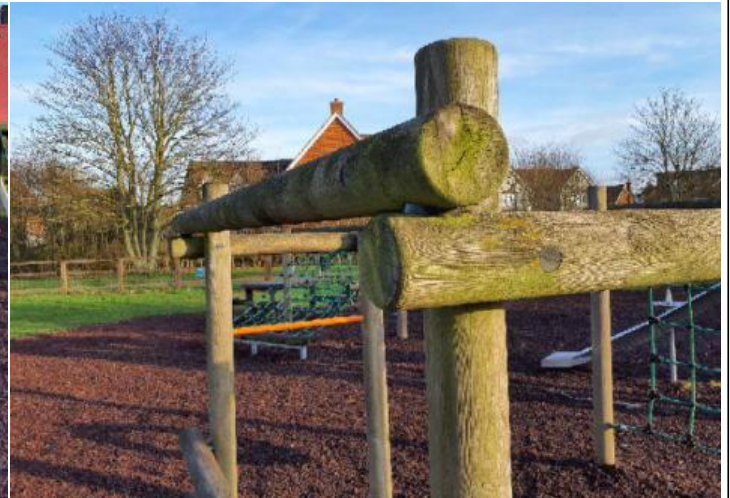
i 8 - Low Risk (Finding 1)

Risk Level: L - Low Risk
Surface: Loose Rubber Mulch

Finding: There is algae or moss on the surface of the equipment

Action: Clean and treat appropriately

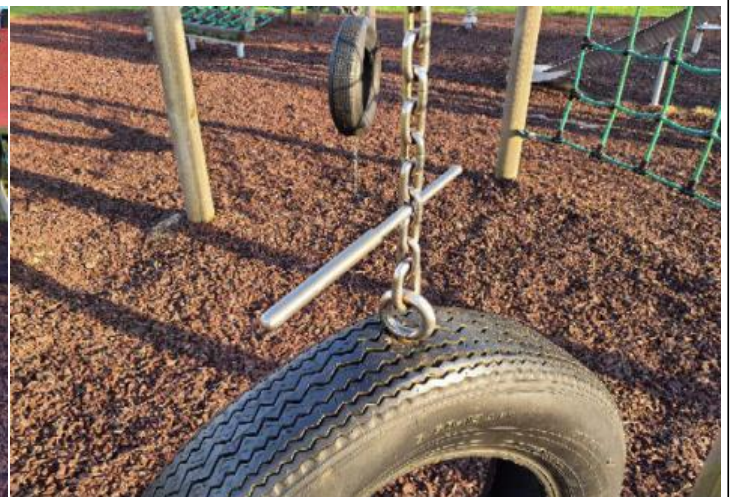
i 5 - Very Low Risk (Finding 2)

Risk Level: V - Very Low Risk
Surface: Loose Rubber Mulch

Finding: The chain openings are in excess of the 8.6mm as recommended by BS EN 1176

Action: Monitor - No action given the risk assessment

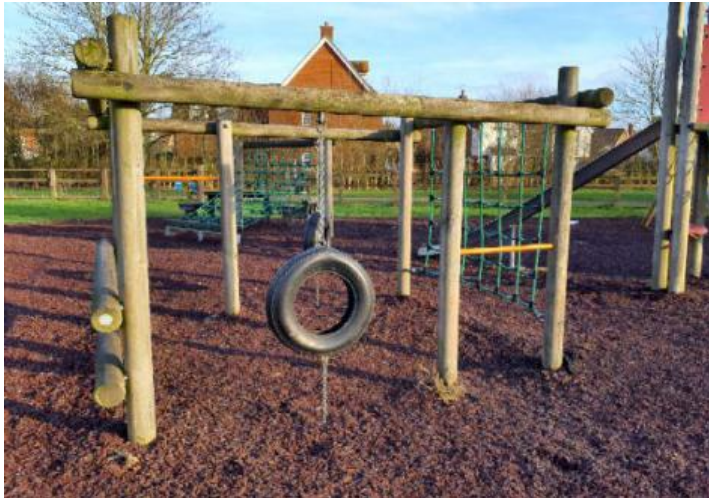
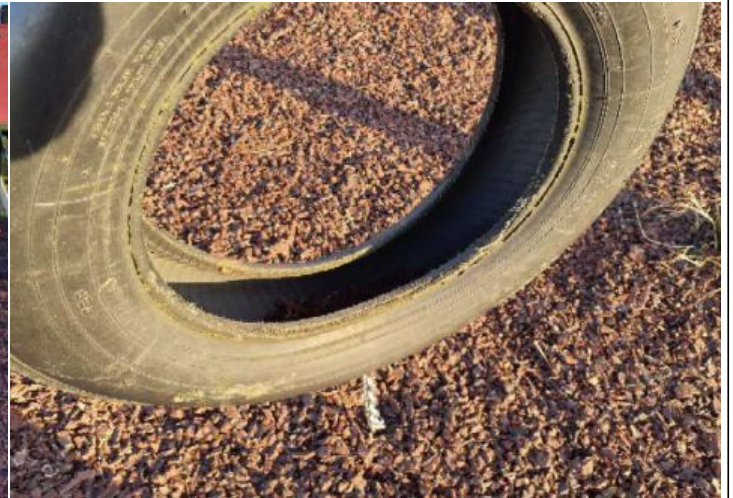
i 6 - Low Risk (Finding 3)

Risk Level: L - Low Risk
Surface: Loose Rubber Mulch

Finding: The item has been damaged

Action: Monitor for any further deterioration and replace as required
