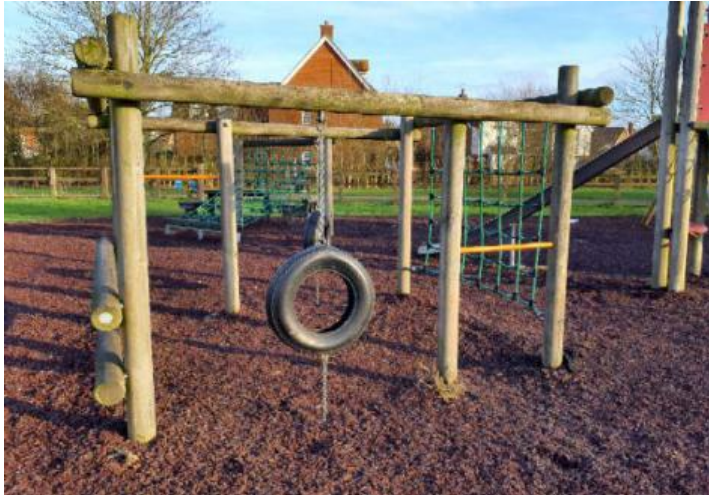
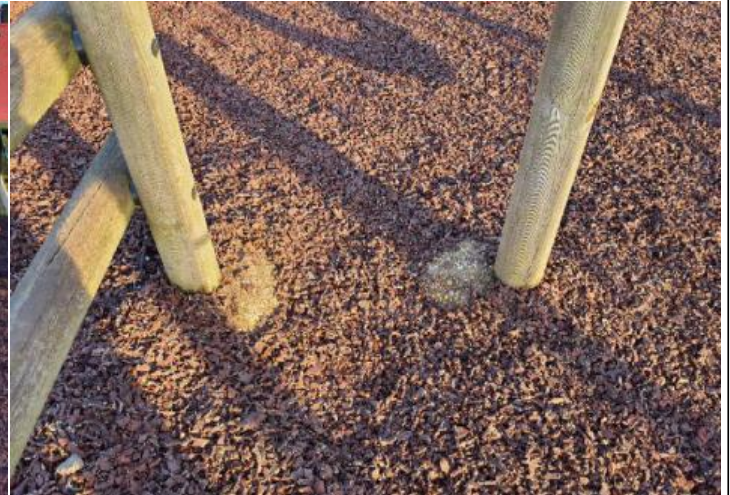
! 12 - Moderate Risk (Finding 4)

Finding: The depth of the loose fill surfacing is lower than the recommended depth specified in BS EN 1176 exposing the concrete foundations; the free height of fall of the equipment is less than 2.0m and a minimum of 300mm depth should be provided (including an extra 100mm to allow for compaction and displacement as per BS EN 1176 Part 1 - Table 4)

Action: Top up loose fill surfacing to recommended levels

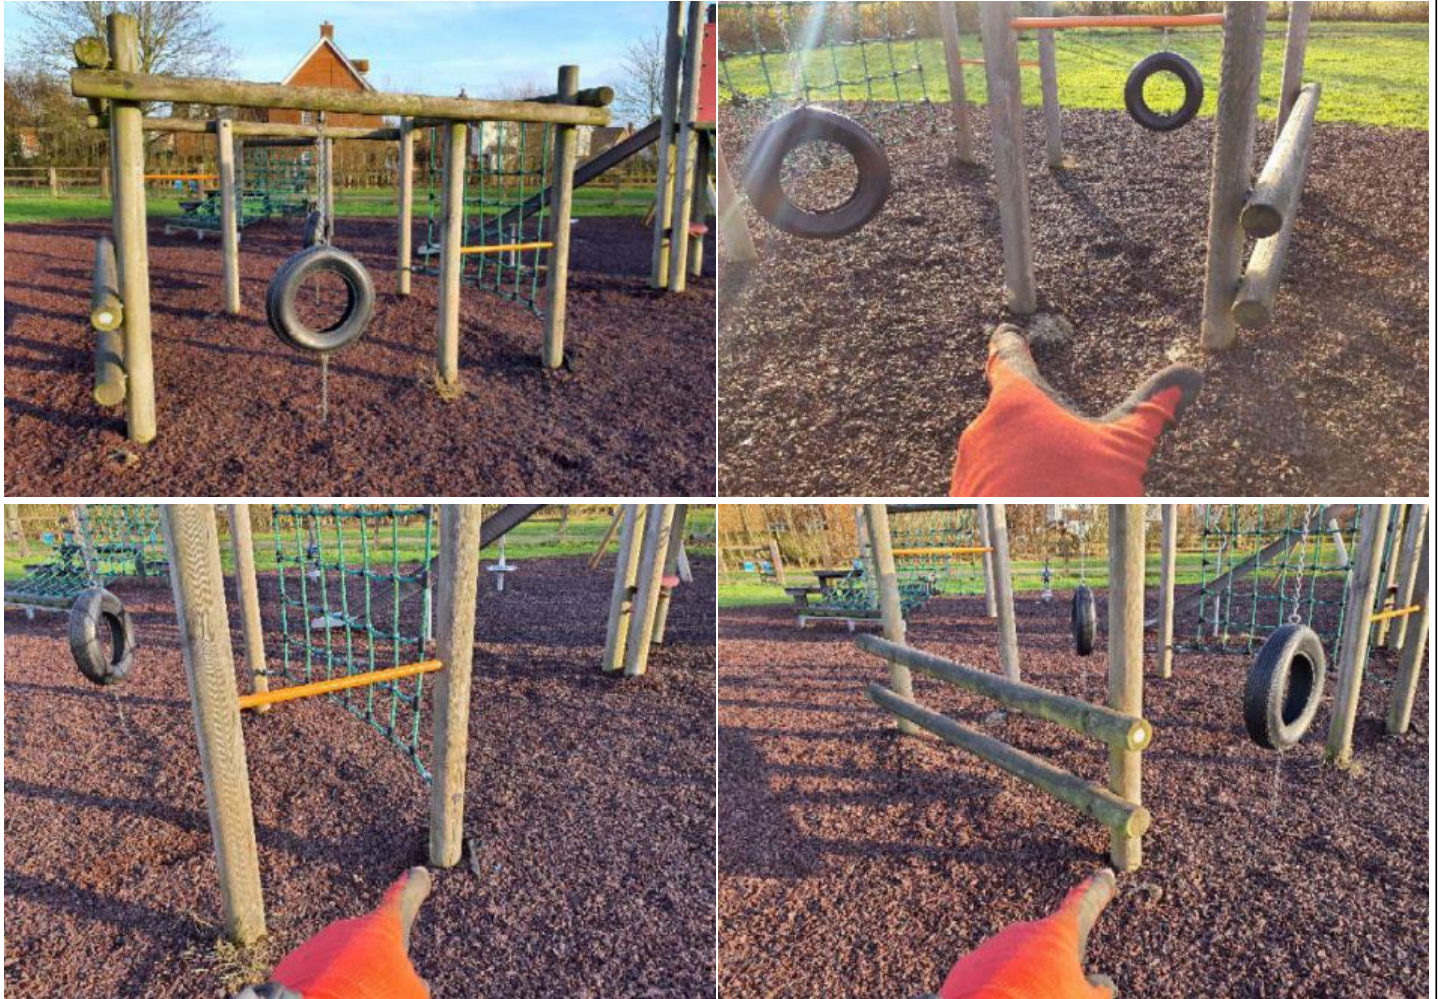
! 15 - Moderate Risk (Finding 5)

Finding: There are areas or parts of the timber on the structure that have rotted

Action: Replace all affected timbers

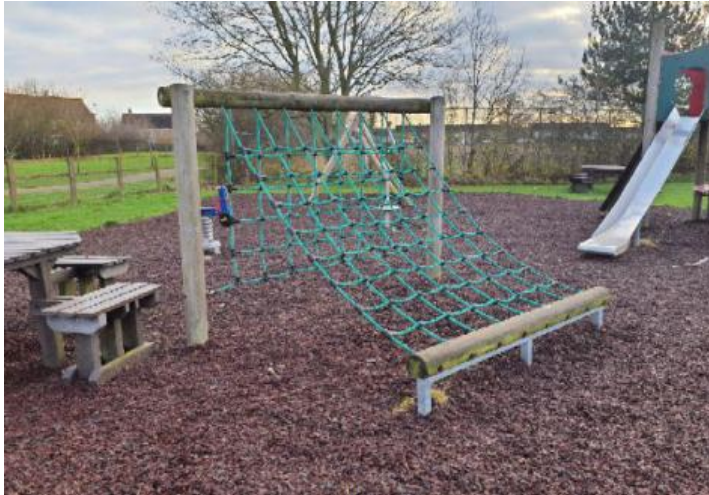
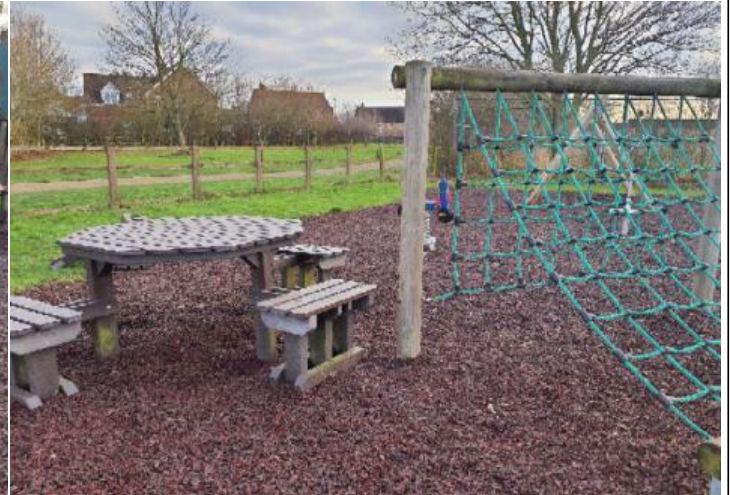
! 16 - High Risk (Finding 1)

Finding: The table forms a hard object within the falling space of the equipment and there is also insufficient surfacing provided in contravention of BS EN 1176 Part 1

Action: Relocate away from the equipment

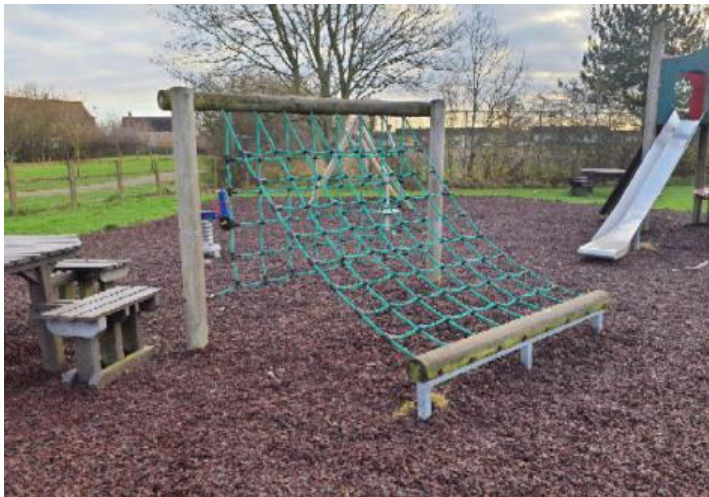
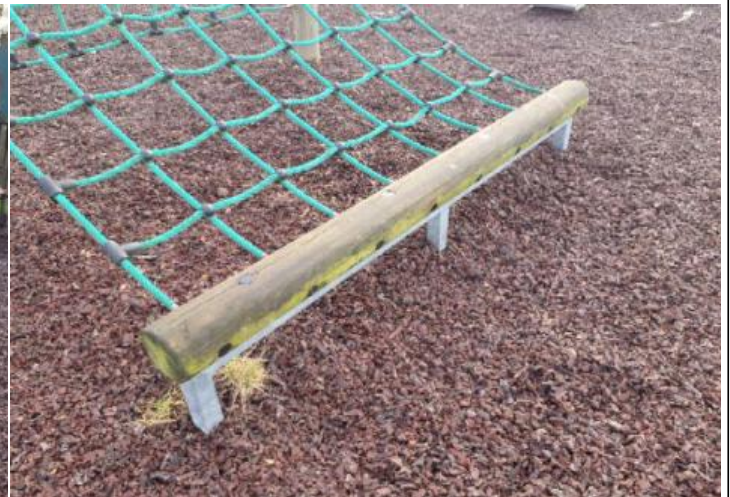
i 8 - Low Risk (Finding 2)

Finding: There is algae or moss on the surface of the equipment

Action: Clean and treat appropriately

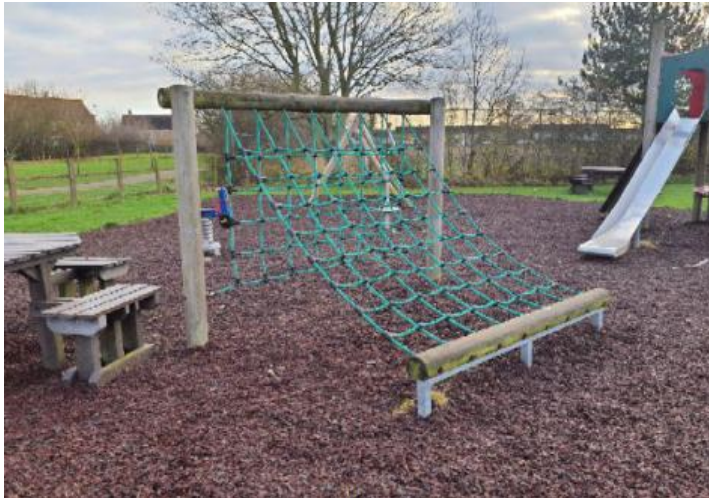
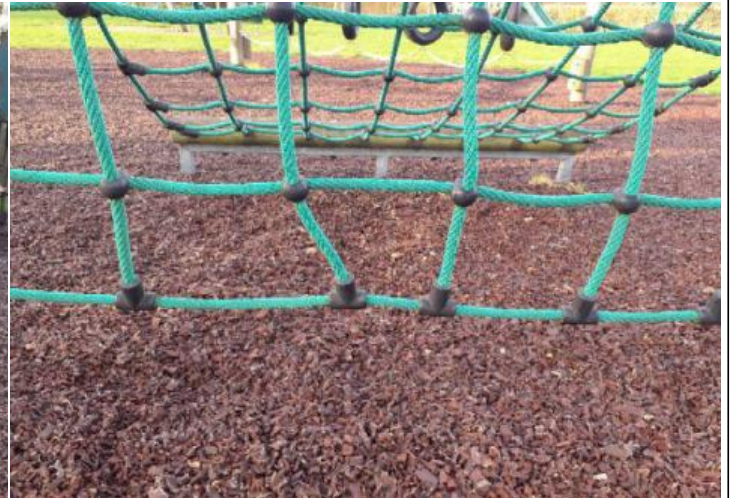
i 6 - Low Risk (Finding 3)

Finding: The rope connection has moved out of position

Action: Reinstate to the correct position

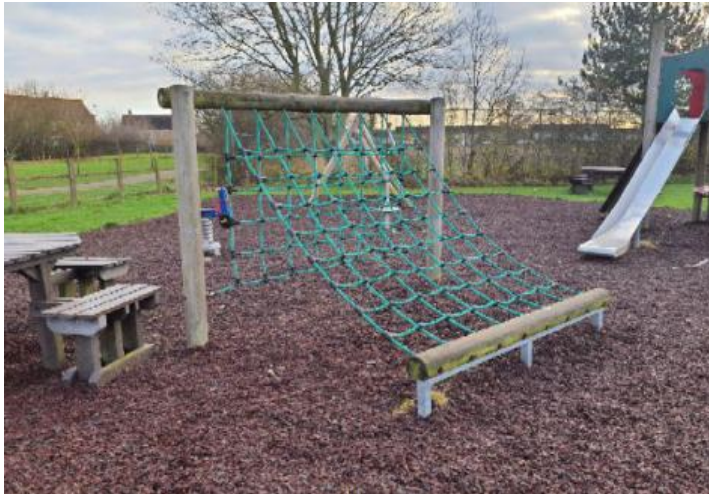
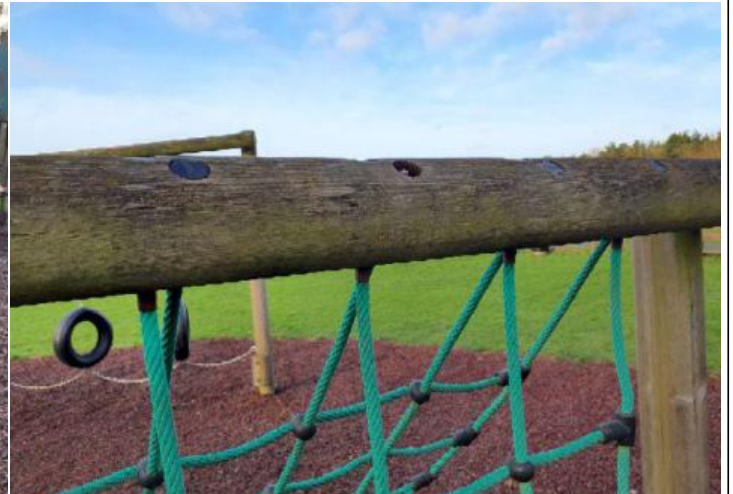
i 4 - Very Low Risk (Finding 4)

Finding: There is/are bolt cap covers missing or damaged on the item

Action: Replace missing or damaged bolt cap covers

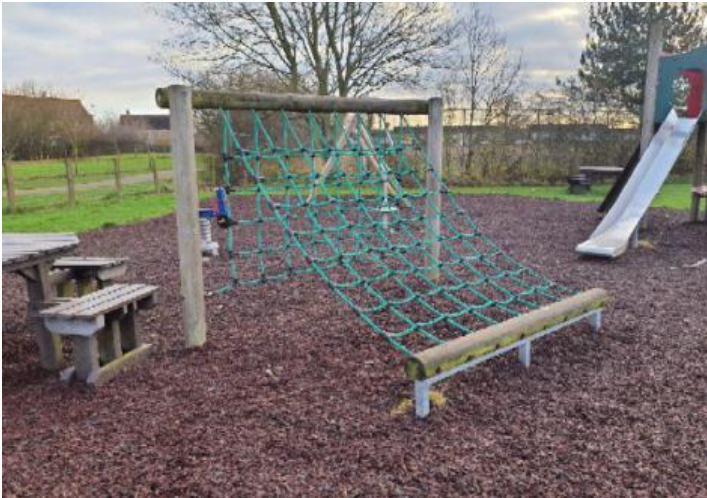
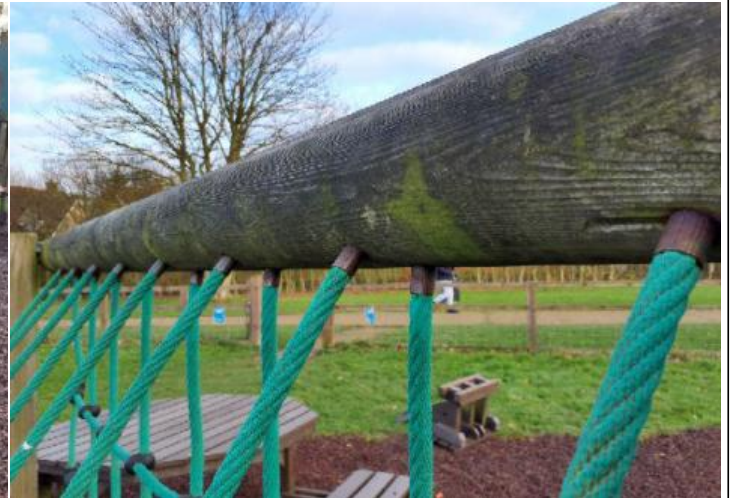
i 8 - Low Risk (Finding 5)

Finding: The fixings are corroding

Action: Monitor for any further deterioration and replace as required

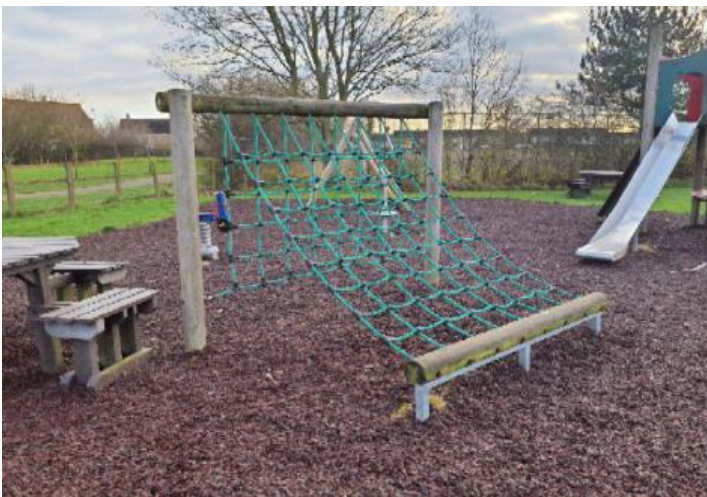
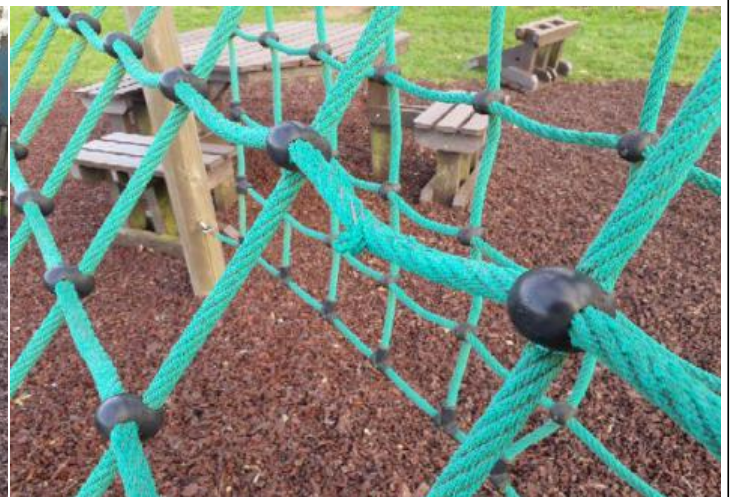
i 6 - Low Risk (Finding 6)

Finding: The ropes/nets are worn/damaged in places

Action: Monitor for any further deterioration and repair or replace as required

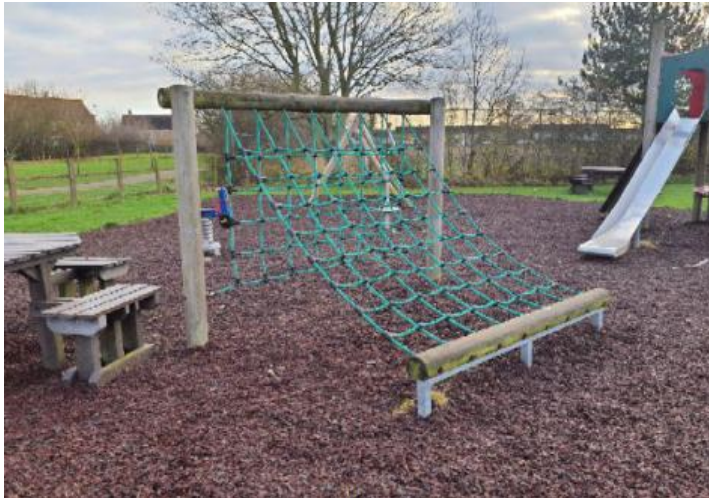
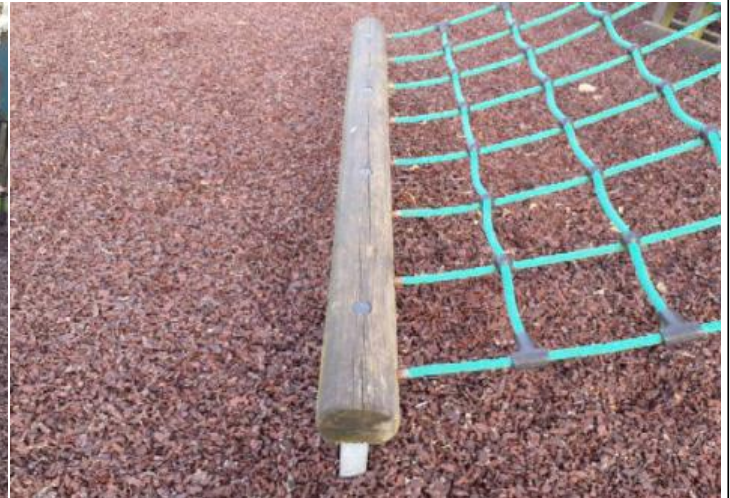
6 - Low Risk (Finding 7)

Finding: The timber has a number of splits/shakes or air cracks and this may affect the stability or allow water ingress which will accelerate the rotting process
Action: Monitor to ensure the splits do not cross through fixing points of the structure and/or cause any instability

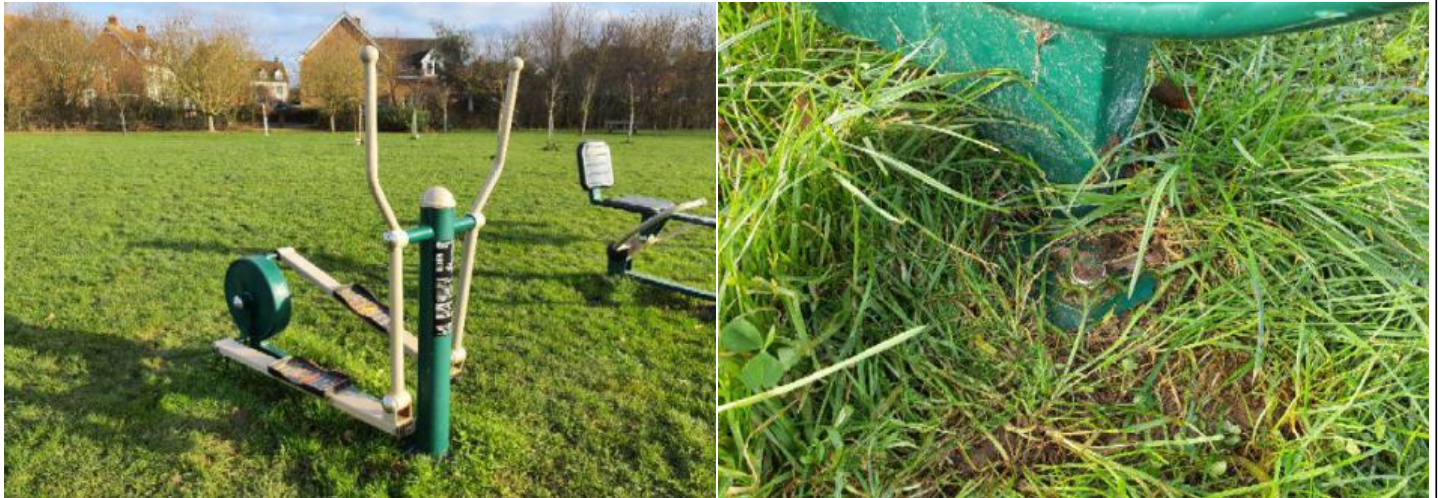
i 4 - Very Low Risk (Finding 2)

Finding: There is/are bolt cap covers missing or damaged on the item **Action:** Replace missing or damaged bolt cap covers

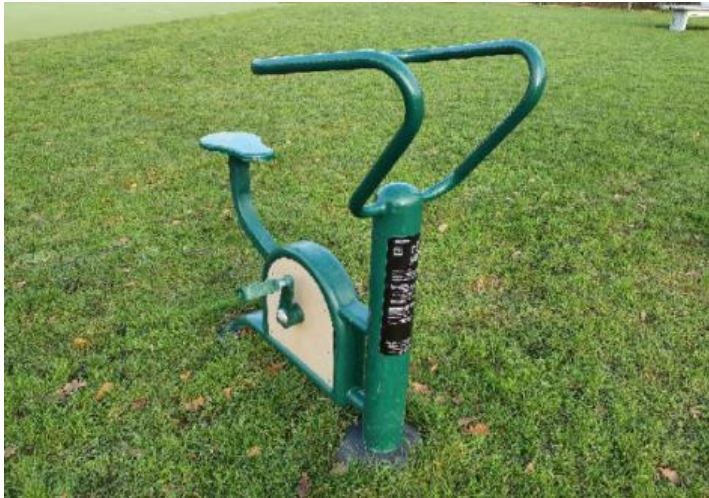
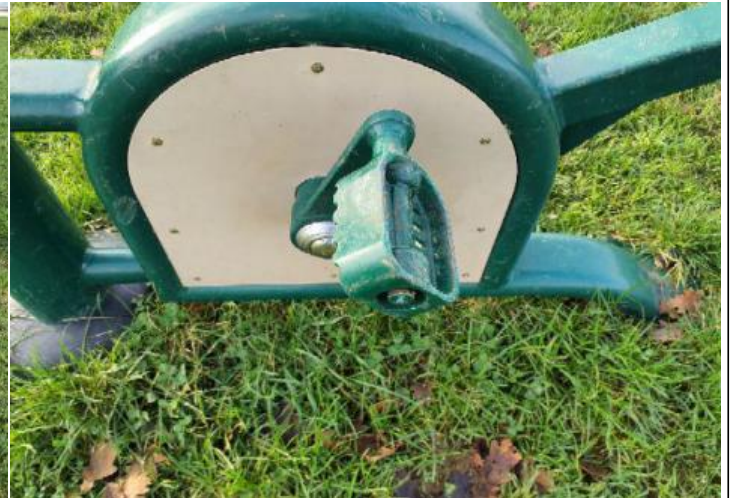
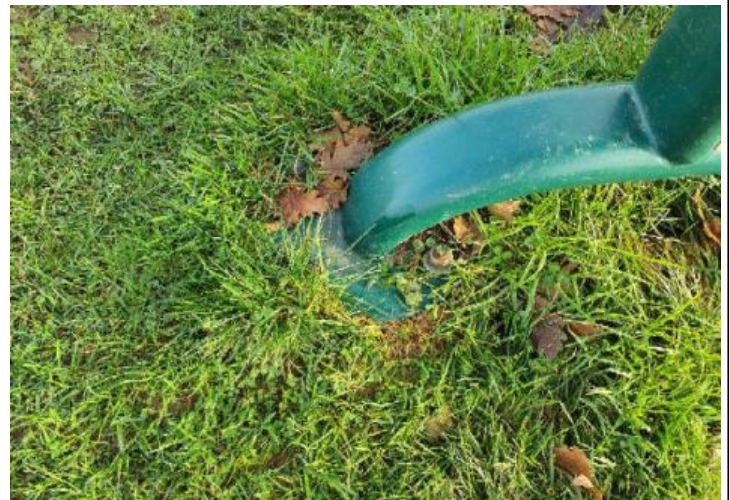
i 4 - Very Low Risk (Finding 1)

Finding: There is/are bolt cap covers missing or damaged on the item

Action: Replace missing or damaged bolt cap covers

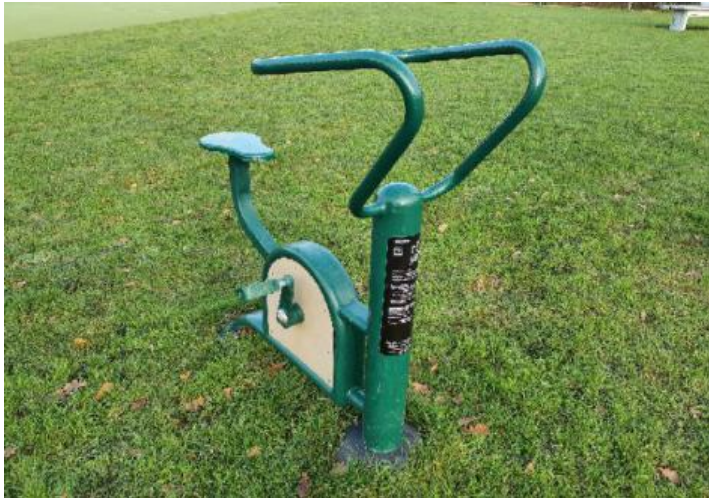
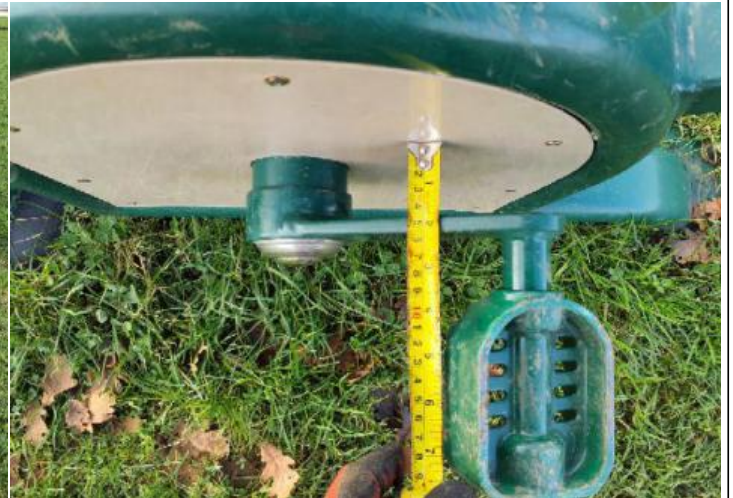
i 8 - Low Risk (Finding 2)

Finding: There are gaps between 8 and 60mm creating a potential crush/shear point in contravention of the requirements of BS EN 16630

Action: Monitor - No remedial work recommended

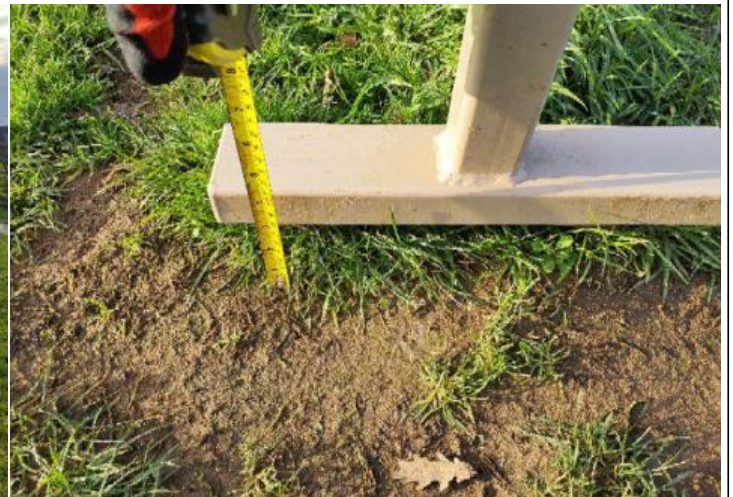
i 8 - Low Risk (Finding 1)

Finding: The distance between the underside of the item and the ground is less than the 110mm required by BS EN 16630

Action: Monitor - No action given the risk assessment

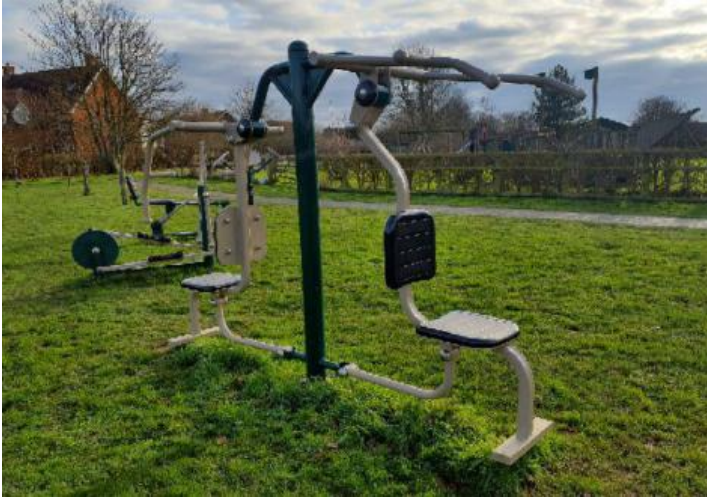
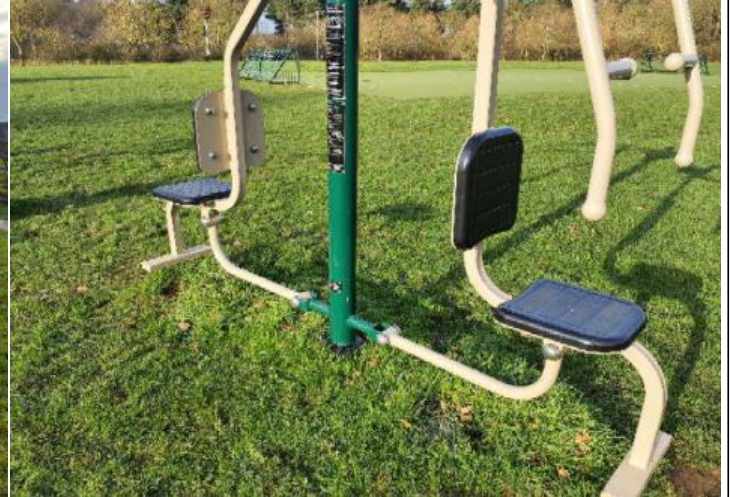
i 10 - Low Risk (Finding 2)

Finding: The item is loose in its foundations

Action: Reinstall item to secure

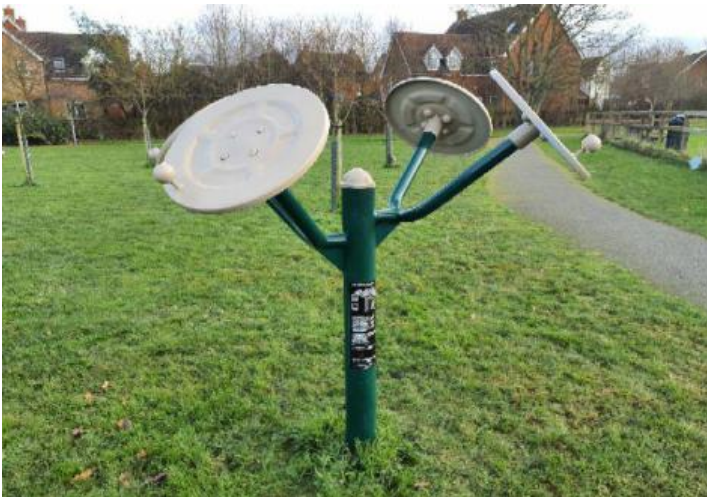
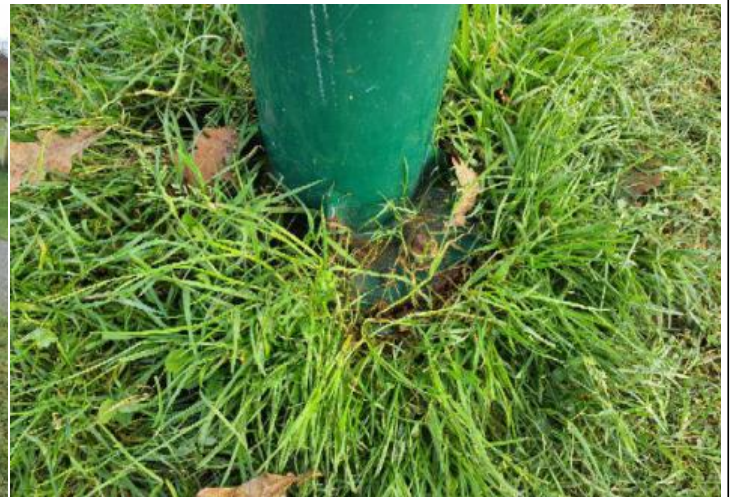
i 4 - Very Low Risk (Finding 1)

Finding: There is/are bolt cap covers missing or damaged on the item

Action: Replace missing or damaged bolt cap covers

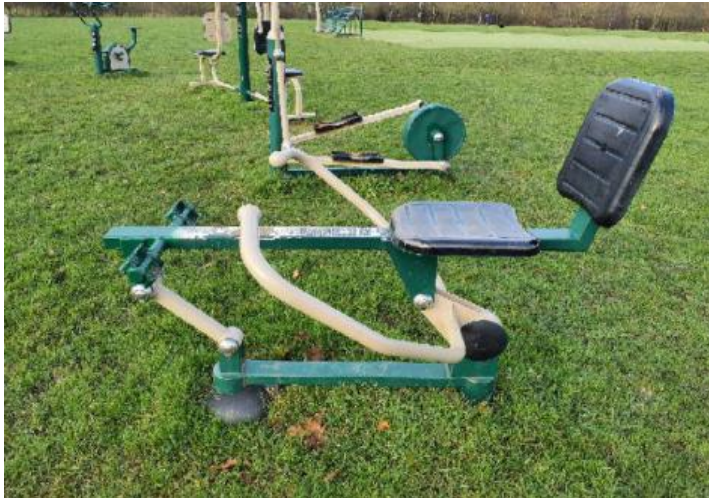
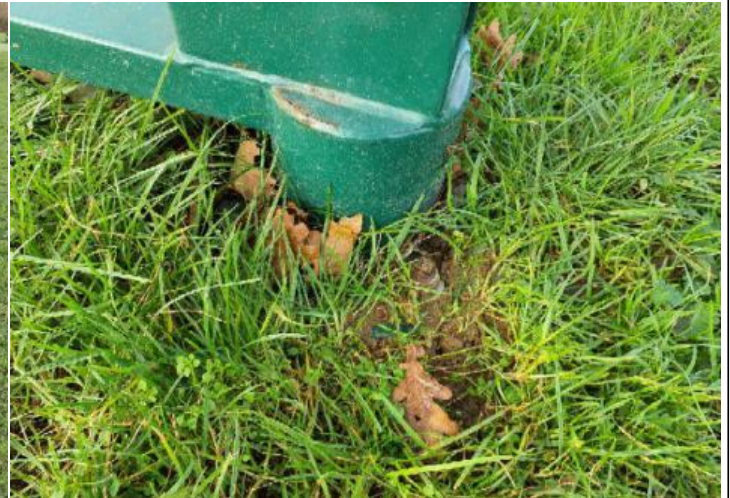
i 4 - Very Low Risk (Finding 2)

Finding: There is/are bolt cap covers missing or damaged on the item

Action: Replace missing or damaged bolt cap covers

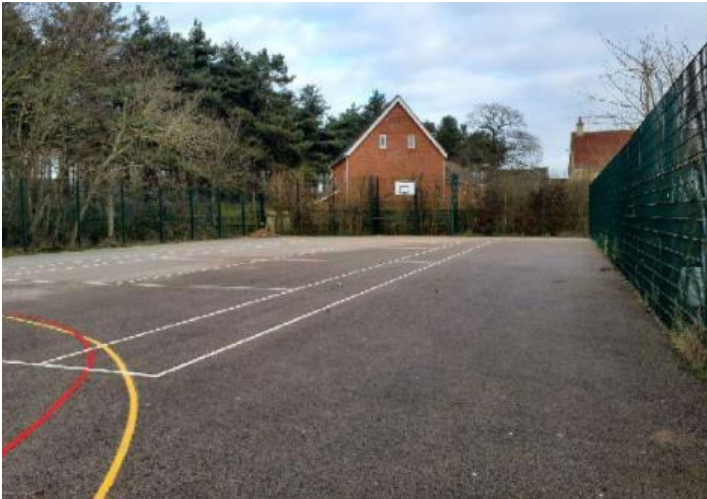
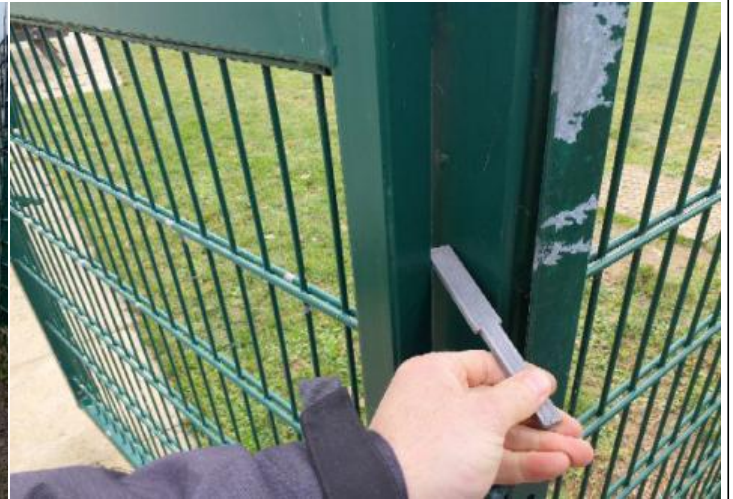
i 10 - Low Risk (Finding 1)

Finding: BS EN 15312 states that gaps whose dimensions change during use shall have a minimum dimension of 18mm
Action: Ensure crushing hazards are removed

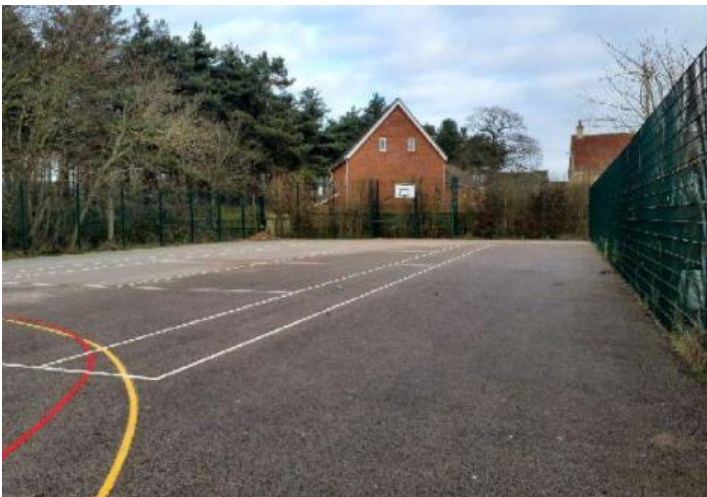
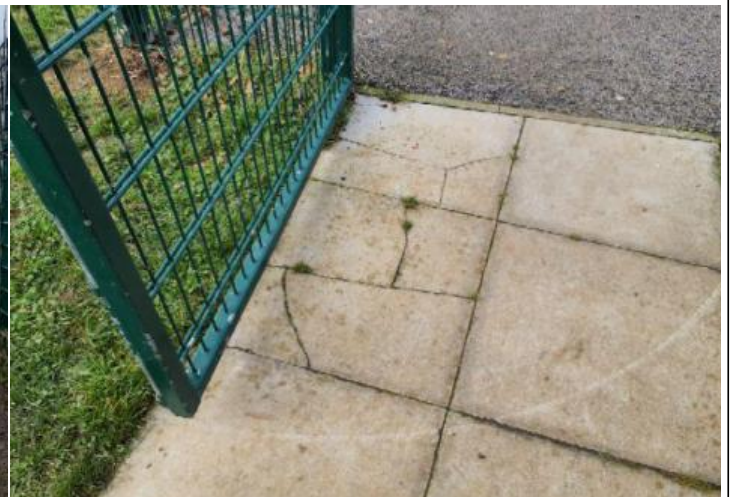
i 4 - Very Low Risk (Finding 2)

Finding: There is some minor damage to the surface
Action: Monitor for any further deterioration and repair as required

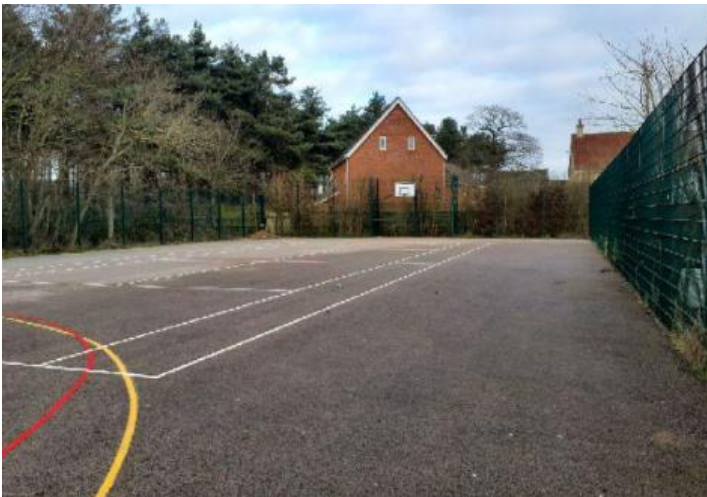
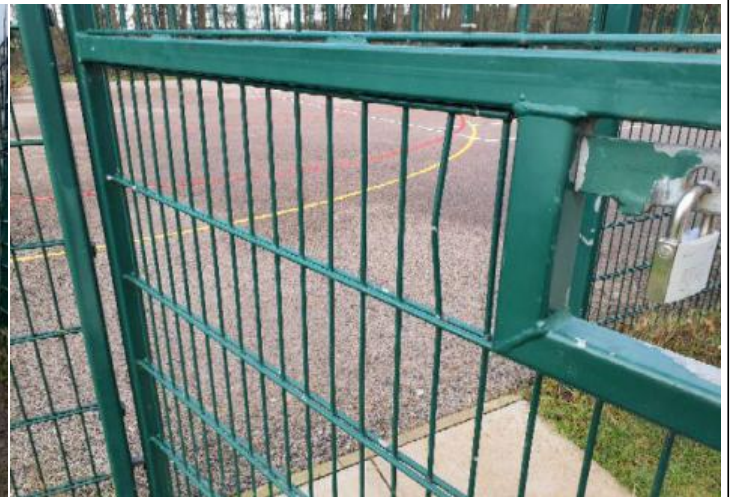
i 6 - Low Risk (Finding 4)

Finding: The item has been damaged

Action: Monitor for any further deterioration and replace as required

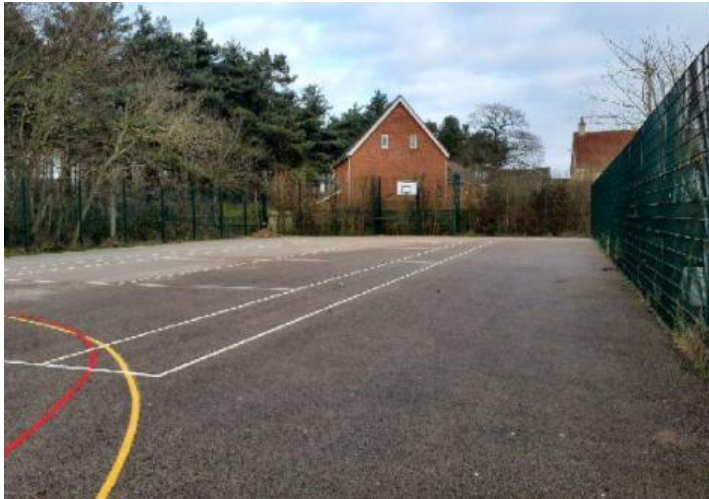
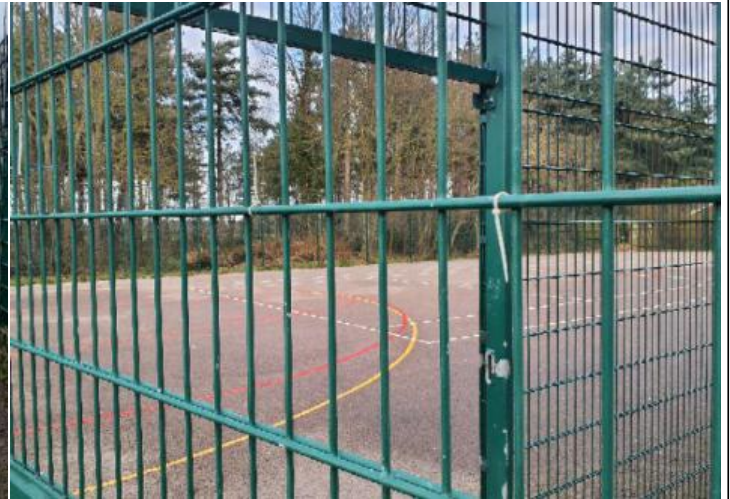
i 6 - Low Risk (Finding 5)

Finding: Cable ties have been used on the item and there are sharp projecting ends

Action: Remove if not required or replace with a more appropriate alternative fixing method if used as a fixing

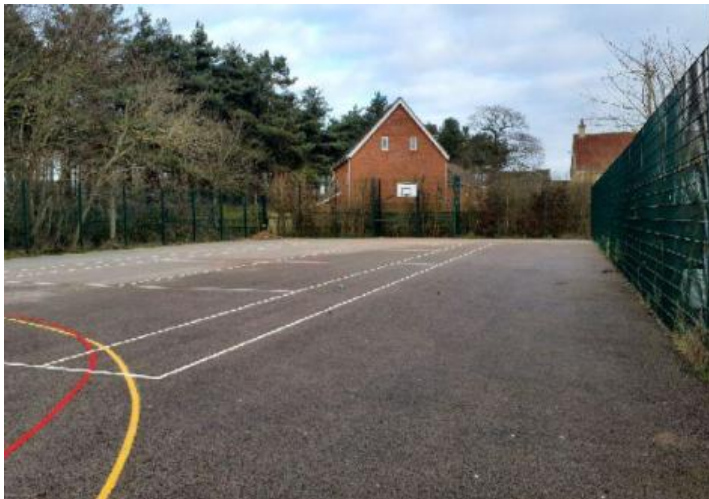
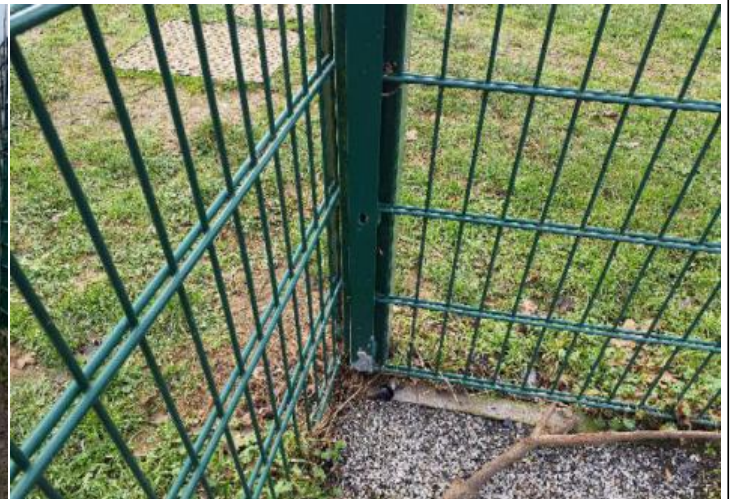
i 8 - Low Risk (Finding 6)

Finding: There is or are fixings missing on the item

Action: Replace all missing fixings

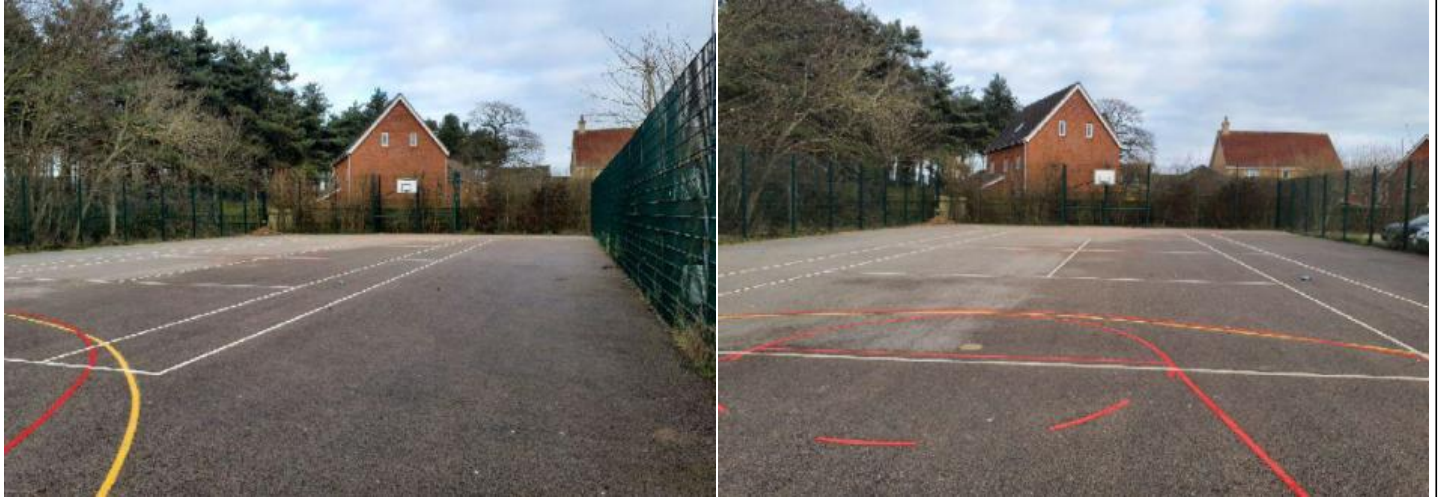
i 5 - Very Low Risk (Finding 7)

Finding: A clearly visible facility sign should be provided in a prominent position with the wording as detailed BS EN 15312- the equipment is not intended for children less than 3 years old- the warning - Do not climb on the framework or nets- the warning - Do not hang on the ring (if provided)- the warning - Do not wear rings or other jewellery- name and telephone number of the administrator- number to call in case of accident

Action: Provide signage to BS EN 15312

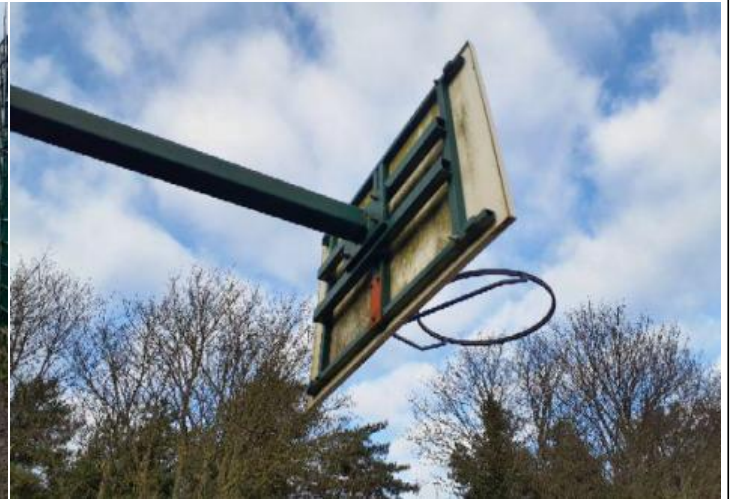
i 8 - Low Risk (Finding 8)

Finding: There are projecting bolt thread(s) present

Action: Remove excess thread length and deburr or provide cap

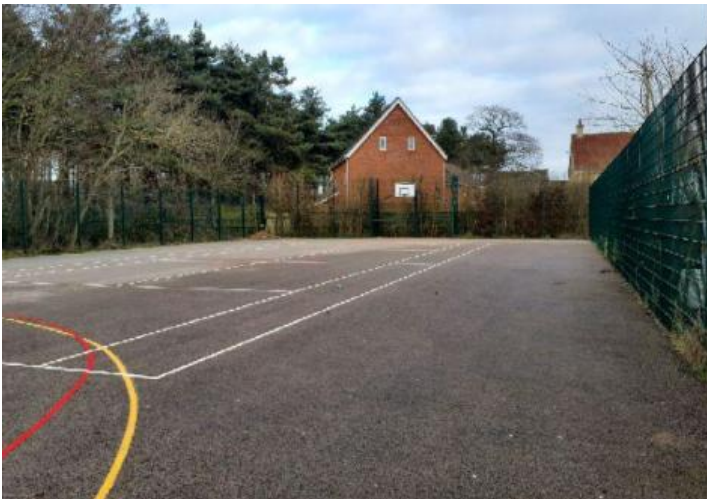
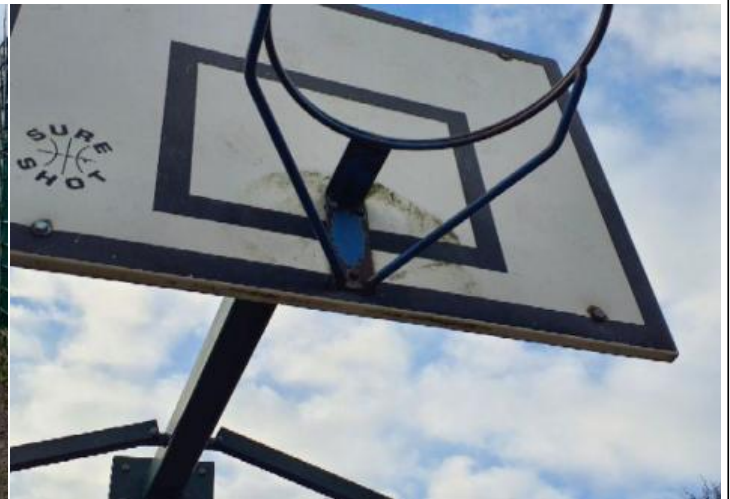
i 6 - Low Risk (Finding 9)

Finding: The paintwork on this item has been damaged or worn exposing the metal underneath which is rusting / corroding

Action: Treat affected areas and repaint

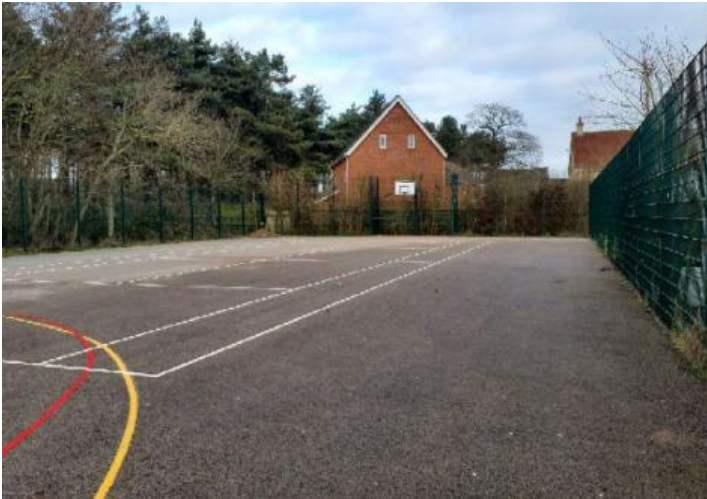
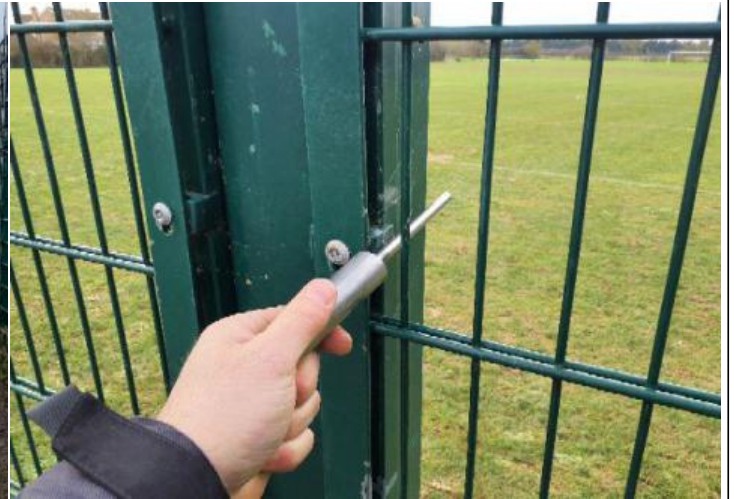
i 5 - Very Low Risk (Finding 10)

Finding: There is/are finger entrapments in the panels and the item fails to meet the requirements of BS EN 15312 Clause 4.4.2.2 Entrapment of fingers

Action: Monitor - No action given the risk assessment

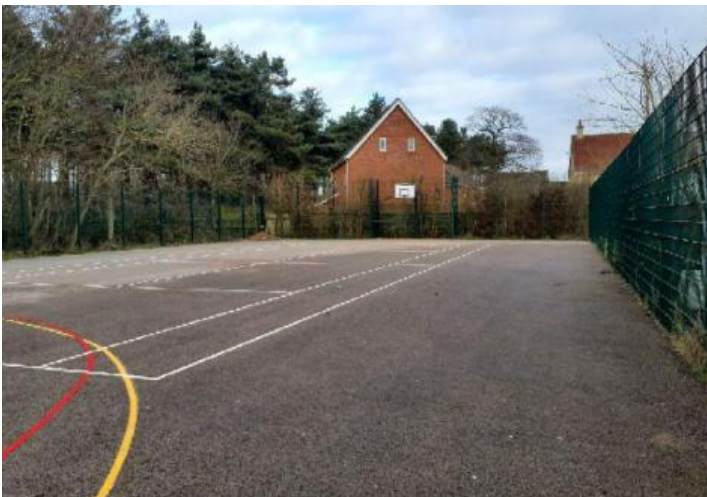
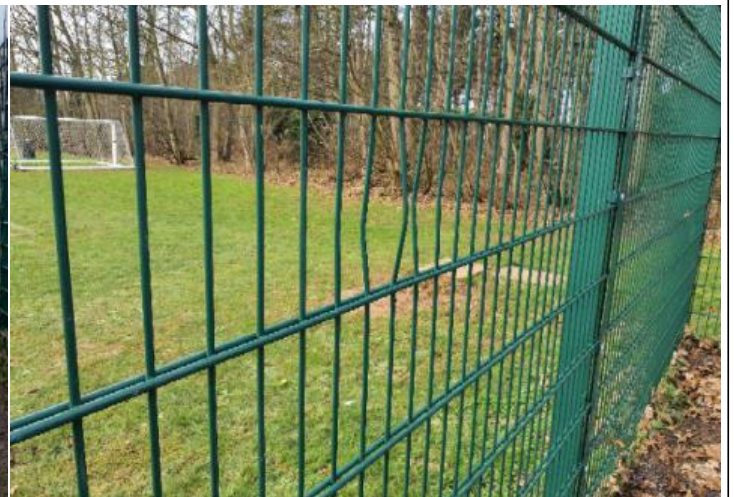
i 6 - Low Risk (Finding 11)

Finding: The item has been damaged

Action: Monitor for any further deterioration and replace as required

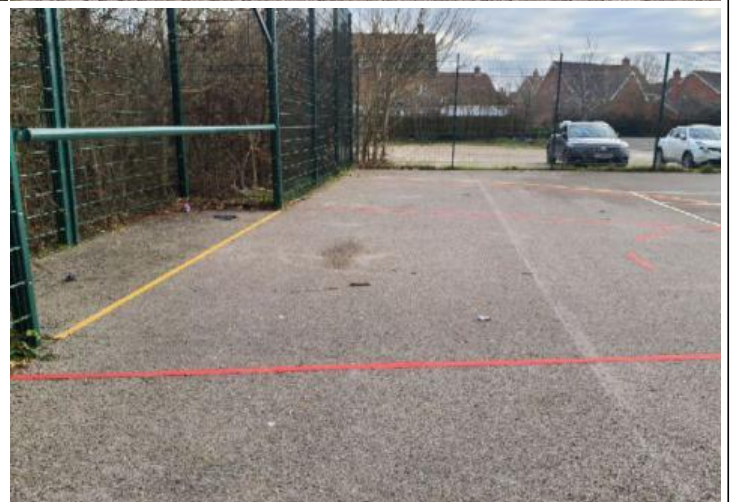
i 6 - Low Risk (Finding 12)

Finding: There is litter/debris in the area

Action: Remove litter/debris from the area and maintain

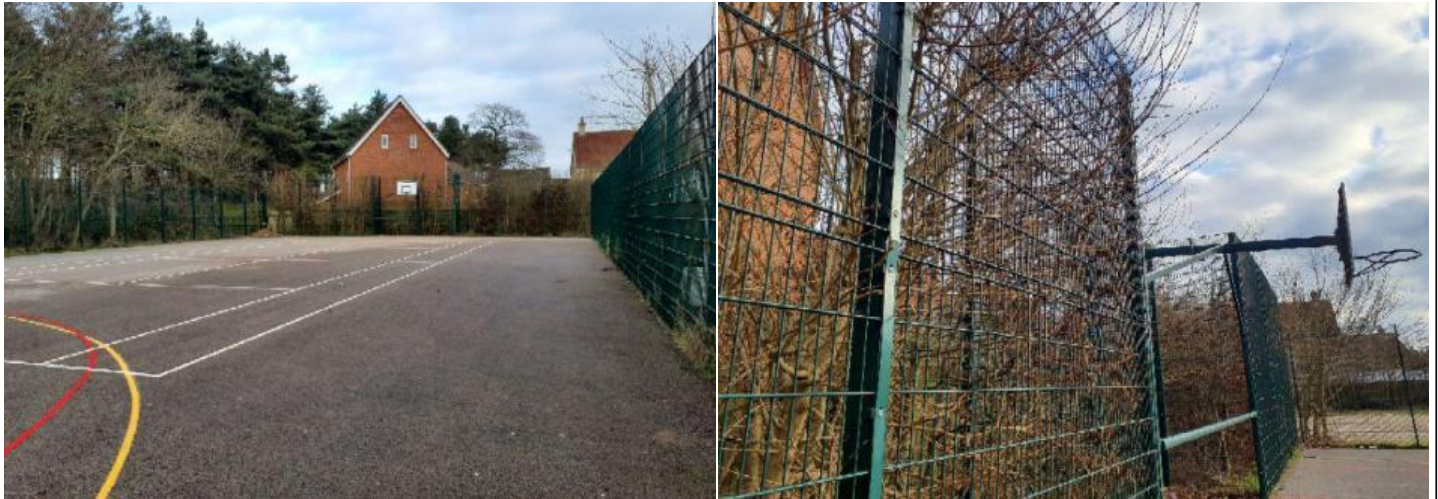
i 6 - Low Risk (Finding 13)

Finding: There is foliage growth through the fence

Action: Cut back and maintain

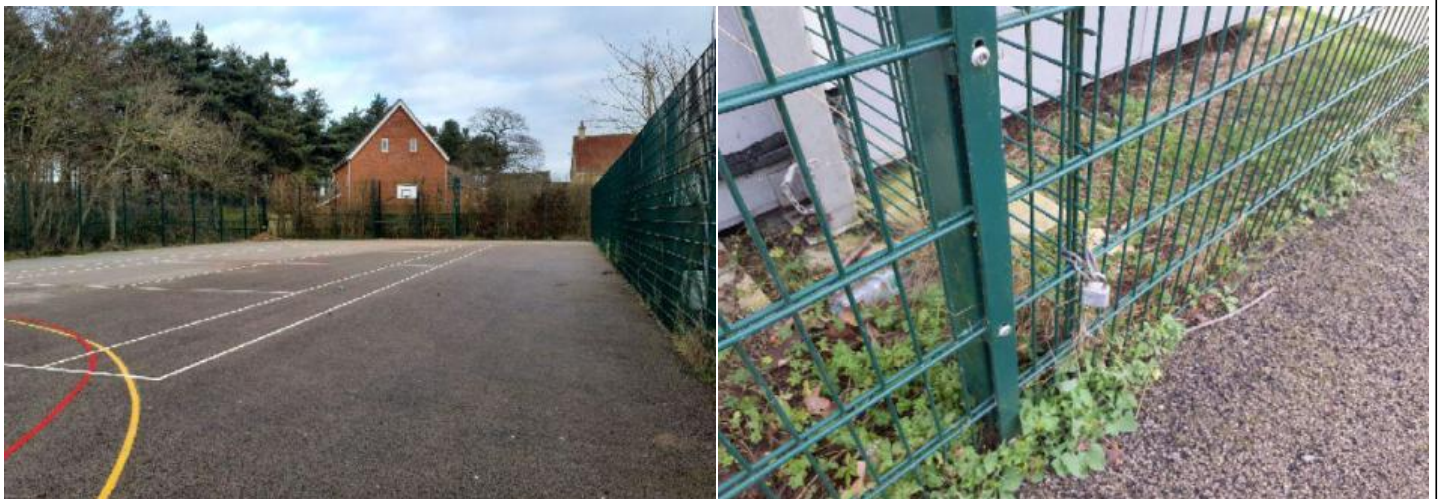
i 8 - Low Risk (Finding 14)

Finding: There is a chain attached securing panels

Action: Remove and provide an alternative fixing method

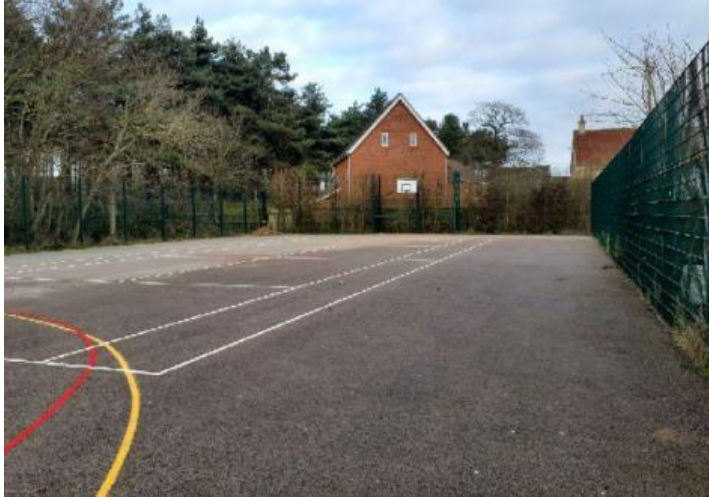
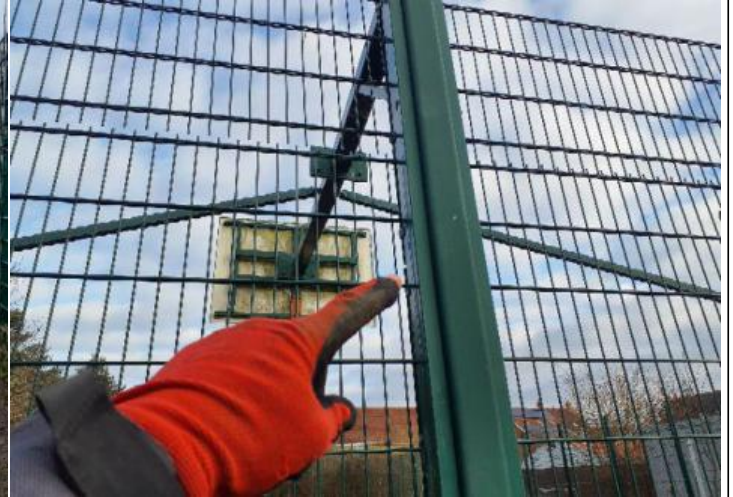
i 8 - Low Risk (Finding 15)

Finding: There is or are fixings missing on the item

Action: Replace all missing fixings
