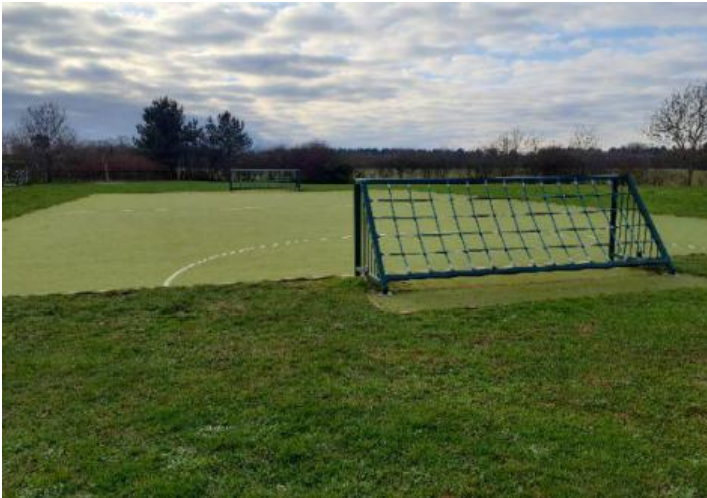
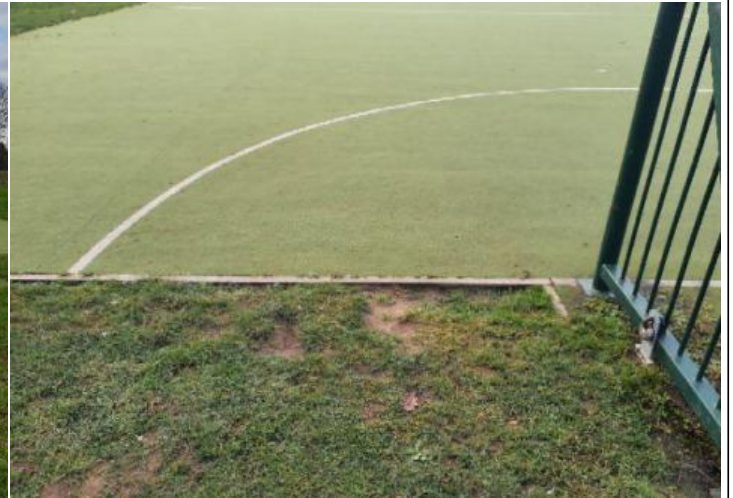
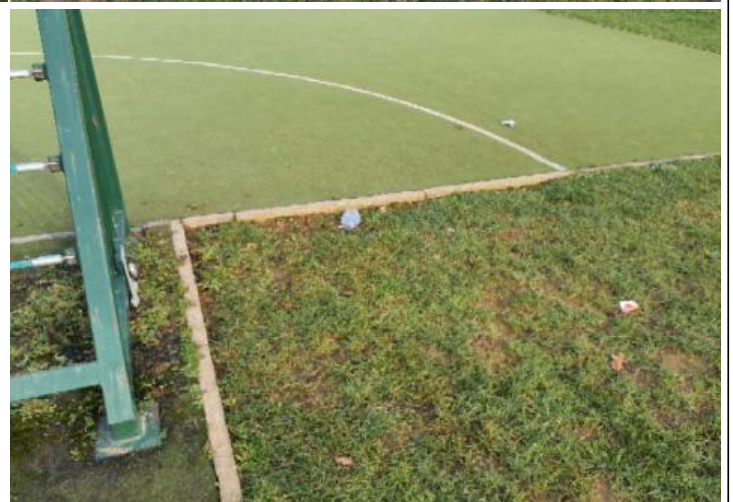
i 8 - Low Risk (Finding 1)

Finding: There are trip hazards at the edges of the surface

Action: Reinstate surrounding surface levels to remove the trip points

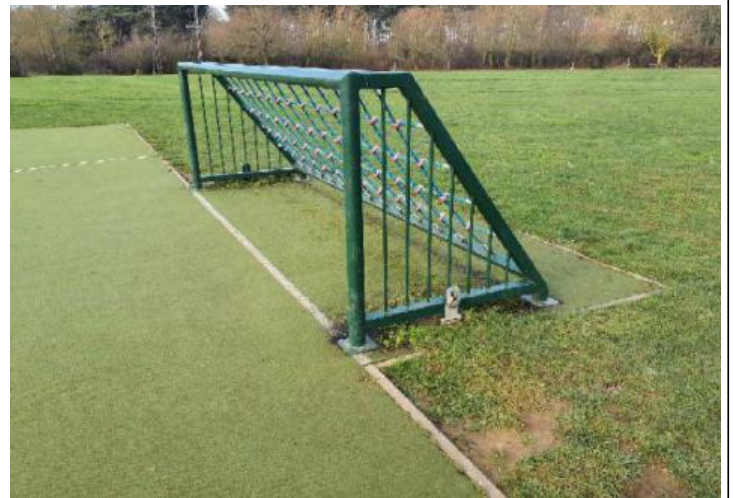
12 - Moderate Risk (Finding 2)

Finding: The design of the equipment may encourage climbs onto the goal, and the concrete edgings form an hard object in the impact area in contravention of BS EN 15312

Action: Refer to the manufacturer / contractor and modify the design to comply with the requirements of BS EN 15312

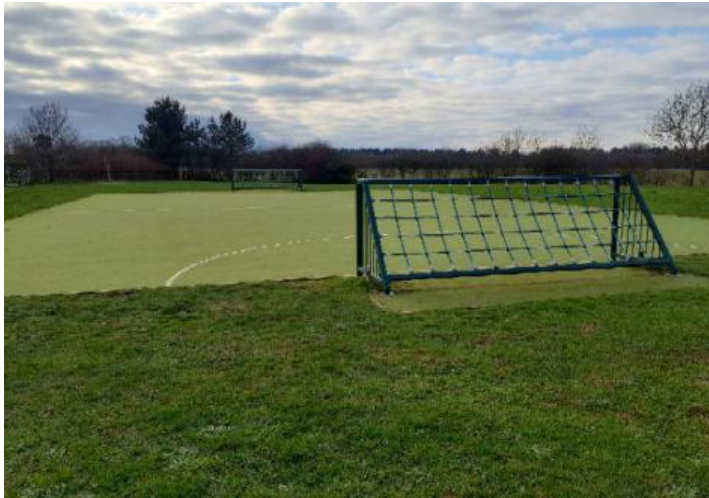
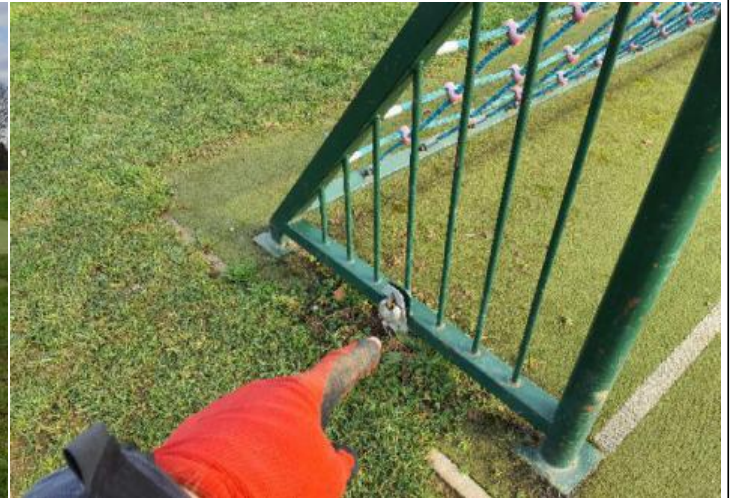
i 10 - Low Risk (Finding 3)

Finding: The goals are not securely fixed to the surface (only by the padlock brackets which appear to be loose in the foundations)

Action: Refer to the contractor

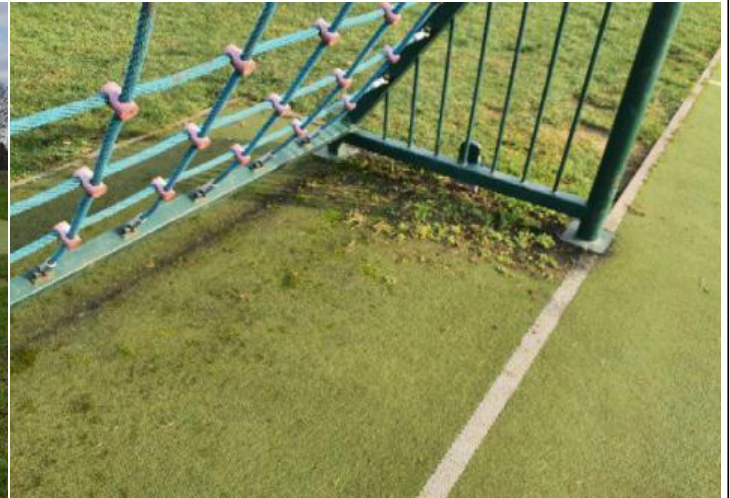
i 6 - Low Risk (Finding 4)

Finding: There is weed / vegetation growth within the surface

Action: Remove weed / vegetation growth

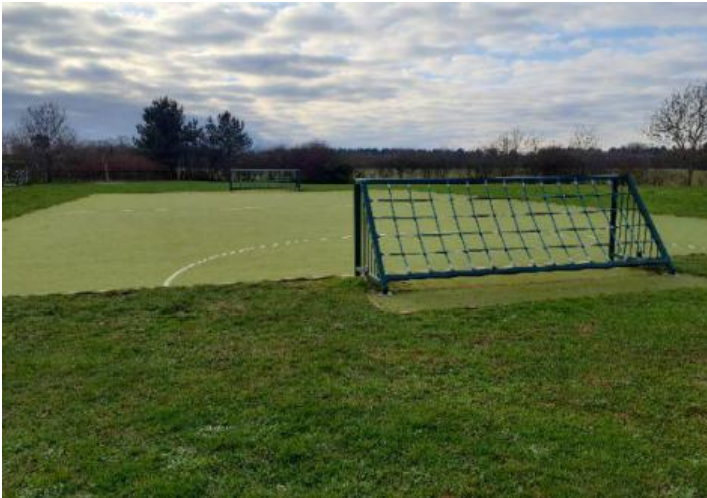
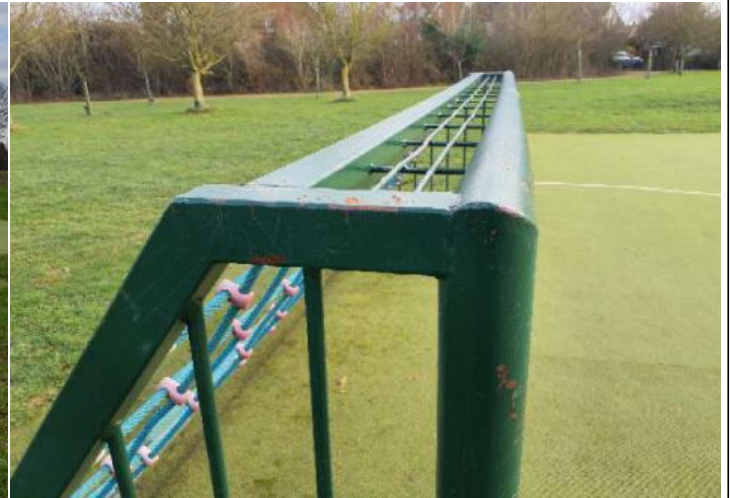
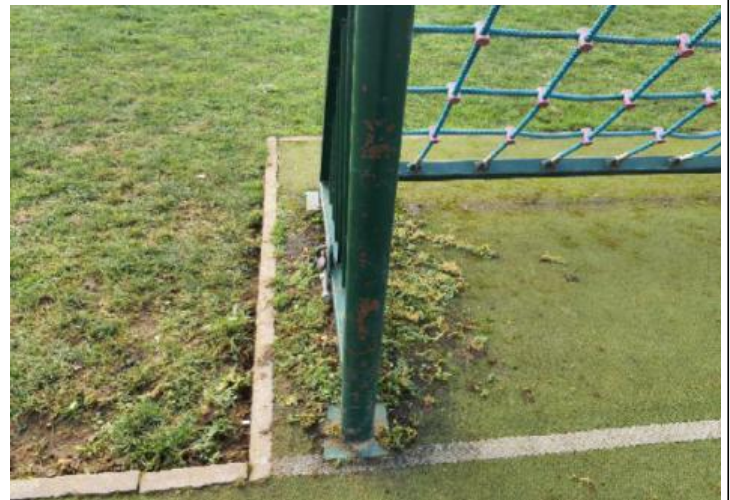
i 6 - Low Risk (Finding 5)

Finding: The paintwork on this item has been damaged or worn exposing the metal underneath which is rusting / corroding

Action: Treat affected areas and repaint

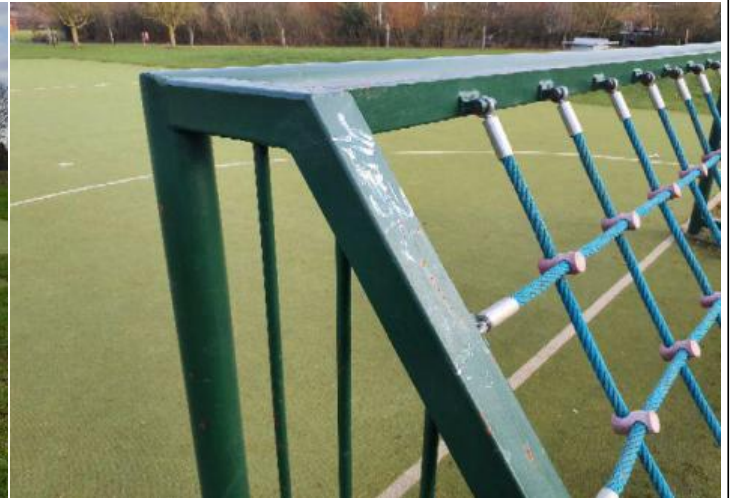
i 0 - Risk Assessment not Undertaken (Finding 6)

Finding: There is some graffiti present

Action: Remove the graffiti

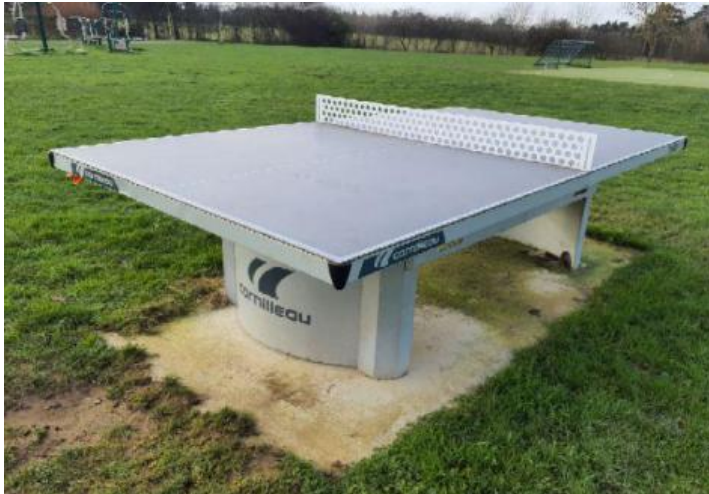
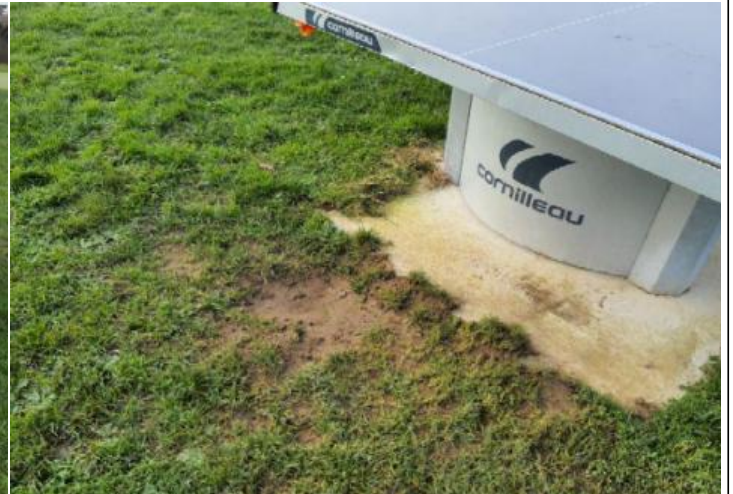
i 6 - Low Risk (Finding 1)

Finding: The surface has eroded in some areas and may be slippery in wet conditions

Action: Reinstate the surface

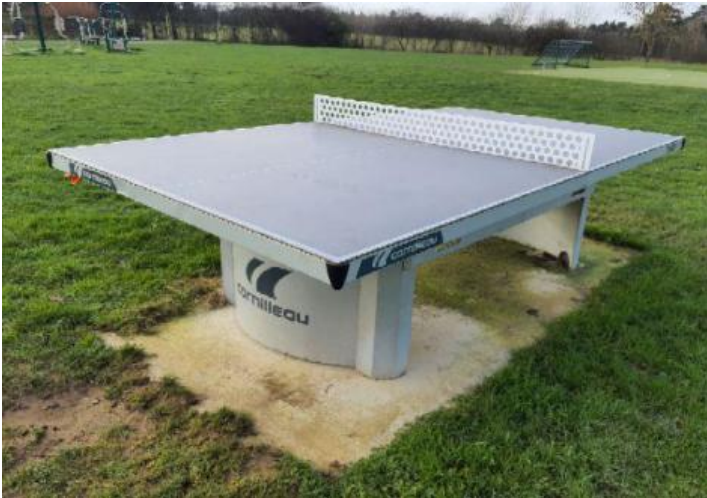
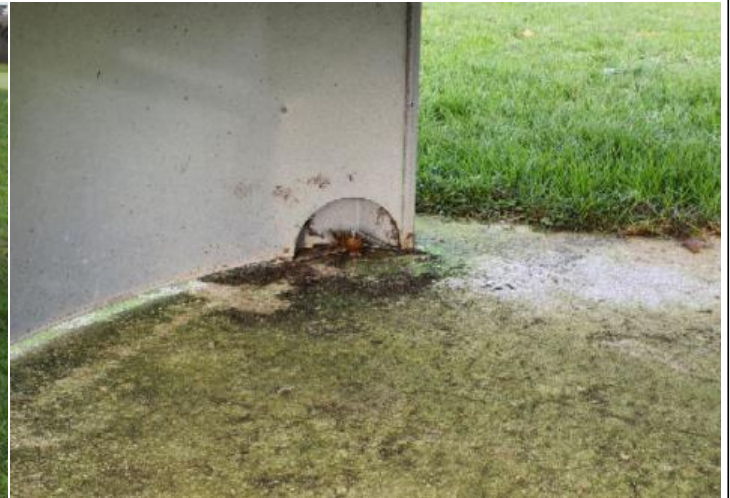
i 8 - Low Risk (Finding 2)

Finding: The base connection is damaged

Action: Repair or replace

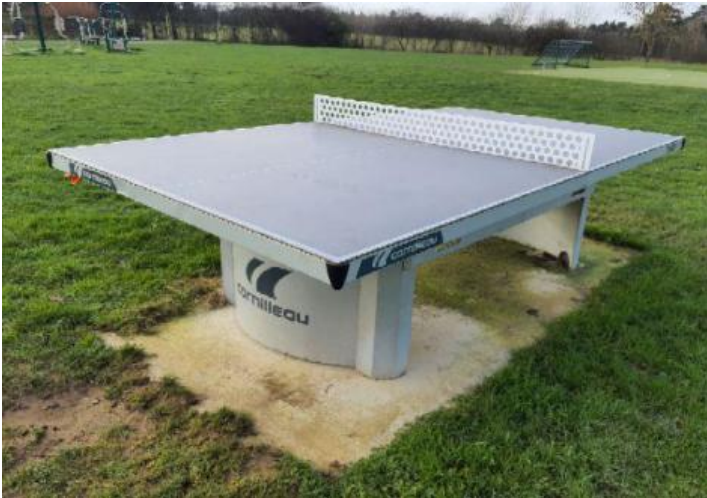
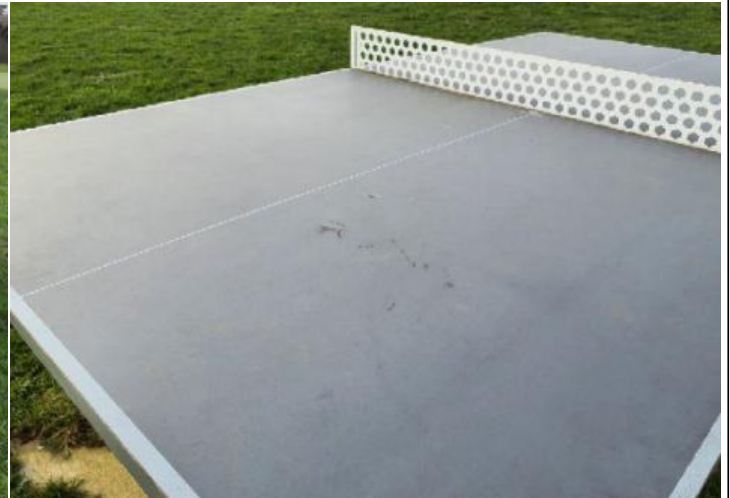
i 4 - Very Low Risk (Finding 4)

Finding: The table has been damaged

Action: Monitor for any further deterioration and replace as required
