the **play inspection** company

Annual Inspection

Rendlesham Parish Council

Jubilee Park Play Area

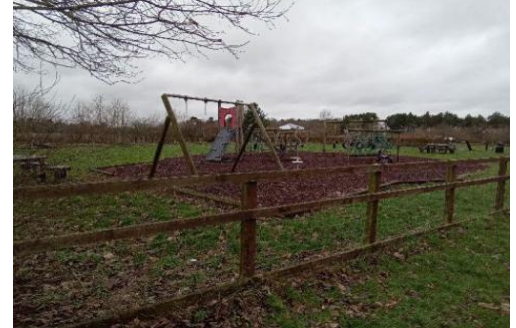
Item: Site General
Manufacturer: Owner/Operator
Surface Type: N/A
Item Quantity: 1
Equipment Compliance: N/A
Surface Area Compliance: N/A

Signage should be provided for the outdoor fitness equipment in accordance with the requirements of BS EN 16630, key requirements of the sign include, but are not limited to, intended users, medical safety and emergency contact details - Provide appropriate signage

There are a number of molehills within the area and these may present unforeseen hazards for users - Remove moles by appropriate means, reinstate surfaces to level and maintain the area

The grass is overgrown within the play area and may hide hazards - Reduce the length of grass to an acceptable height and maintain

The depth of the loose fill surfacing is lower than the recommended depth specified in BS EN 1176; the free height of fall of the equipment is less than 2.0m and a minimum of 300mm depth should be provided (including an extra 100mm to allow for compaction and displacement as per BS EN 1176 Part 1 - Table 4) - Top up loose fill surfacing to recommended levels

There is some evidence of rot in the timber - Monitor for any further deterioration and replace as required

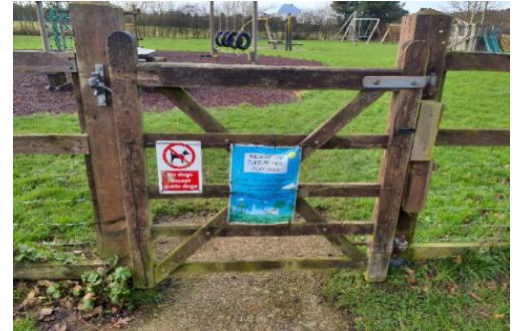
Item: Gate
Manufacturer: Not Identified
Surface Type: N/A
Item Quantity: 1
Equipment Compliance: N/A
Surface Area Compliance: N/A

Cable ties are present and there are sharp projecting ends - Replace with a more appropriate fixing method

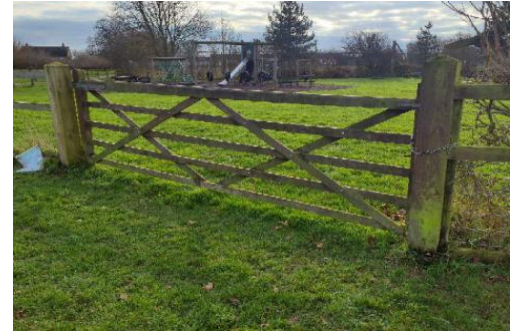
Item: Gate - Maintenance
Manufacturer: Not Identified
Surface Type: N/A
Item Quantity: 1
Equipment Compliance: N/A
Surface Area Compliance: N/A

There is or are fixings missing on the item - Replace all missing fixings

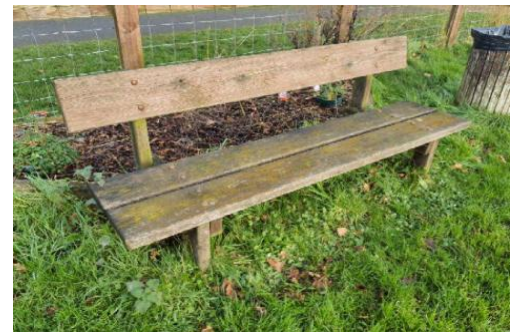
Item: Bench
Manufacturer: Playdale Playgrounds Ltd
Surface Type: Grass
Item Quantity: 1
Equipment Compliance: N/A
Surface Area Compliance: N/A

There is some strimmer / machinery damage apparent on the posts, this can penetrate the preservative applied to the timber and accelerate the rotting process - Monitor for any deterioration (rot) and replace as required

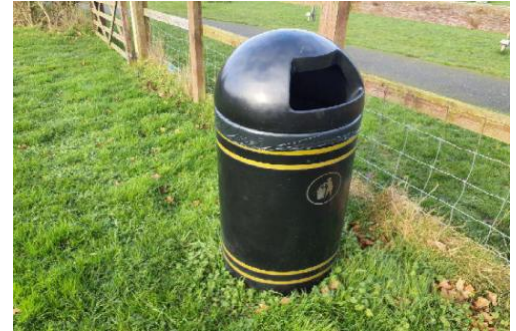
Item: Litter Bin
Manufacturer: Not Identified
Surface Type: N/A
Item Quantity: 2
Equipment Compliance: N/A
Surface Area Compliance: N/A

The bin is not securely fixed to the surface and there is some possibility of the item tipping or rolling over - Secure the bin to the ground

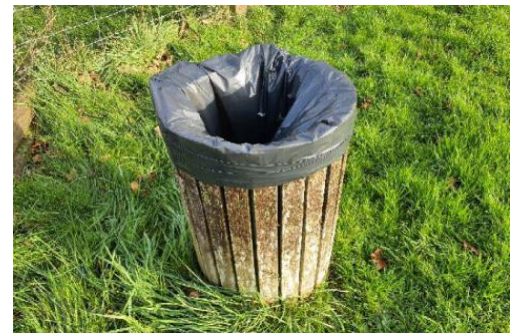
Item: Litter Bin
Manufacturer: Not Identified
Surface Type: Grass
Item Quantity: 1
Equipment Compliance: N/A
Surface Area Compliance: N/A

The lid of the bin is missing - Replace

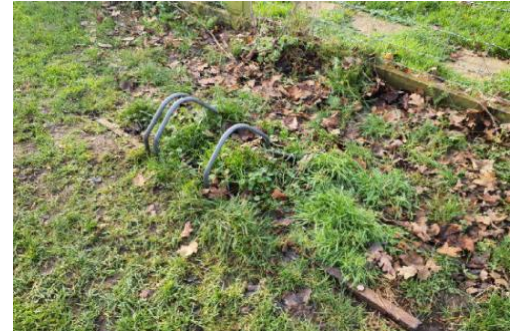
Item: Cycle Rack
Manufacturer: Not Identified
Surface Type: Grass
Item Quantity: 1
Equipment Compliance: N/A
Surface Area Compliance: N/A

The item has been severely damaged - Repair or replace the item / affected part

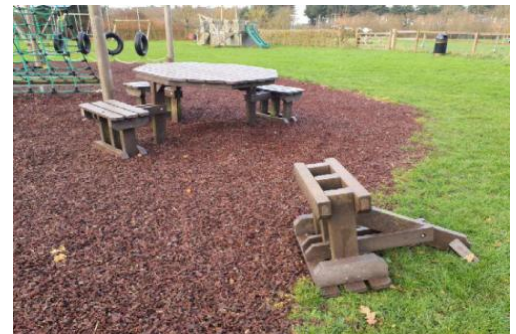
Item: Picnic Table
Manufacturer: Not Identified
Surface Type: N/A
Item Quantity: 2
Equipment Compliance: N/A
Surface Area Compliance: N/A

The item has been severely damaged - Repair or replace the item / affected part

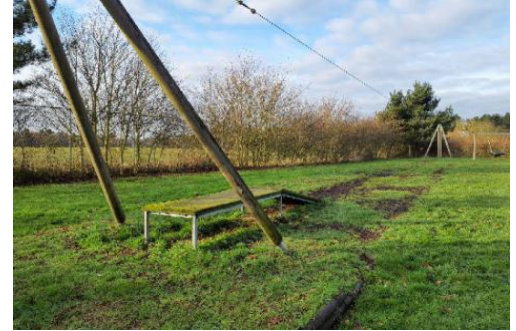
Item: Cable Runway
Manufacturer: Playdale Playgrounds Ltd
Surface Type: Bark Mulch
Item Quantity: 1
Equipment Compliance: Yes
Surface Area Compliance: Yes

We have completed a visual inspection of the suspension links, cable and fixing points from ground level, however it is not possible to fully inspect these areas without either hiring equipment to gain access or removing the cable and suspension and inspecting at ground level. We recommend that the main cable and fixing security is thoroughly inspected at least in accordance with the manufacturers recommendations to check for wear, damage, security or internal rusting; this will help to ensure the continued safe use of the equipment - Inspect in accordance with the manufacturers recommendations

There are damaged/ unsecured edgings in the area - Remove or replace

There is/are bolt cap covers missing or damaged on the item - Replace missing or damaged bolt cap covers

The cableway seat has been damaged - Monitor for any further deterioration and replace as required

The timber has a number of splits/shakes or air cracks and this may affect the stability or allow water ingress which will accelerate the rotting process - Monitor to ensure the splits do not cross through fixing points of the structure and/or cause any instability

There is some strimmer / machinery damage apparent on the posts, this can penetrate the preservative applied to the timber and accelerate the rotting process - Monitor for any deterioration (rot) and replace as required

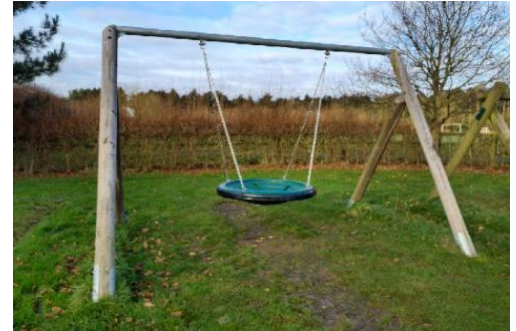
Item: Basket Swing - Type 1
Manufacturer: Playdale Playgrounds Ltd
Surface Type: Grass Matrix Tiles
Item Quantity: 1
Equipment Compliance: No
Surface Area Compliance: Yes

Swings of this design should have a secondary safety mechanism fitted to prevent collapse of the seat in the event of a joint failure to comply with BS EN 1176 Part 2, however this swing was installed prior to the standards being updated in 2018 and the manufacturer has confirmed that the joint was independently cycle tested by BSi - Monitor use and check the joint and fixing security regularly

The surfacing is severely damaged - Repair damaged areas of surfacing

The joint collar is missing - Replace

The timber has a number of splits/shakes or air cracks and this may affect the stability or allow water ingress which will accelerate the rotting process - Monitor to ensure the splits do not cross through fixing points of the structure and/or cause any instability

There is/are bolt cap covers missing or damaged on the item - Replace missing or damaged bolt cap covers

There is / are post or end caps missing / damaged on the item - Replace missing / damaged post or end caps

There is some notable evidence of chain wear - Monitor for any further deterioration and replace when 40% worn

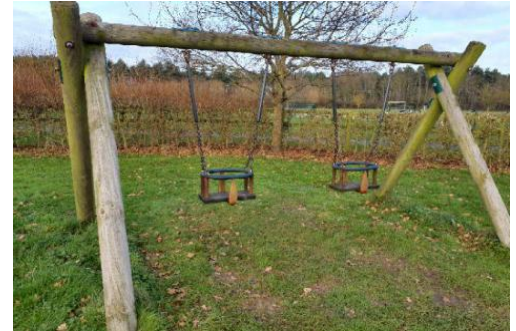
Item: 1 Bay 2 Seat (Cradle)
Manufacturer: Sovereign Leisure
Surface Type: Grass Matrix Tiles
Item Quantity: 1
Equipment Compliance: No
Surface Area Compliance: Yes

The timber has a number of splits/shakes or air cracks and this may affect the stability or allow water ingress which will accelerate the rotting process - Monitor to ensure the splits do not cross through fixing points of the structure and/or cause any instability

The chain openings are in excess of the 8.6mm as recommended by BS EN 1176 - Monitor - No action given the risk assessment

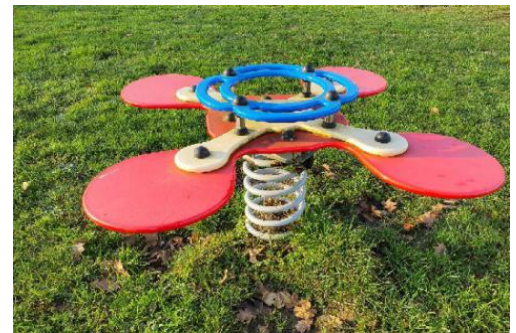
Item: Four Way Springer
Manufacturer: Benito
Surface Type: Grass Matrix Tiles
Item Quantity: 1
Equipment Compliance: Yes
Surface Area Compliance: Yes

The paintwork on this item has been damaged or worn exposing the metal underneath which is rusting / corroding - Treat affected areas and repaint

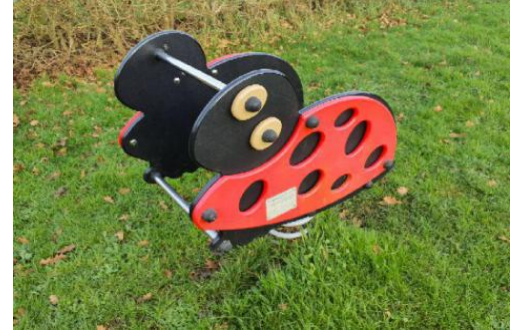
Item: Spring Ladybird
Manufacturer: Benito
Surface Type: Grass Matrix Tiles
Item Quantity: 1
Equipment Compliance: Yes
Surface Area Compliance: Yes

The paintwork on this item has been damaged or worn exposing the metal underneath which is rusting / corroding - Treat affected areas and repaint

A number of fixing(s) have worked loose - Secure all loose fixings

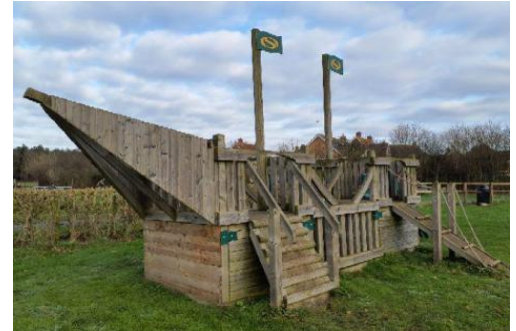
Item: Ship (Pirate)
Manufacturer: Sovereign Leisure
Surface Type: Grass Matrix Tiles
Item Quantity: 1
Equipment Compliance: No
Surface Area Compliance: Yes

There is weed / vegetation growth within the surface - Remove weed / vegetation growth

There are areas or parts of the timber on the structure that have rotted - Replace all affected timbers

There is some evidence of rot in the timber - Monitor for any further deterioration and replace as required

The paintwork on this item has been damaged or worn exposing the metal underneath which is rusting / corroding - Treat affected areas and repaint

The item has been damaged - Monitor for any further deterioration and replace as required

The rope has worn - Replace rope or net

The crossbeam is damaged - Repair or replace as required

The item has missing component(s) - Consider replacing missing components

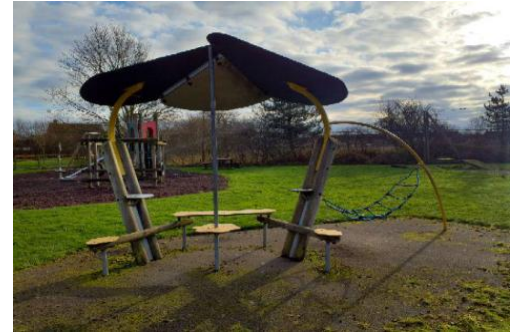
Item: Seating Area
Manufacturer: Playdale Playgrounds Ltd
Surface Type: Bitmac
Item Quantity: 1
Equipment Compliance: N/A
Surface Area Compliance: N/A

There is algae, silt or moss growth on the surface resulting in slippery conditions - Clean and treat appropriately

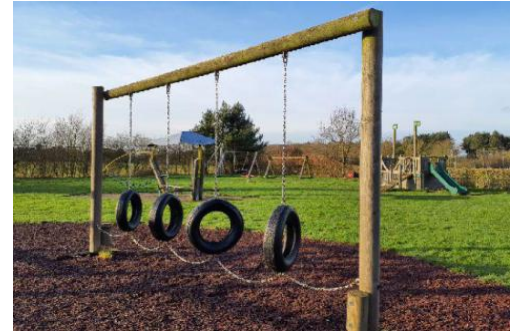
Item: Swinging Tyres
Manufacturer: Parkdale Play & Leisure Ltd
Surface Type: Loose Rubber Mulch
Item Quantity: 1
Equipment Compliance: Yes
Surface Area Compliance: Yes

The fixings are corroding - Monitor for any further deterioration and replace as required

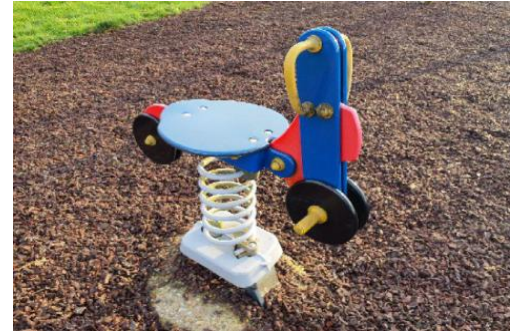
Item: Spring Bike
Manufacturer: Ledon
Surface Type: Loose Rubber Mulch
Item Quantity: 1
Equipment Compliance: No
Surface Area Compliance: Yes

The depth of the loose fill surfacing is lower than the recommended depth specified in BS EN 1176 exposing the concrete foundations; the free height of fall of the equipment is less than 2.0m and a minimum of 300mm depth should be provided (including an extra 100mm to allow for compaction and displacement as per BS EN 1176 Part 1 - Table 4) - Top up loose fill surfacing to recommended levels

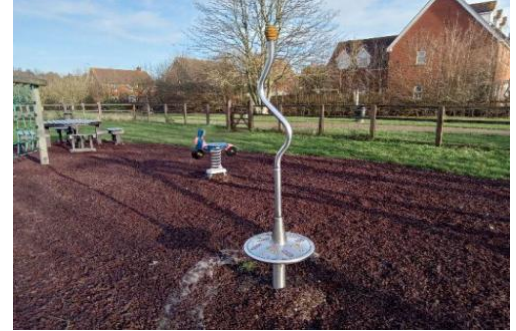
Item: Spinning Pole
Manufacturer: Playdale Playgrounds Ltd
Surface Type: Loose Rubber Mulch
Item Quantity: 1
Equipment Compliance: No
Surface Area Compliance: Yes

The depth of the loose fill surfacing is lower than the recommended depth specified in BS EN 1176 exposing the concrete foundations; the free height of fall of the equipment is less than 2.0m and a minimum of 300mm depth should be provided (including an extra 100mm to allow for compaction and displacement as per BS EN 1176 Part 1 - Table 4) - Top up loose fill surfacing to recommended levels

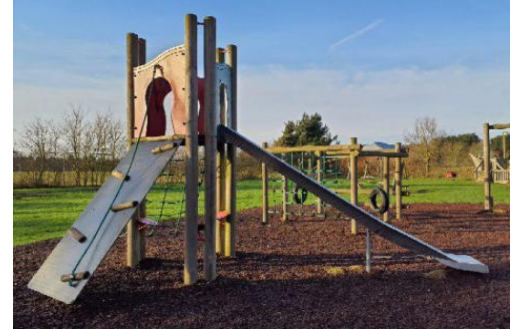
Item: Multi Play (Senior)
Manufacturer: Playdale Playgrounds Ltd
Surface Type: Loose Rubber Mulch
Item Quantity: 1
Equipment Compliance: No
Surface Area Compliance: Yes

The item has been damaged - Monitor for any further deterioration and replace as required

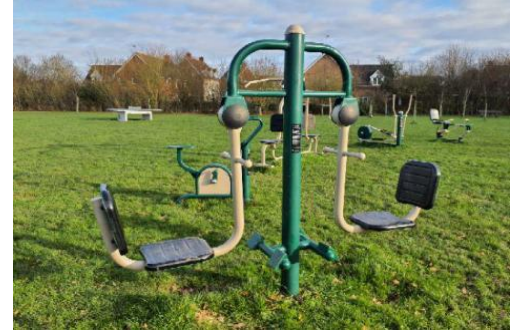
Item: Leg Press
Manufacturer: Fresh Air Fitness
Surface Type: Grass
Item Quantity: 1
Equipment Compliance: Yes
Surface Area Compliance: Yes

There is no instruction label provided; an instruction label should be provided with each item of equipment in accordance with the requirements of BS EN 16630 - Provide appropriate instruction label/s

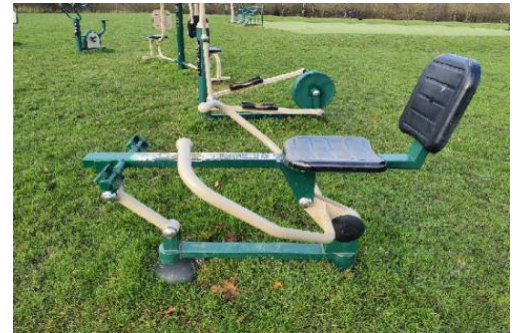
Item: Rower
Manufacturer: Fresh Air Fitness
Surface Type: Grass
Item Quantity: 1
Equipment Compliance: Yes
Surface Area Compliance: Yes

The signage is faded ; an instruction label should be provided with each item of equipment in accordance with the requirements of BS EN 16630 - Provide appropriate instruction label/s

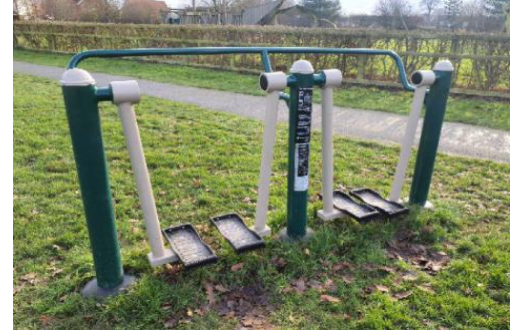
Item: Air Walker
Manufacturer: Fresh Air Fitness
Surface Type: Grass
Item Quantity: 1
Equipment Compliance: No
Surface Area Compliance: Yes

The swinging movement of the item exceeds the maximum 55 degrees from the vertical required by BS EN 16630 - Monitor - No action given the risk assessment

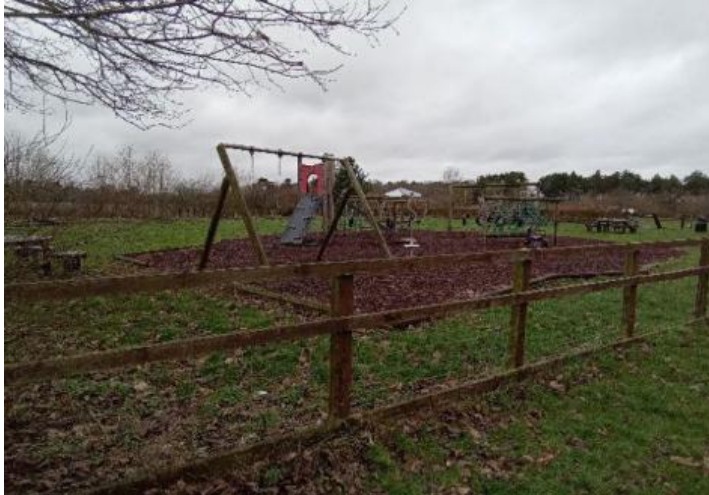
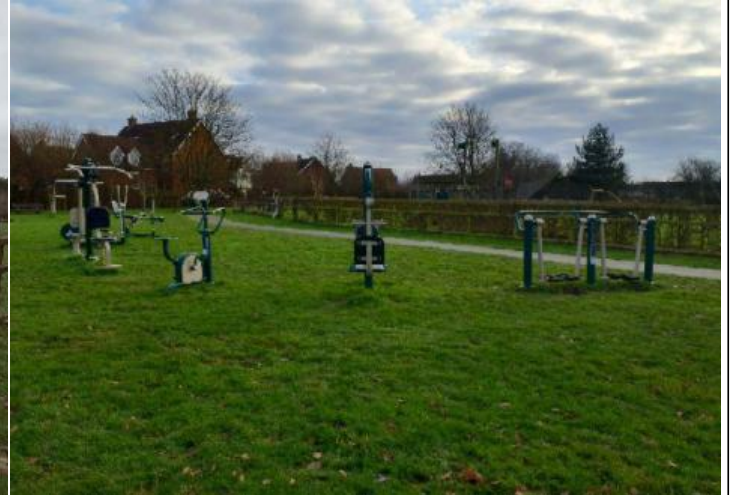
Item: Ancillary Items - Site General
Manufacturer: Owner/Operator

Finding: Signage should be provided for the outdoor fitness equipment in accordance with the requirements of BS EN 16630, key requirements of the sign include, but are not limited to, intended users, medical safety and emergency contact details

Action: Provide appropriate signage

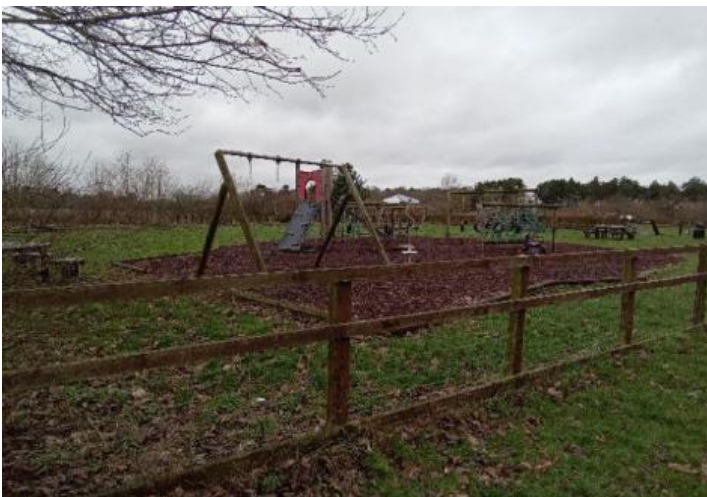
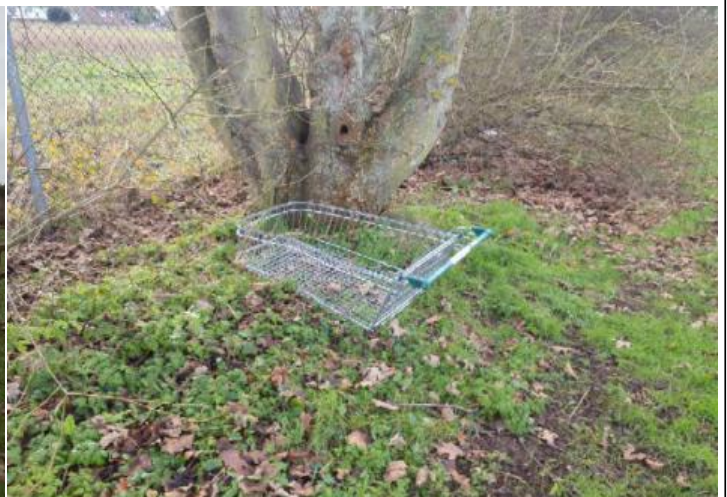
Item: Ancillary Items - Site General
Manufacturer: Owner/Operator

Finding: There is litter/debris in the area

Action: Remove litter/debris from the area and maintain

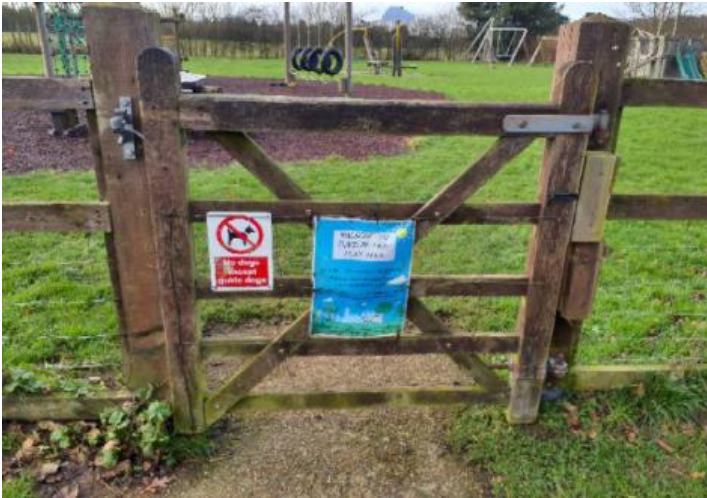
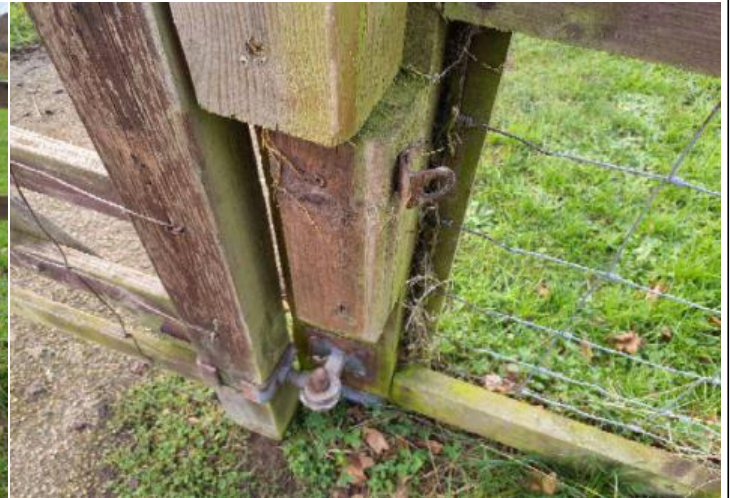
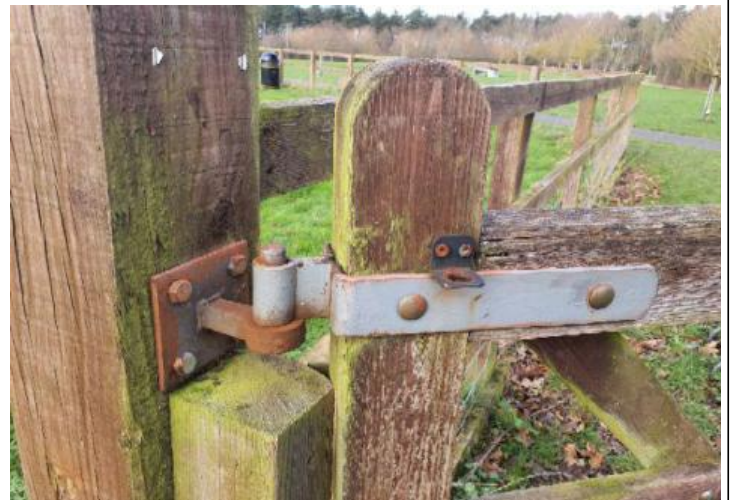
Item: Gates - Gate
Manufacturer: Not Identified

Finding: There is a redundant bracket attached

Action: Remove

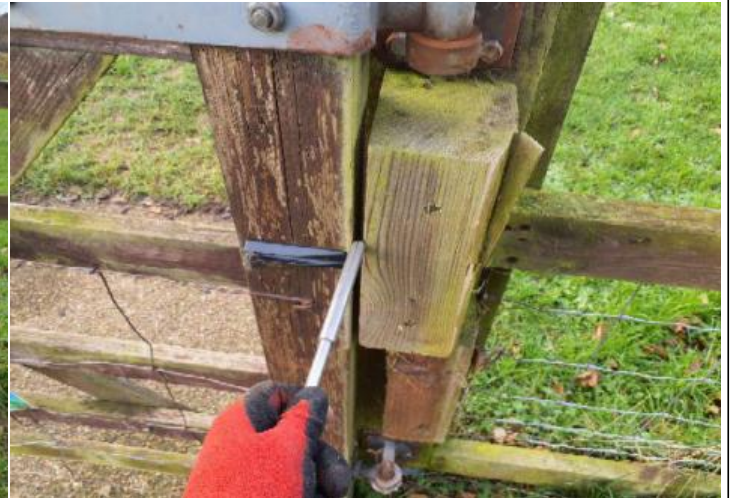
Item: Gates - Gate
Manufacturer: Not Identified

Finding: There are openings that are less than 12mm that could trap or crush fingers

Action: Provide a 12mm gap throughout full range of motion at both sides of gate

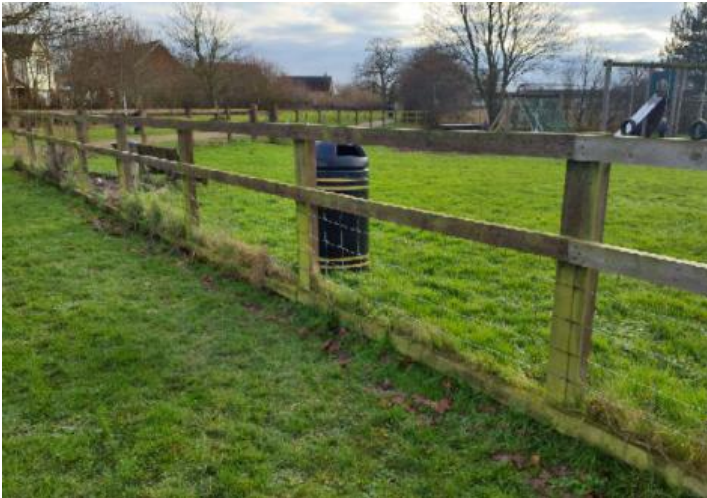
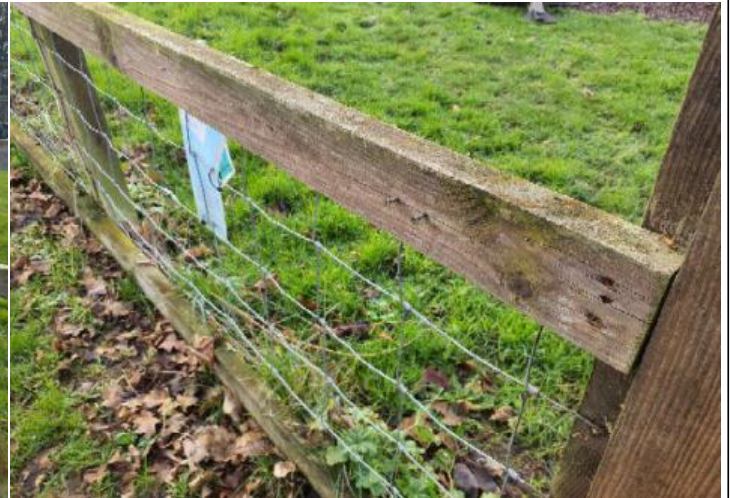
Item: Fences - Fence - Timber & Mesh Infill
Manufacturer: Not Identified

Finding: There are projecting bolt thread(s) present

Action: Remove excess thread length and deburr or provide cap

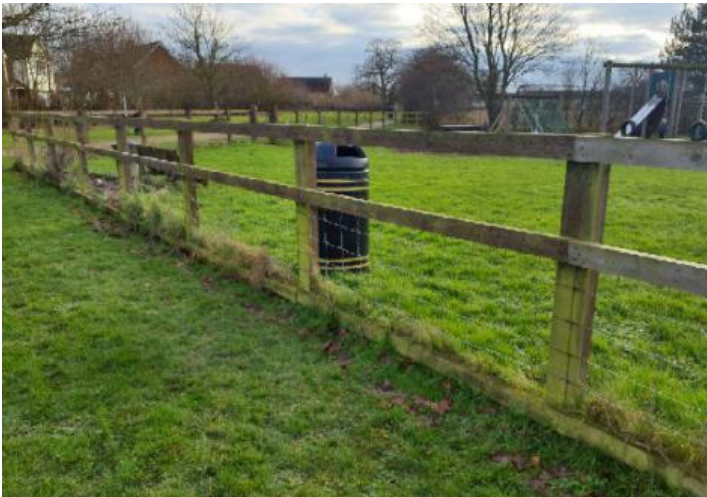
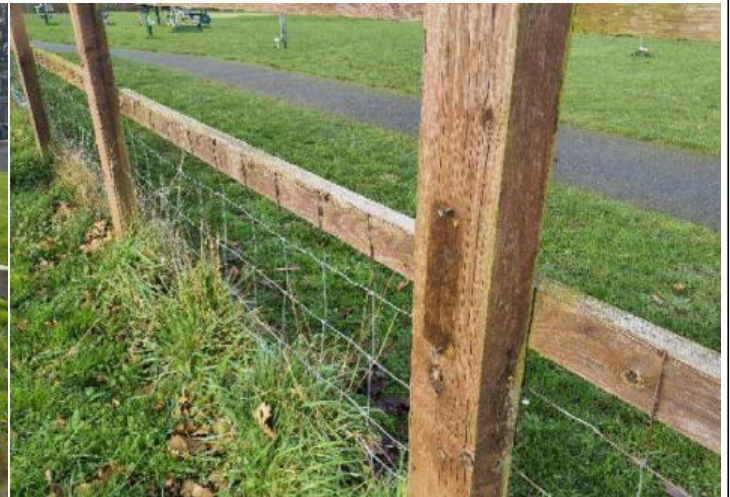
Item: Fences - Fence - Timber & Mesh Infill
Manufacturer: Not Identified

Finding: There are projecting bolt thread(s) present

Action: Remove excess thread length and deburr or provide cap

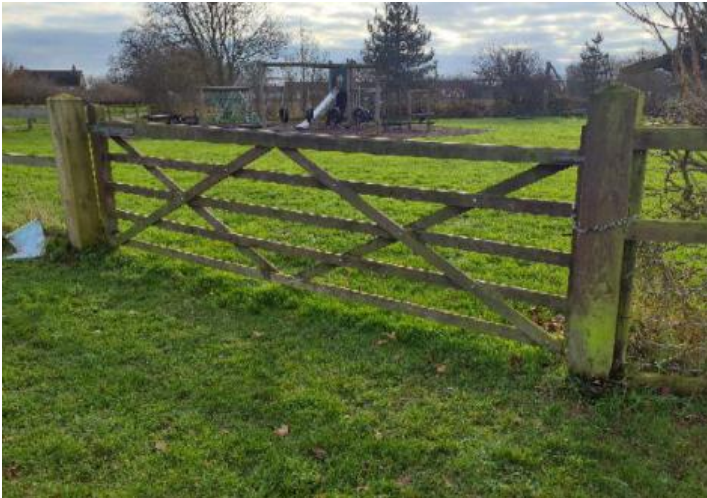
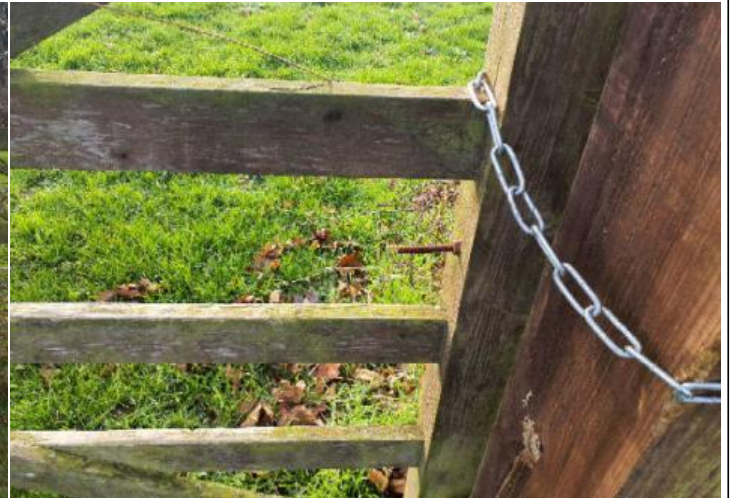
Item: Gates - Gate - Maintenance
Manufacturer: Not Identified

Finding: There are projecting bolt thread(s) present

Action: Remove excess thread length and deburr or provide cap

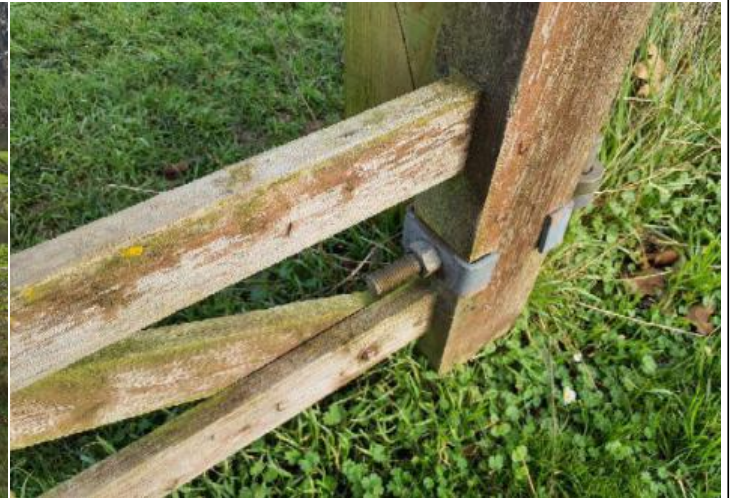
Item: Gates - Gate - Maintenance
Manufacturer: Not Identified

Finding: There are sharp protruding staples on the item

Action: Remove staples

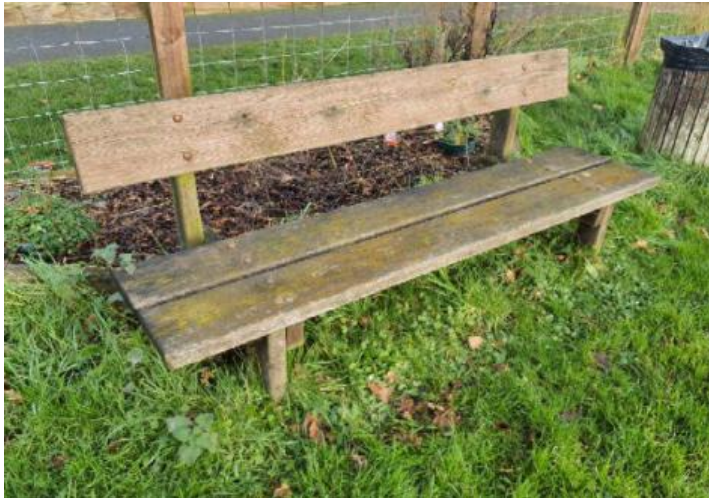
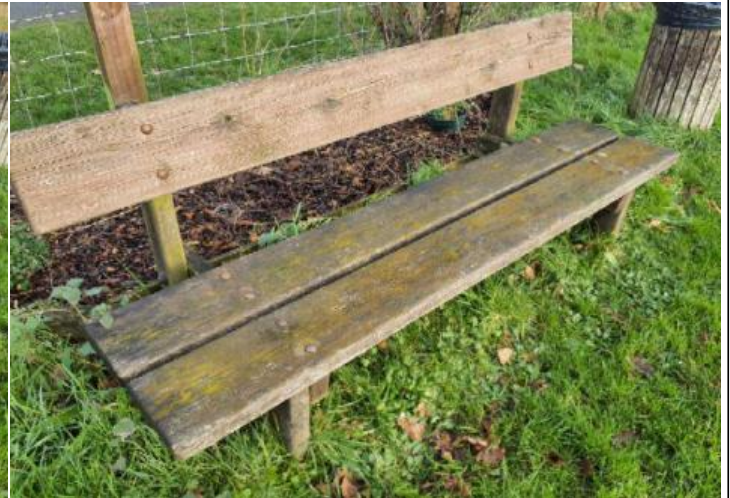
Item: Ancillary Items - Bench
Manufacturer: Playdale Playgrounds Ltd

Finding: There is algae or moss on the surface of the equipment

Action: Clean and treat appropriately

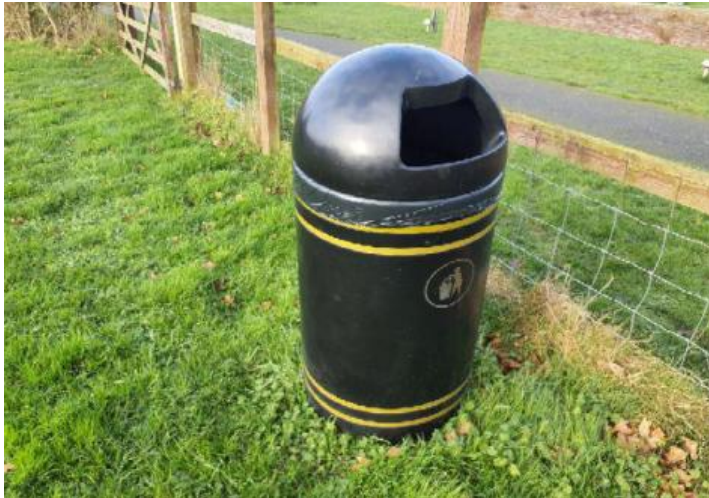
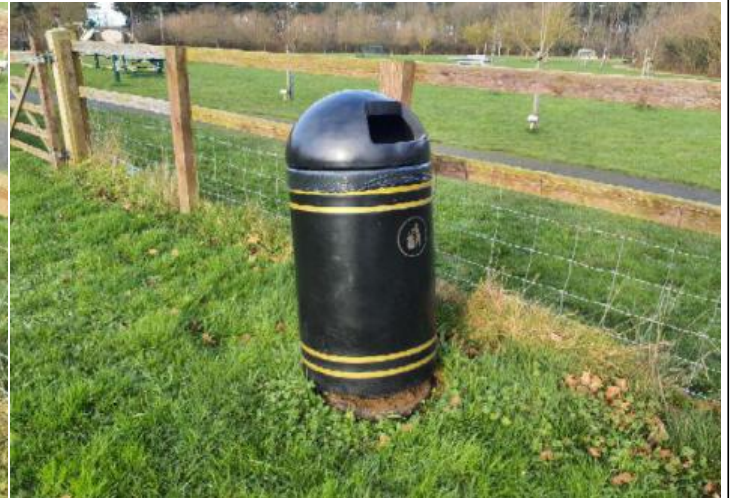
Item: Ancillary Items - Litter Bin
Manufacturer: Not Identified

Finding: The bin is not securely fixed to the surface and there is some possibility of the item tipping or rolling over

Action: Secure the bin to the ground

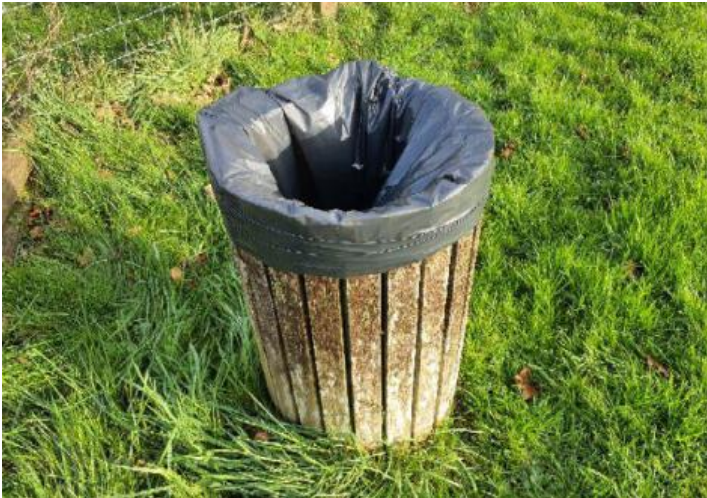
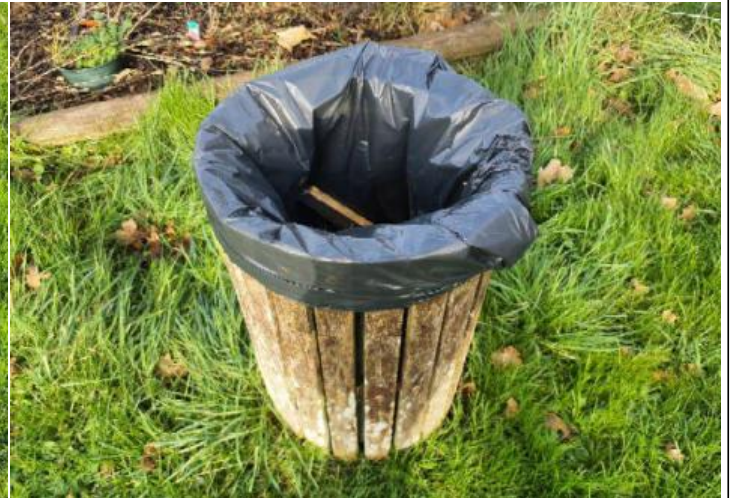
Item: Ancillary Items - Litter Bin
Manufacturer: Not Identified

Finding: The liner of the litter bin is not secured and can be easily removed
Action: Ensure the liner is secured

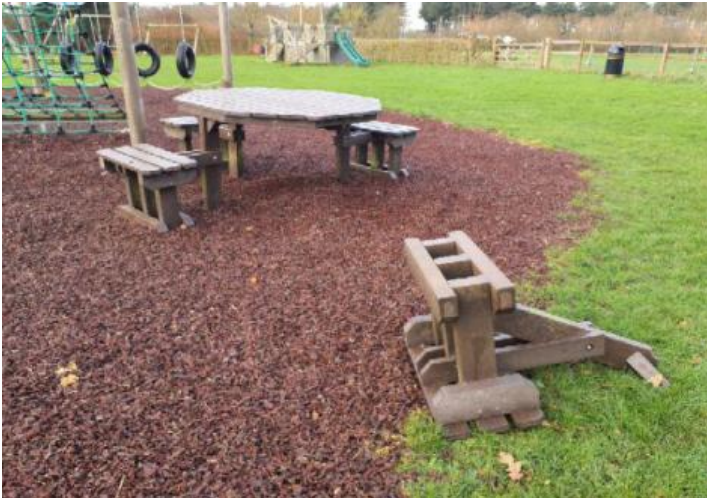
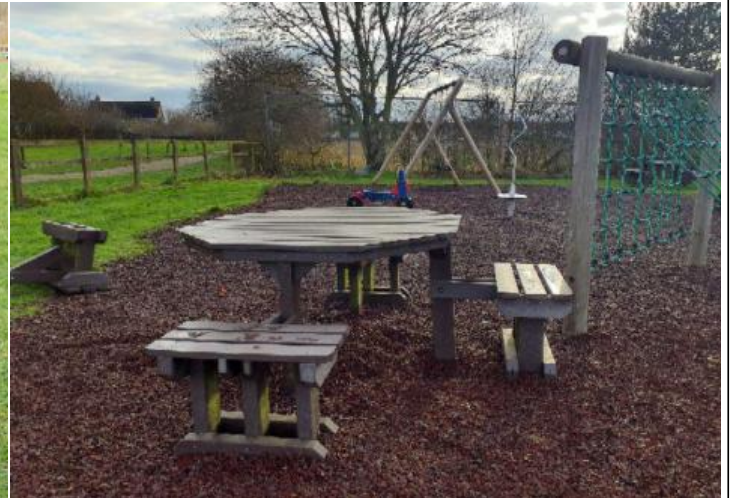
Item: Ancillary Items - Picnic Table
Manufacturer: Not Identified

Finding: The table/s is/are not secured to the ground and there is some potential for the item/s to be moved within falling spaces of equipment

Action: Secure to the ground

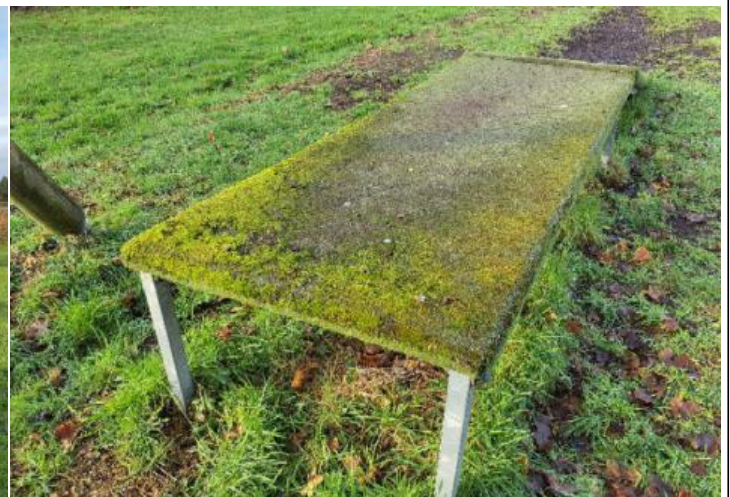
Item: Other - Cable Runway
Manufacturer: Playdale Playgrounds Ltd

Finding: There is algae or moss on the surface of the equipment

Action: Clean and treat appropriately

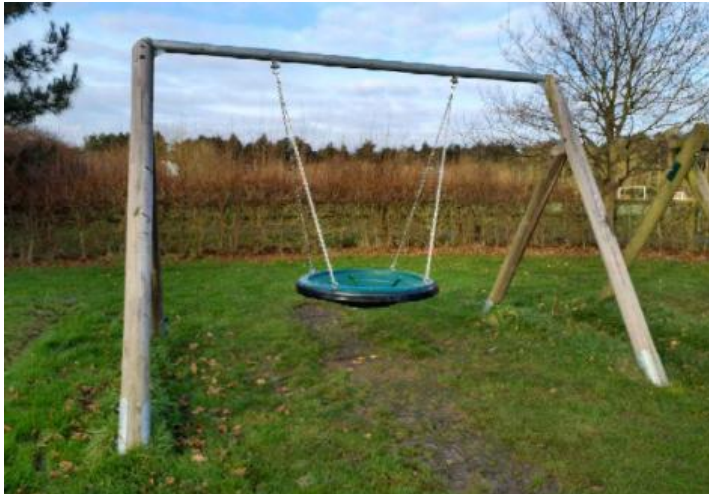
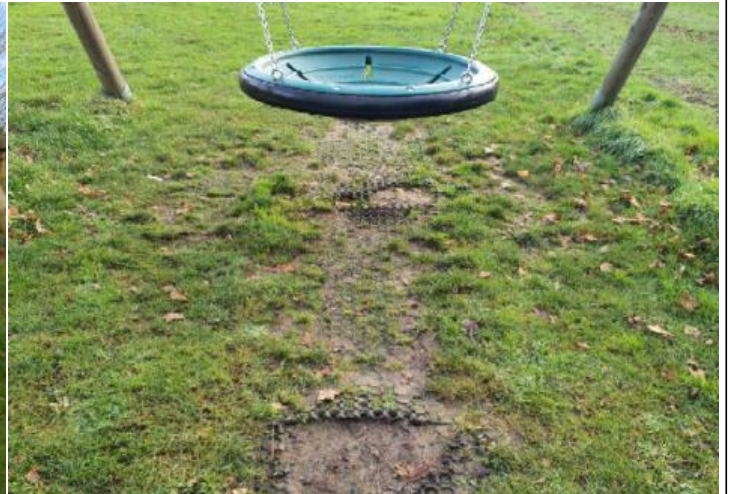
Item: Swings - Basket Swing - Type 1
Manufacturer: Playdale Playgrounds Ltd

Finding: The grass mats are silted up, the soil is compacted and the area will become very slippery when the soil is wet.

Action: Reinstate as required

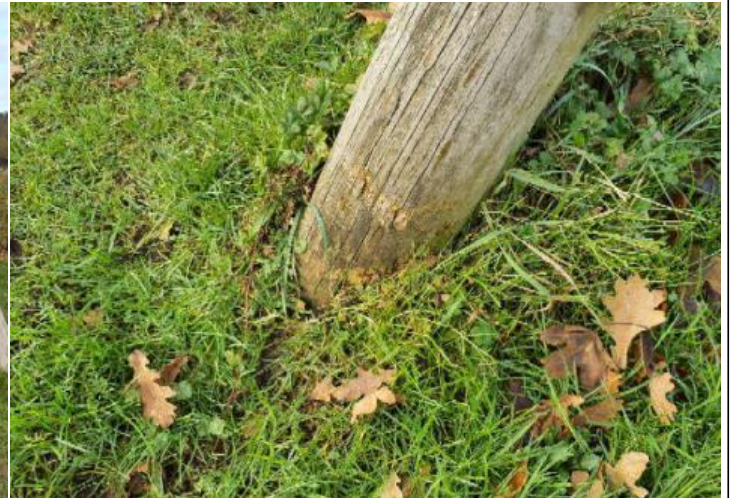
Item: Swings - 1 Bay 2 Seat (Cradle)
Manufacturer: Sovereign Leisure

Finding: Parts of the timber are rough or splintered

Action: Remove all rough or sharp edges

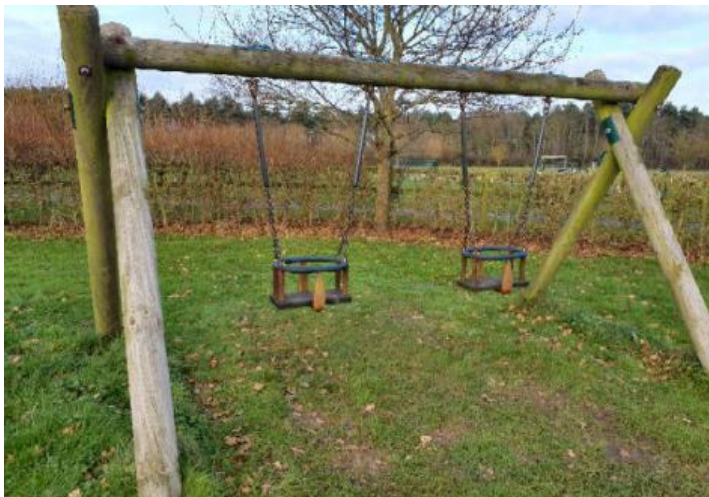
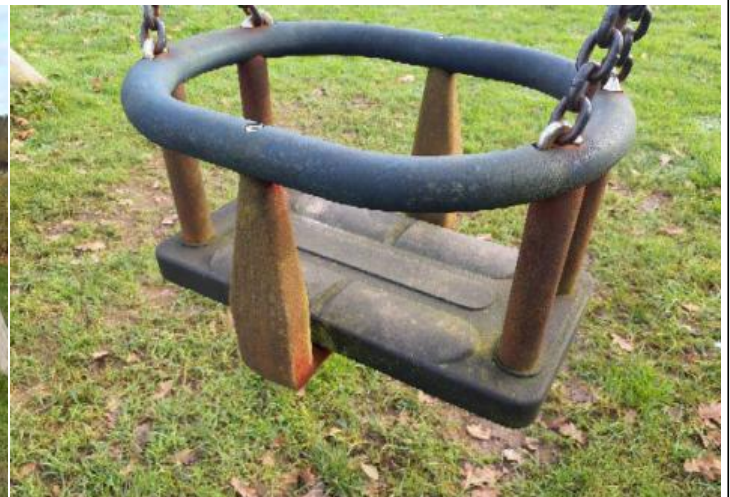
Item: Swings - 1 Bay 2 Seat (Cradle)
Manufacturer: Sovereign Leisure

Finding: There is algae or moss on the surface of the equipment

Action: Clean and treat appropriately

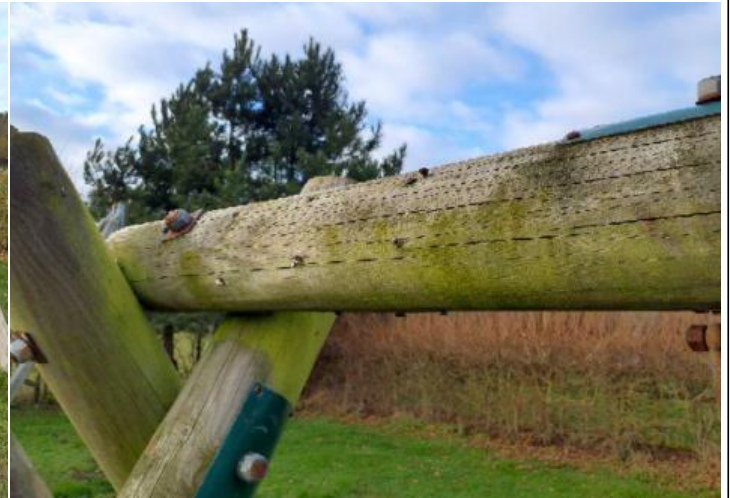
Item: Swings - 1 Bay 2 Seat (Cradle)
Manufacturer: Sovereign Leisure

Finding: The remains of a sign are still attached to the crossbeam

Action: Remove

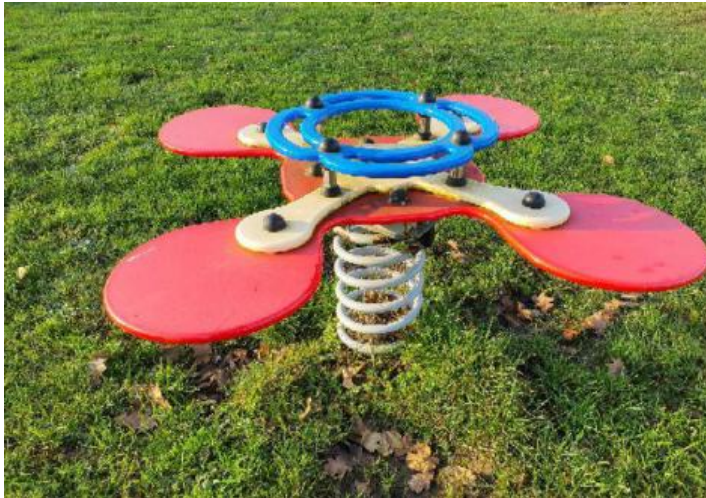
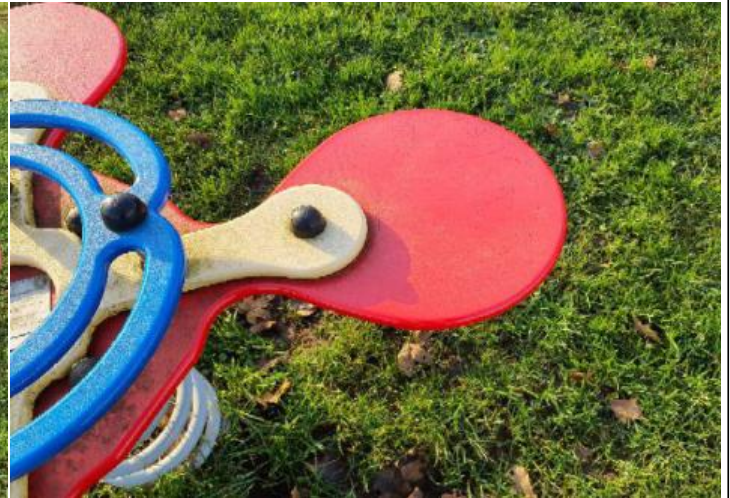
Item: Rocking Equipment - Four Way Springer
Manufacturer: Benito

Finding: There is some graffiti present

Action: Remove the graffiti

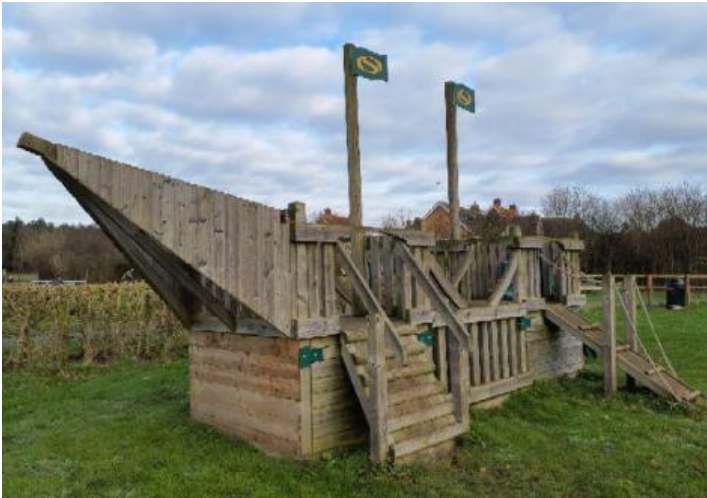
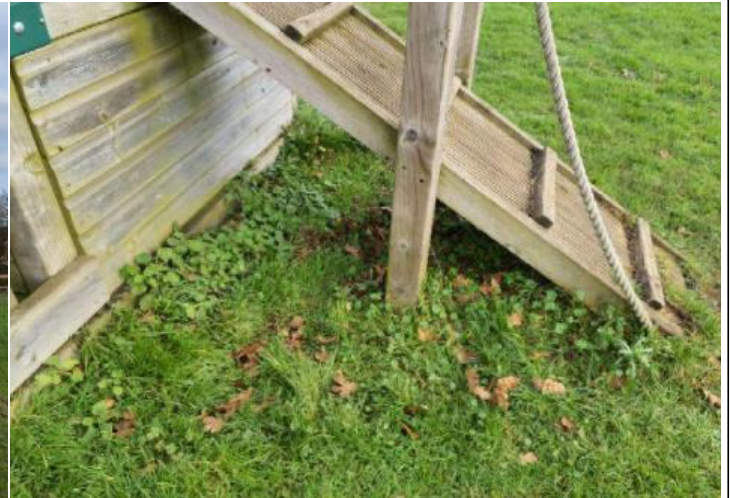
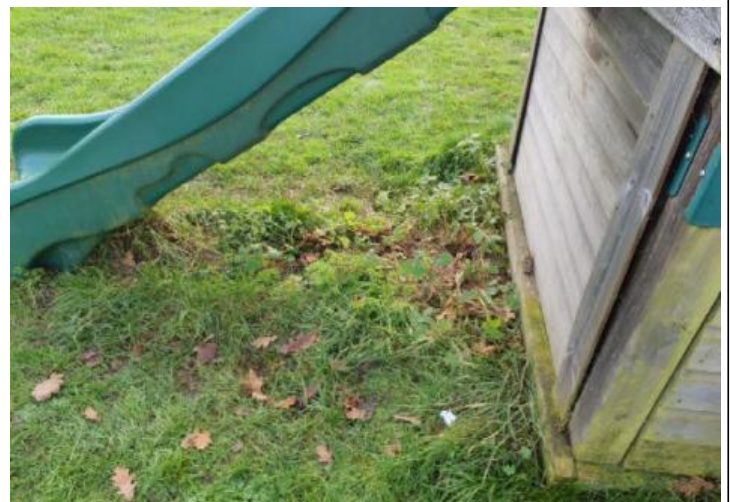
Item: Activity Equipment - Ship (Pirate)
Manufacturer: Sovereign Leisure

Finding: There is weed / vegetation growth within the surface

Action: Remove weed / vegetation growth

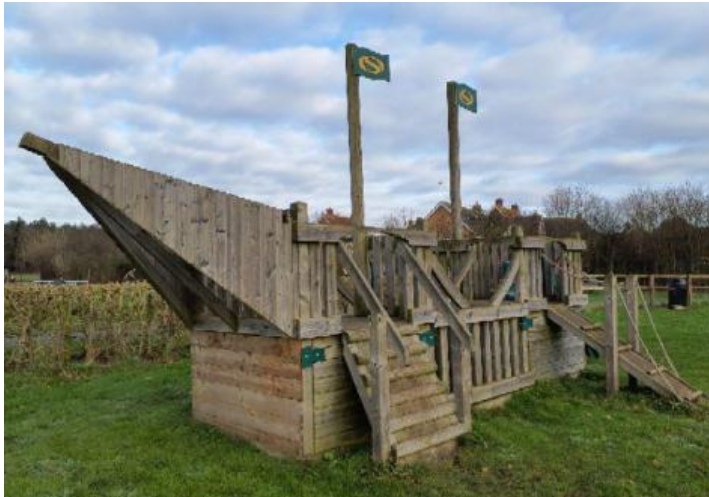
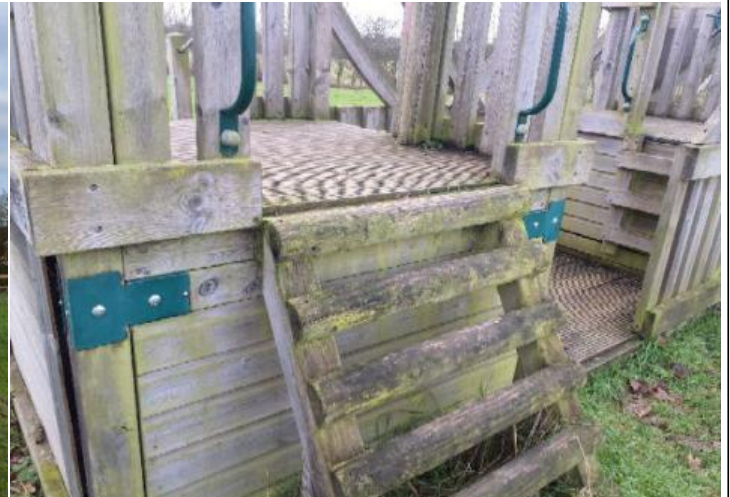
Item: Activity Equipment - Ship (Pirate)
Manufacturer: Sovereign Leisure

Finding: There is algae or moss on the surface of the equipment

Action: Clean and treat appropriately
