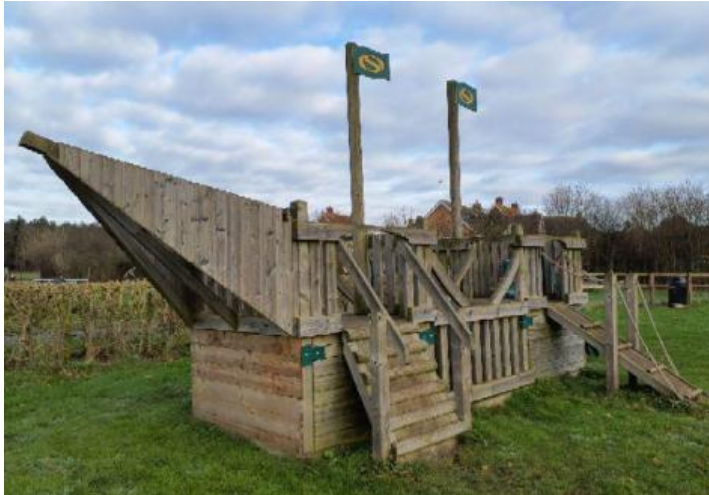
! 12 - Moderate Risk (Finding 4)

Finding: There are areas or parts of the timber on the structure that have rotted

Action: Replace all affected timbers

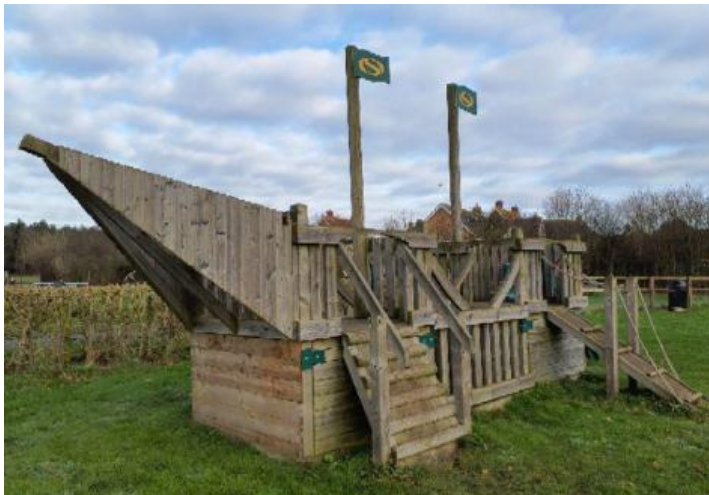
i 9 - Low Risk (Finding 5)

Finding: There are areas or parts of the timber on the structure that have rotted

Action: Replace all affected timbers

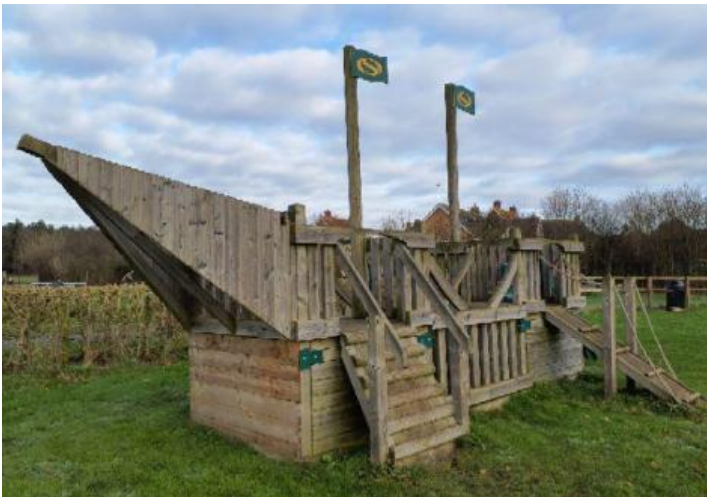
! 12 - Moderate Risk (Finding 10)

Finding: The crossbeam is damaged

Action: Repair or replace as required

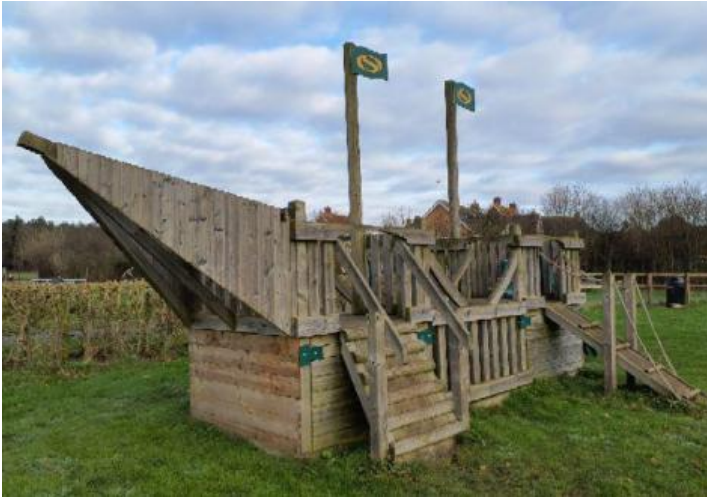
12 - Moderate Risk (Finding 13)

Finding: There are areas or parts of the timber on the structure that have rotted

Action: Replace all affected timbers

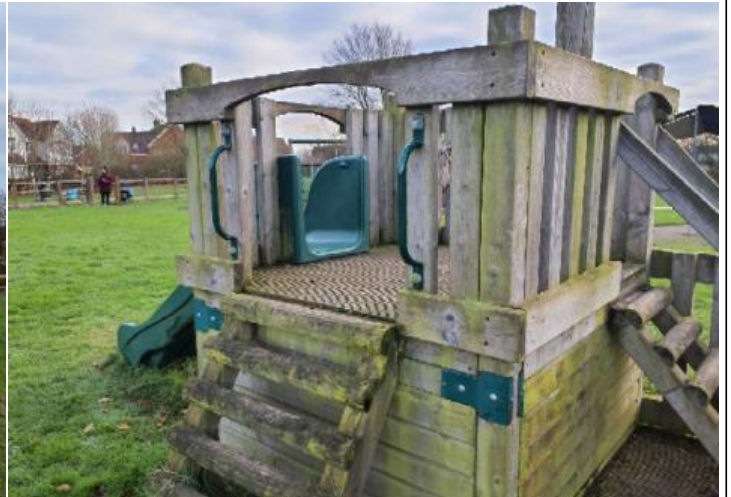
i 6 - Low Risk (Finding 15)

Finding: There is an opening in the barriers exceeding the width allowed (500mm) in BS EN 1176 Part 1

Action: Monitor - No action given the risk assessment

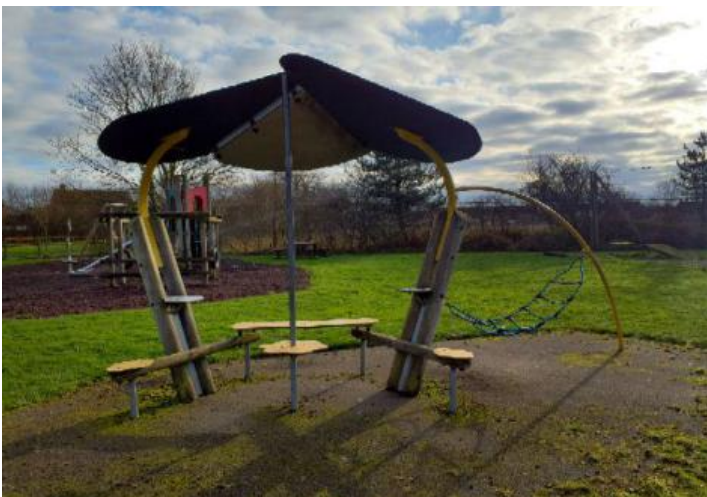
i 8 - Low Risk (Finding 1)

Finding: There is algae, silt or moss growth on the surface resulting in slippery conditions

Action: Clean and treat appropriately

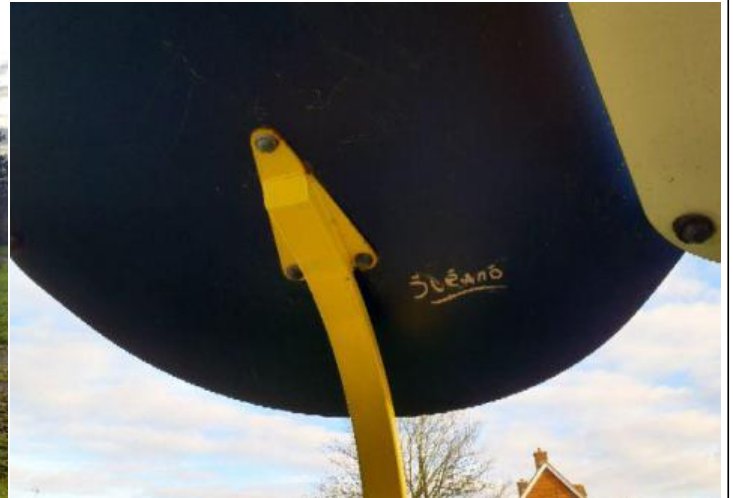
i 0 - Risk Assessment not Undertaken (Finding 2)

Finding: There is some graffiti present

Action: Remove the graffiti

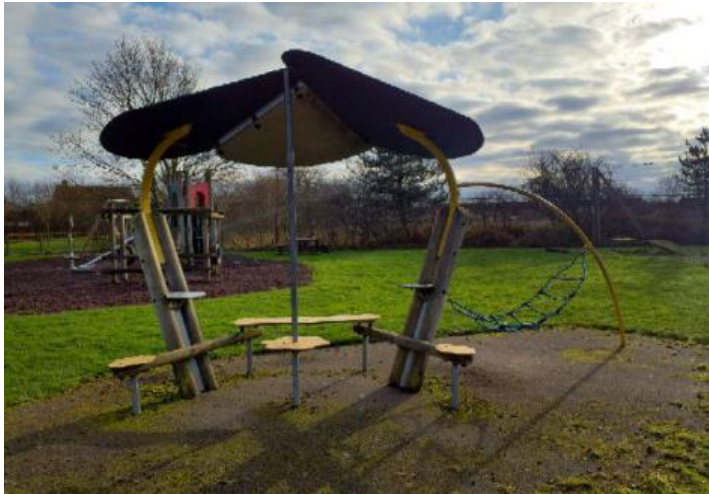
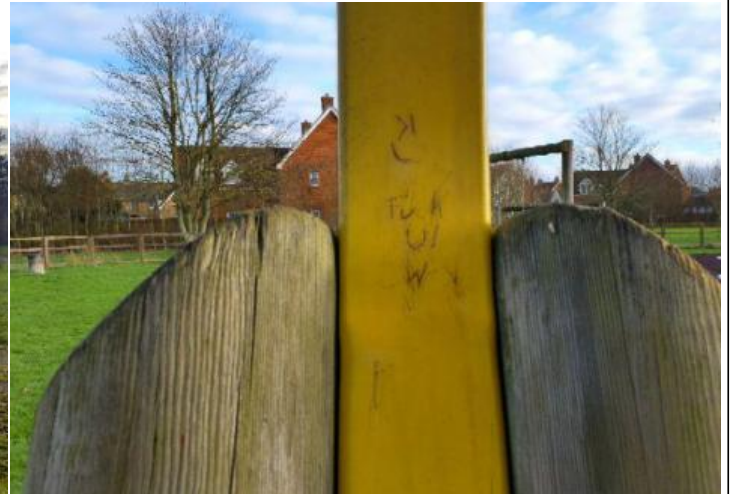
i 0 - Risk Assessment not Undertaken (Finding 3)

Finding: There is offensive graffiti present

Action: Remove as soon as practicable

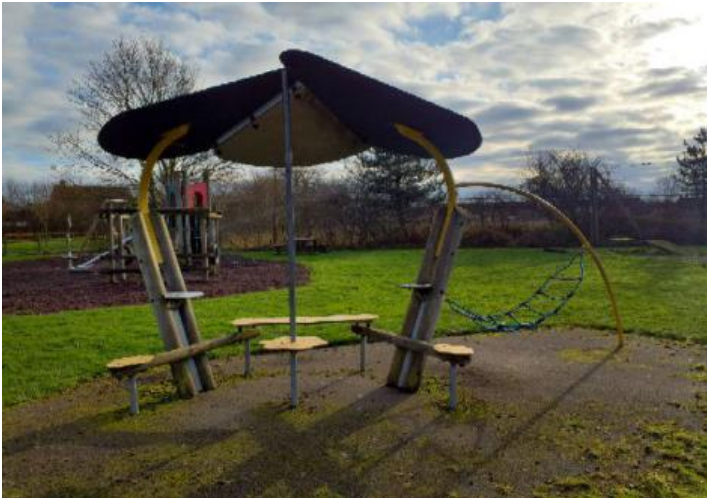
i 6 - Low Risk (Finding 4)

Finding: The ropes/nets are worn/damaged in places

Action: Monitor for any further deterioration and repair or replace as required

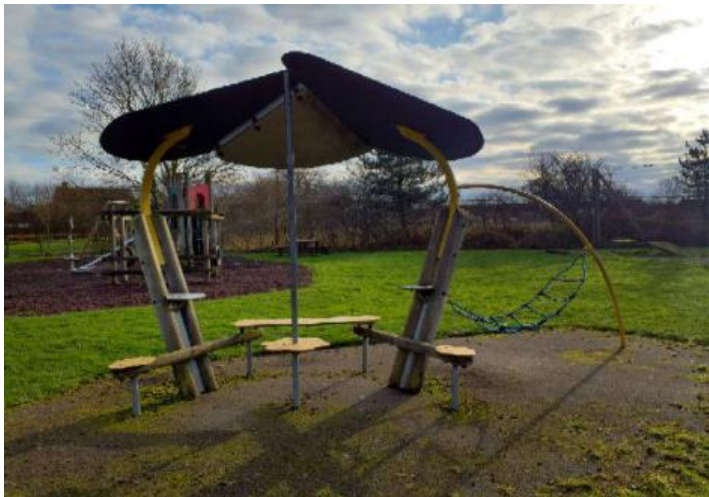
i 6 - Low Risk (Finding 7)

Finding: A number of fixing(s) have worked loose

Action: Secure all loose fixings

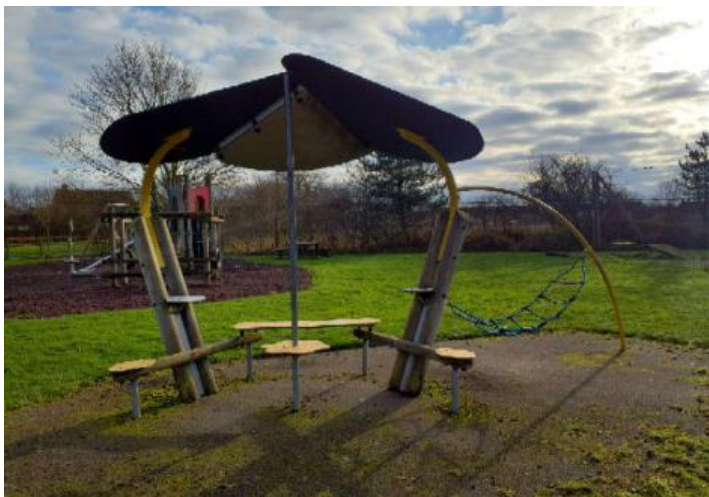
i 8 - Low Risk (Finding 9)

Finding: The location of this item may encourage use by younger users leading to fall heights exceeding 600mm to the hard surface below

Action: Monitor use and risk assess regularly and consider relocating the equipment if found to be necessary

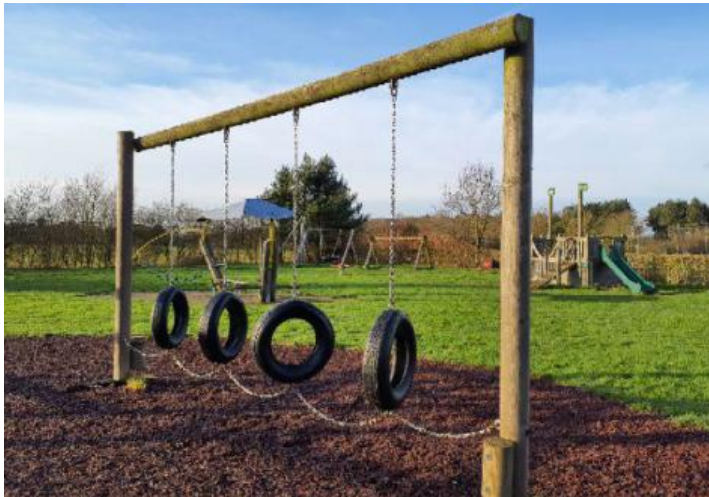
i 6 - Low Risk (Finding 2)

Finding: The item has been damaged

Action: Monitor for any further deterioration and replace as required

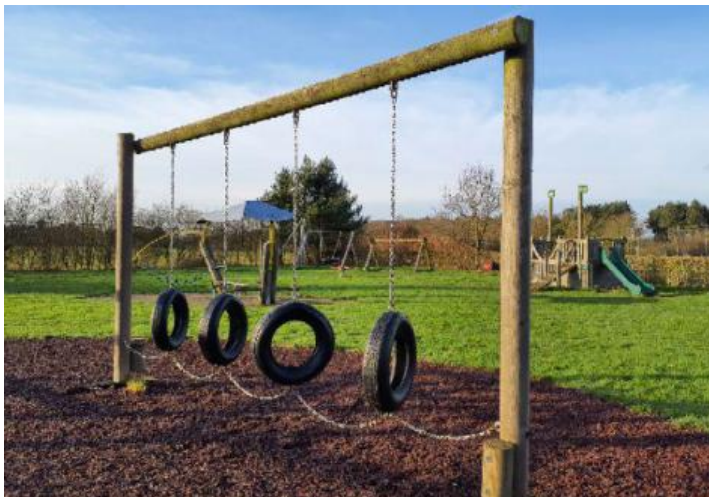
i 8 - Low Risk (Finding 4)

Finding: The safety surface is low and the membrane is exposed creating trip points

Action: Remove or resecure the exposed membrane and top up the surface to the correct level

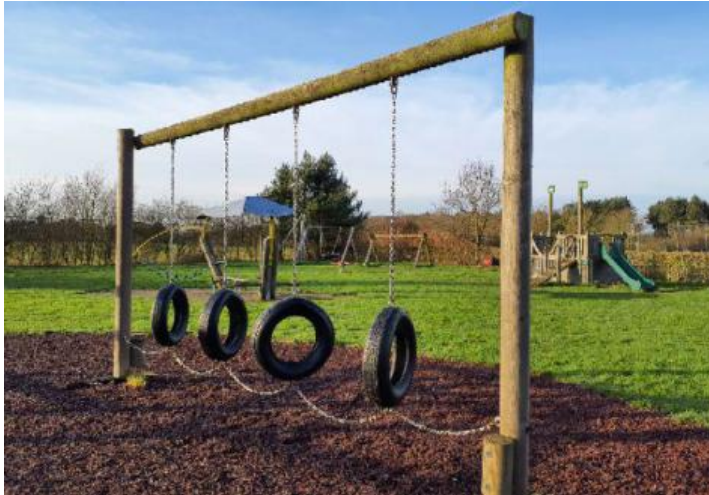
12 - Moderate Risk (Finding 5)

Finding: There are areas or parts of the timber on the structure that have rotted

Action: Replace all affected timbers

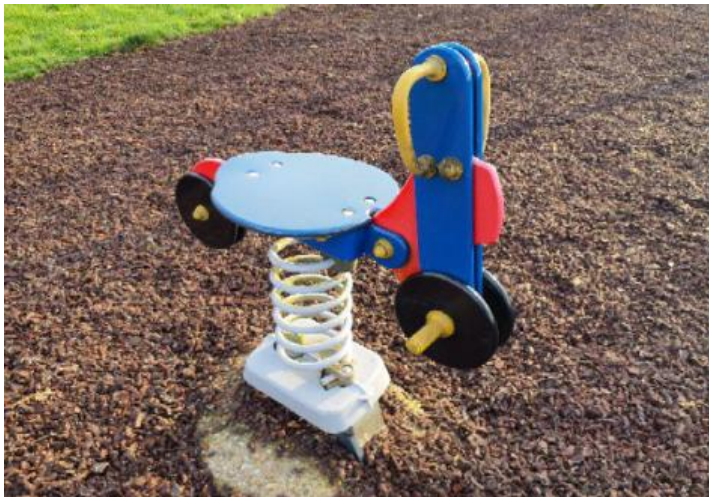
i 6 - Low Risk (Finding 3)

Finding: The paintwork on this item has been damaged or worn exposing the metal underneath which is rusting / corroding
Action: Treat affected areas and repaint

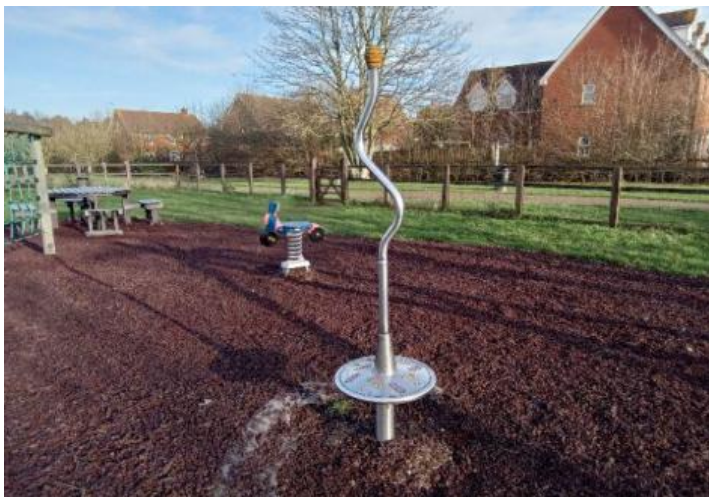
i 8 - Low Risk (Finding 3)

Finding: There is or are fixings missing on the item

Action: Replace all missing fixings

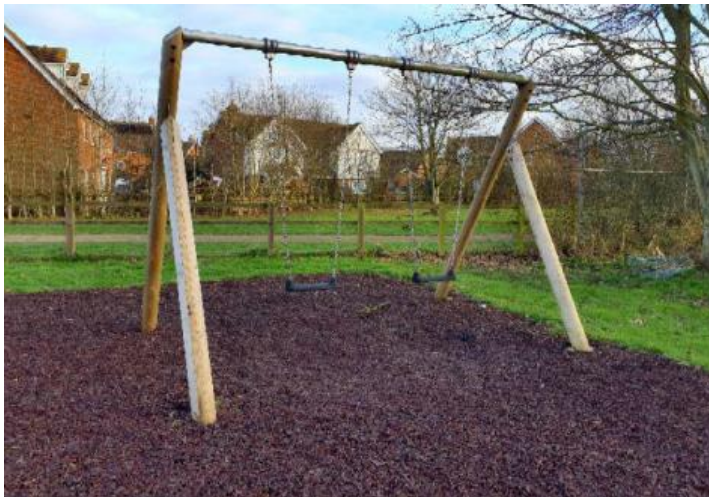
Finding: The swing seat connectors are worn more than 40% and require replacement

Action: Replace swing seat connectors if possible or replace seat

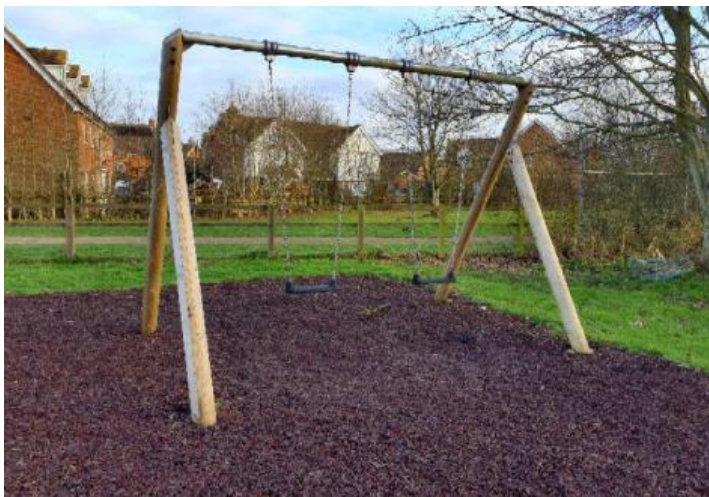
Finding: The safety surface is low and the membrane is exposed creating trip points
Action: Remove or resecure the exposed membrane and top up the surface to the correct level

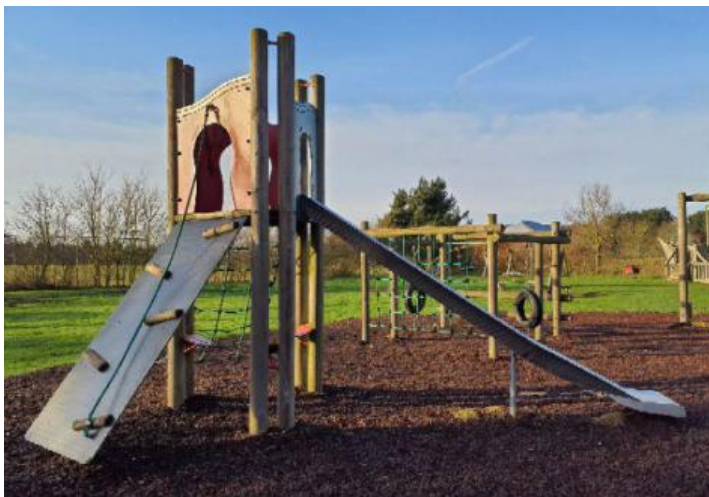
Finding: The ropes/nets are worn/damaged in places

Action: Monitor for any further deterioration and repair or replace as required

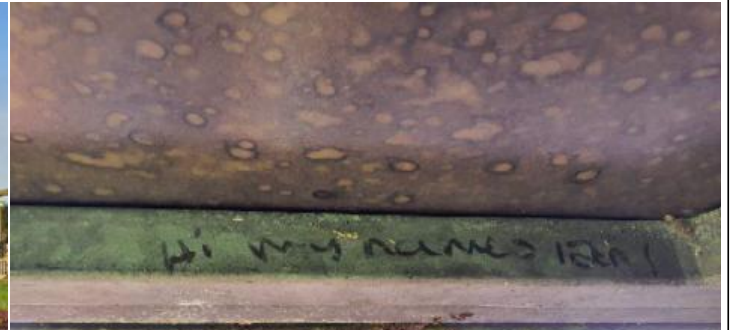
Finding: There is some graffiti present

Action: Remove the graffiti

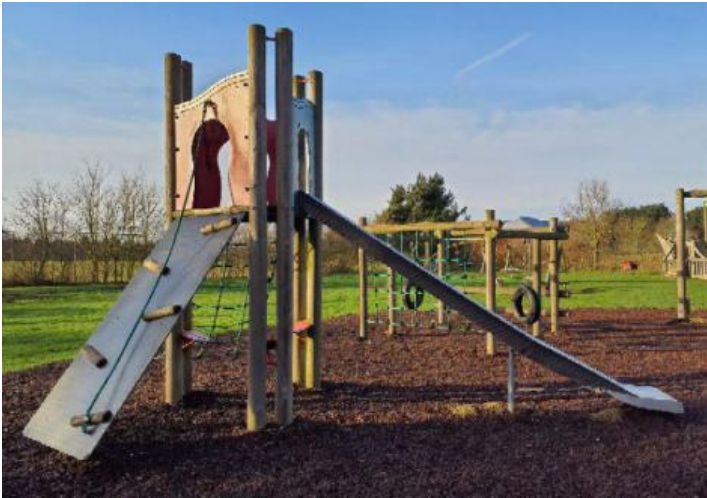
Finding: There is/are bolt cap covers missing or damaged on the item

Action: Replace missing or damaged bolt cap covers

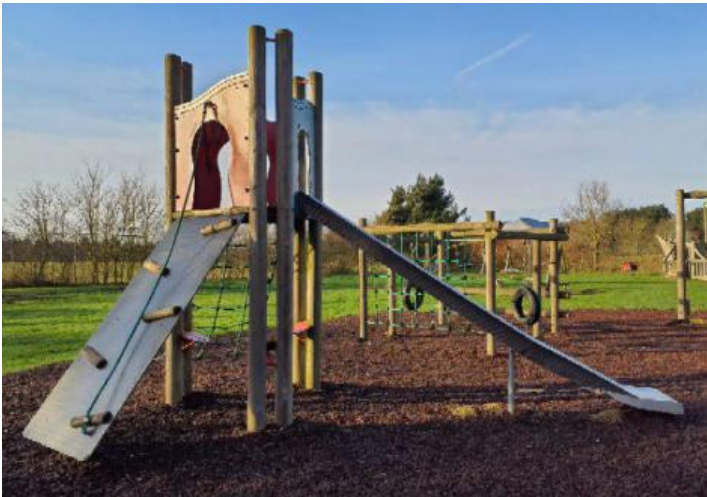
Finding: The impact area of the climbing frame overlaps the freespace of the slide in contravention of BS EN 1176

Action: Monitor - No remedial work recommended

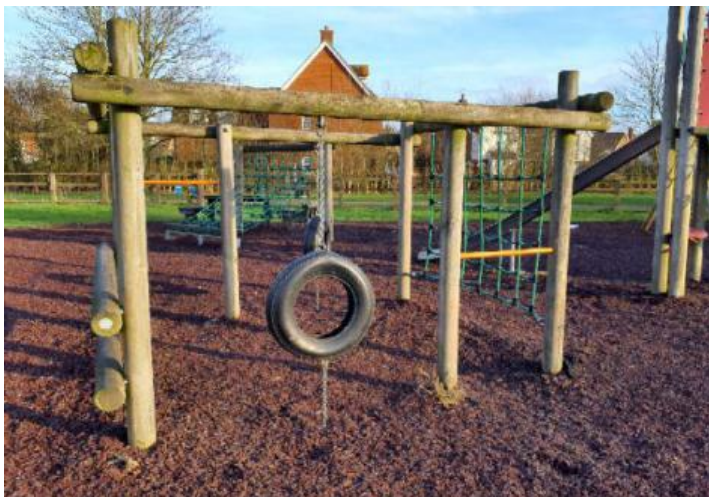
Finding: The chain openings are in excess of the 8.6mm as recommended by BS EN 1176

Action: Monitor - No action given the risk assessment
