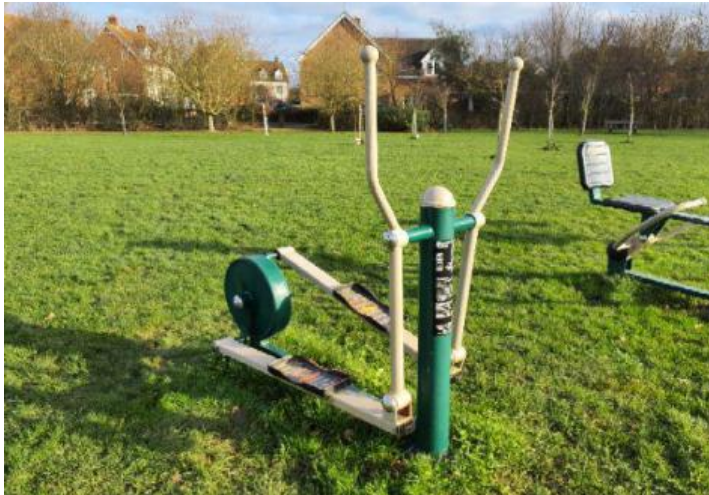
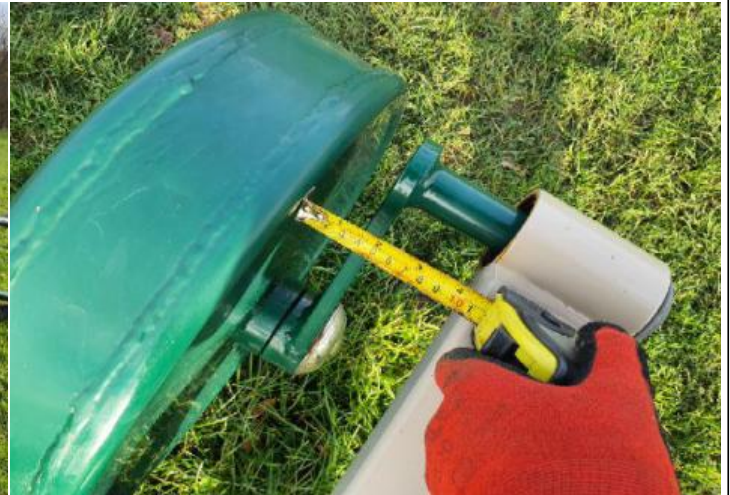
Item: Outdoor Fitness Equipment - Cross Trainer
Manufacturer: Fresh Air Fitness

Finding: The distance between the crank and frame is between 8 and 60mm creating a potential crush/shear point in contravention of the requirements of BS EN 16630
Action: Monitor use

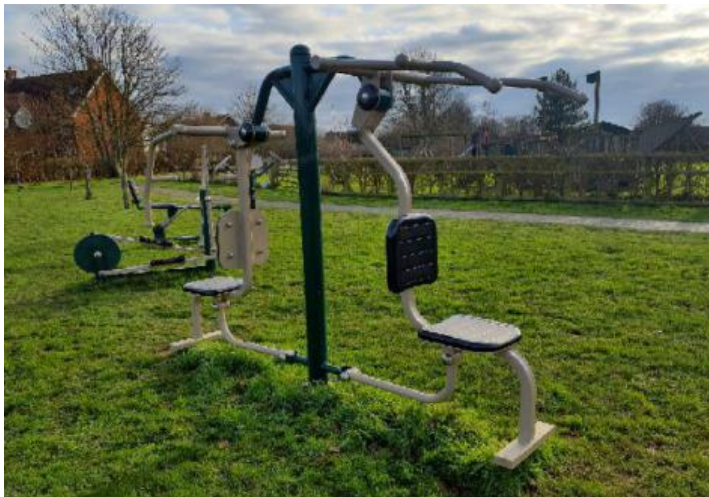
Item: Outdoor Fitness Equipment - Pull Down Challenger
Manufacturer: Fresh Air Fitness

Finding: The distance between the underside of the item and the ground is less than the 110mm required by BS EN 16630

Action: Monitor - No action given the risk assessment

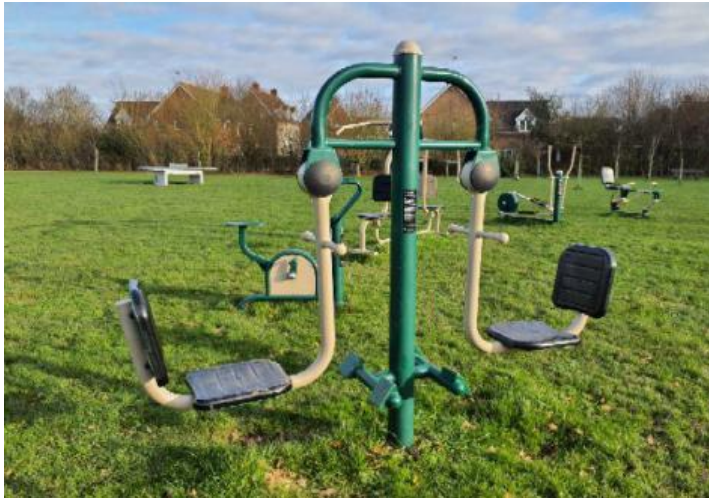
Item: Outdoor Fitness Equipment - Leg Press
Manufacturer: Fresh Air Fitness

Finding: There is no instruction label provided; an instruction label should be provided with each item of equipment in accordance with the requirements of BS EN 16630

Action: Provide appropriate instruction label/s

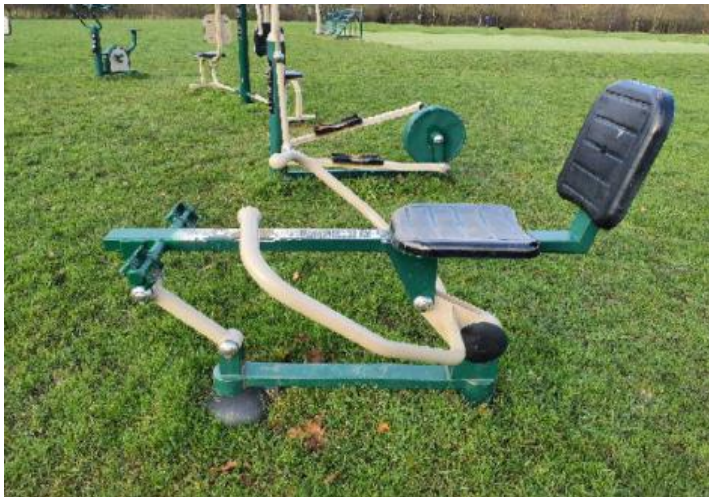
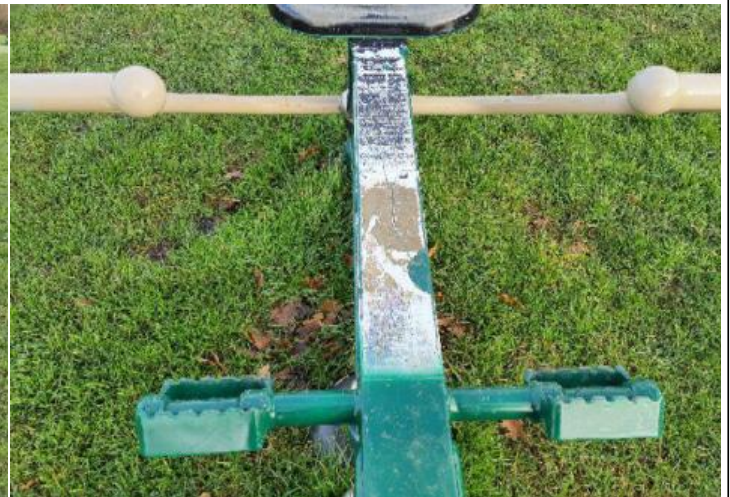
Item: Outdoor Fitness Equipment - Rower
Manufacturer: Fresh Air Fitness

Finding: The signage is faded ; an instruction label should be provided with each item of equipment in accordance with the requirements of BS EN 16630

Action: Provide appropriate instruction label/s

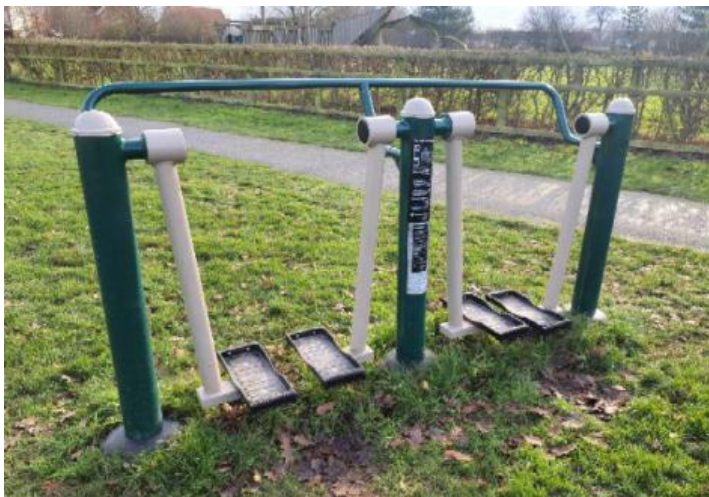
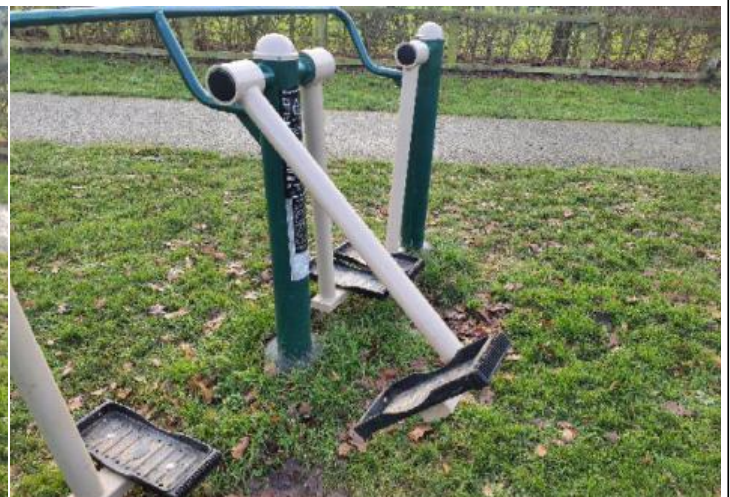
Item: Outdoor Fitness Equipment - Air Walker
Manufacturer: Fresh Air Fitness

Finding: The swinging movement of the item exceeds the maximum 55 degrees from the vertical required by BS EN 16630

Action: Monitor - No action given the risk assessment

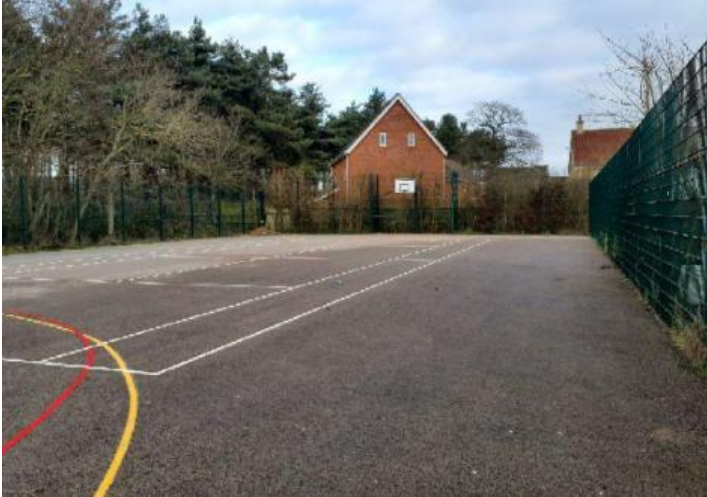
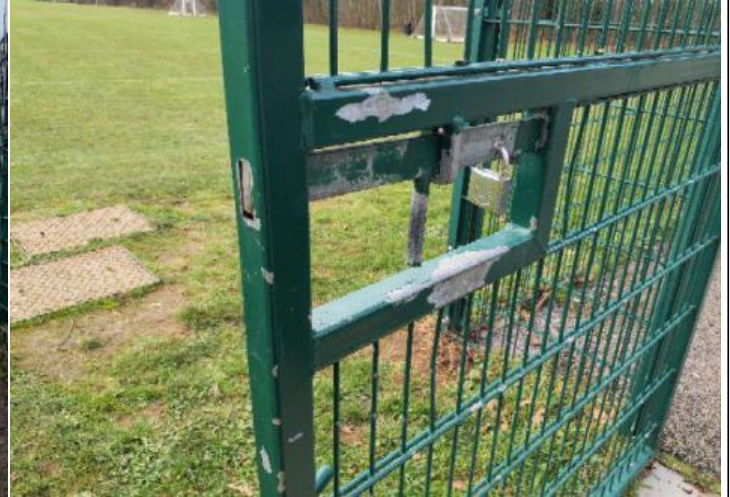
Item:	Multi Use Games Area - Multi Use Games Area (MUGA)	Risk Level:	L - Low Risk
Manufacturer:	Sure Shot	Surface:	Bitmac

Finding: The paint is flaking off the metalwork

Action: Rub down and re-paint

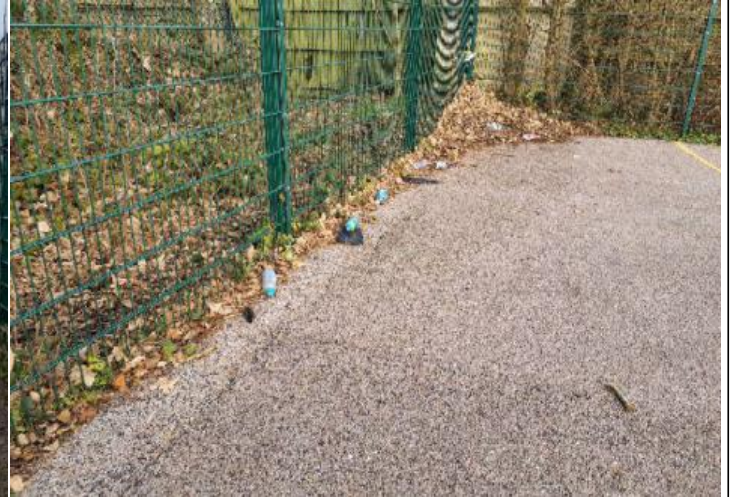
Item: Multi Use Games Area - Multi Use Games Area (MUGA)
Manufacturer: Sure Shot

Finding: There is litter/debris in the area

Action: Remove litter/debris from the area and maintain

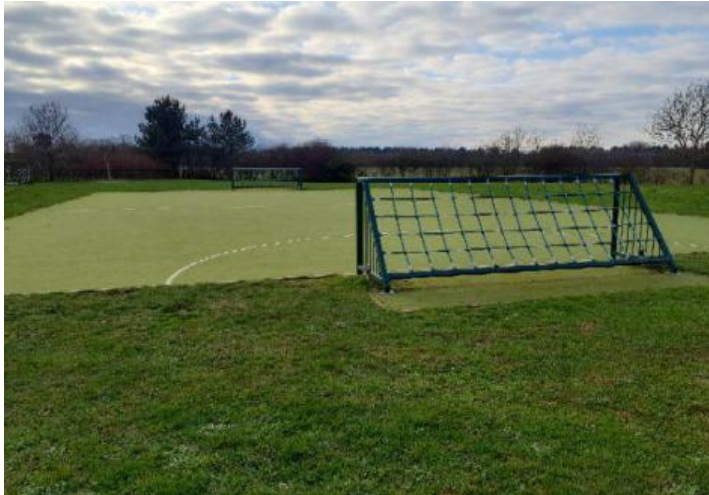
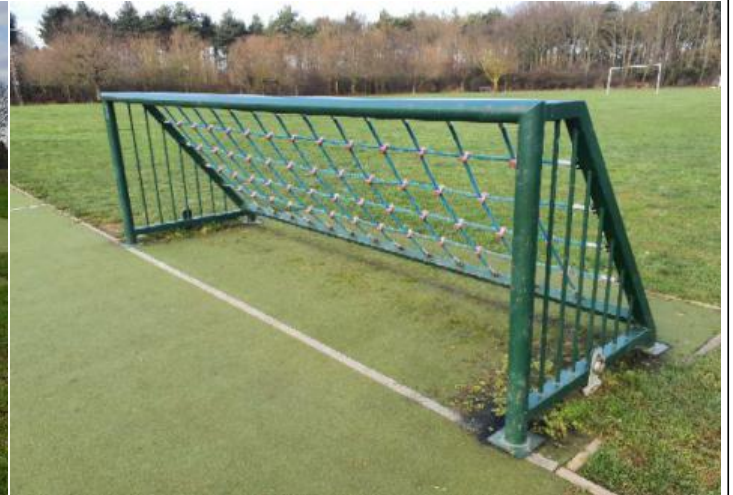
Item: Multi Use Games Area - 5 a side Goals
Manufacturer: Not Identified

Finding: The design of the equipment may encourage climbs onto the goal, and the concrete edgings form an hard object in the impact area in contravention of BS EN 15312

Action: Refer to the manufacturer / contractor and modify the design to comply with the requirements of BS EN 15312

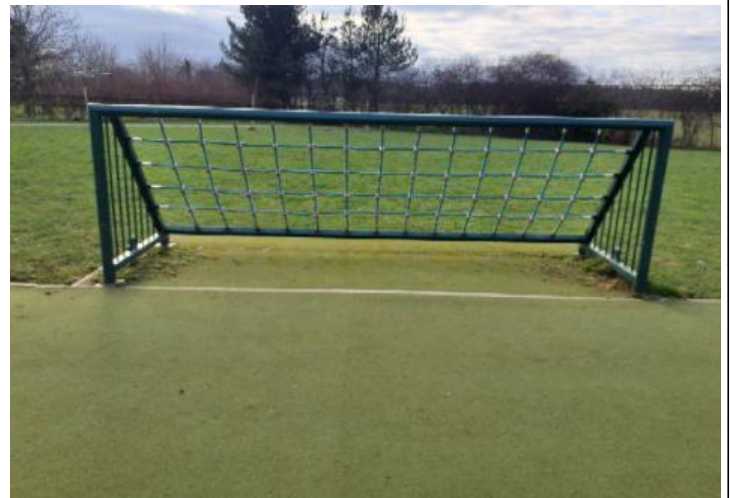
Item: Multi Use Games Area - 5 a side Goals
Manufacturer: Not Identified

Finding: There is weed / vegetation growth within the surface

Action: Remove weed / vegetation growth

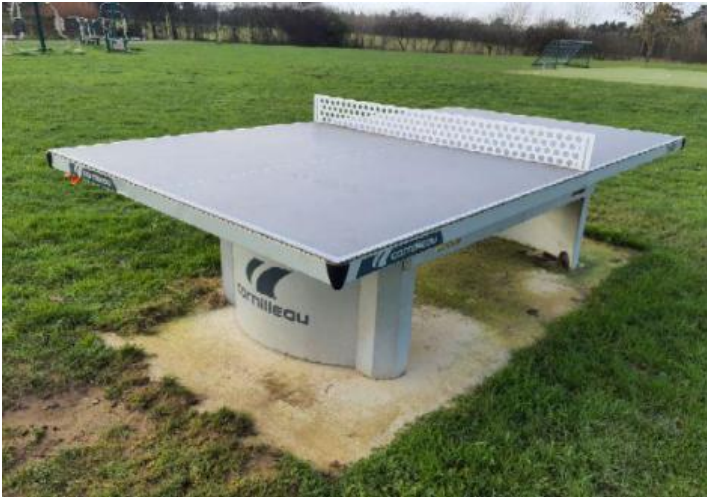
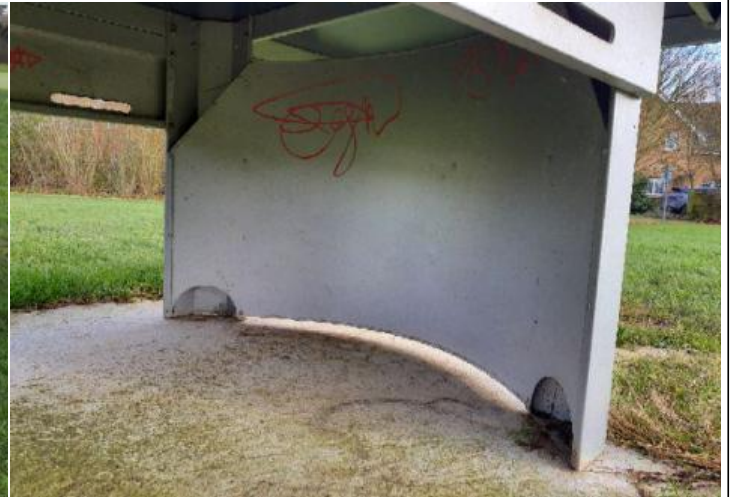
Item: Other - Table Tennis
Manufacturer: Cornilleau

Finding: There is some graffiti present

Action: Remove the graffiti
